May 12, 1988
ST-HL-AE-2655
PFN: G4.2
10CFR50

South Texas Project Electric Generating Station
Units 1 and 2
Docket Nos. STN 50-498, STN 50-499
Bottom Mounted Instrumentation (BMI) Thimble Inspection

SUMMARY OF THIMBLE WEAR
SOUTH TEXAS 1 - 5/9/88

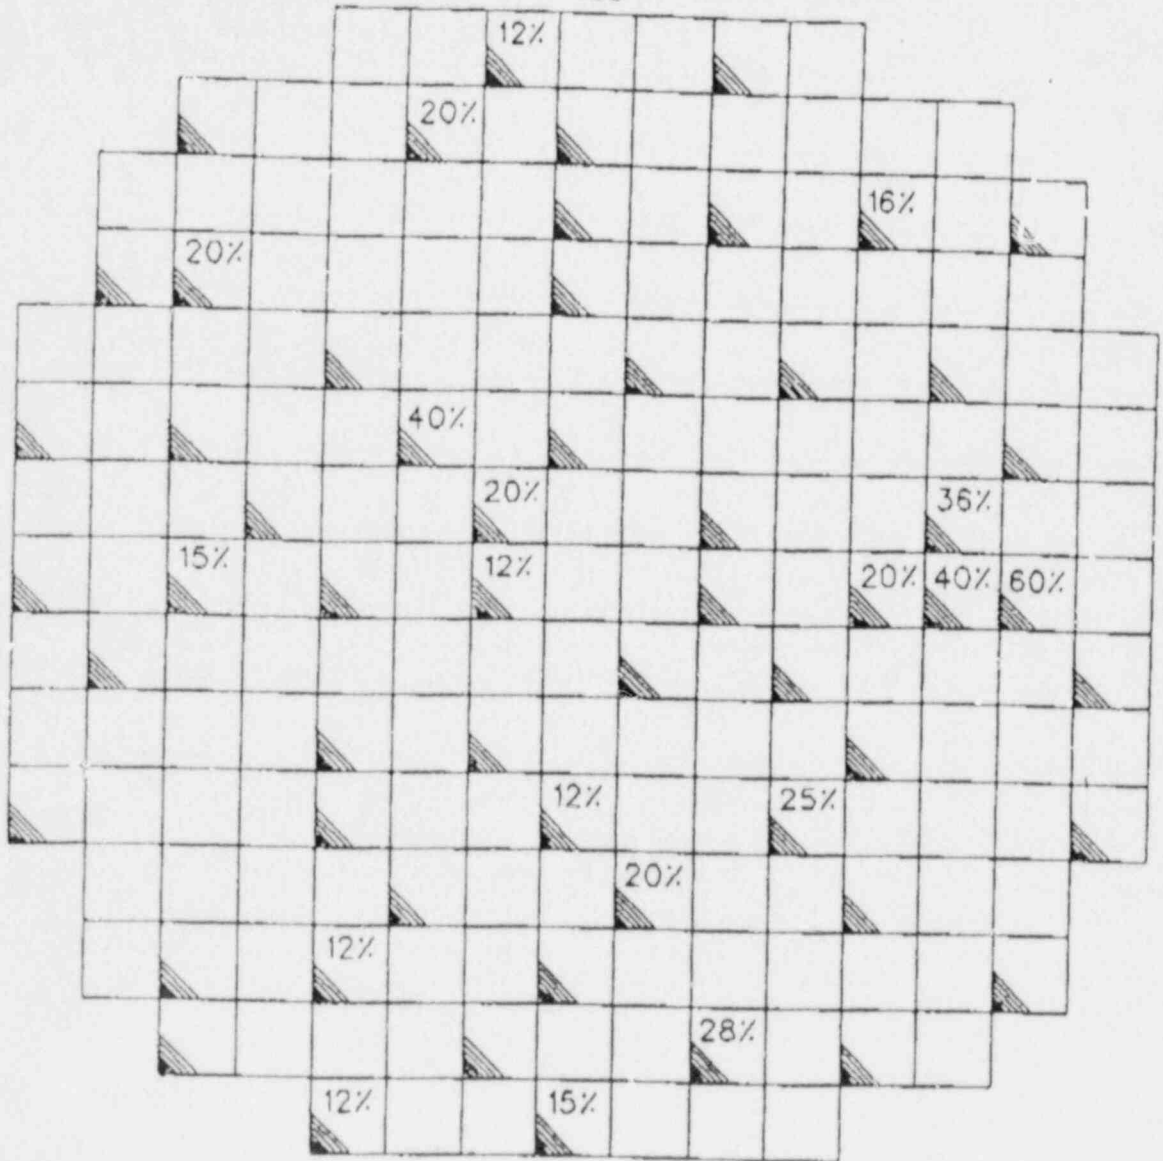
- THIMBLE LOCATIONS

QUANTITY	PERCENT WALL LOSS (FLOW LIMITER)	CORE LOCATION
1 EACH	60 %	B-8
2 EACH	40 %	K-6, C-8*
1 EACH	36 %	C-7
1 EACH	28 %	F-14
1 EACH	25 %	E-11
5 EACH	20 %	J-7, D-8, G-12, K-2, N-4
1 EACH	16 %	D-3
2 EACH	15 %	H-15, N-8
5 EACH	12 %	L-13, H-11, J-1, J-8, L-15

QUANTITY	PERCENT WALL LOSS	CORE LOCATION
1 EACH	20 %	K-2*
1 EACH	16 %	B-8*
1 EACH	15 %	H-15*
1 EACH	12 %	D-3*
3 EACH	10 %	D-12, F-1, P-4

* INDICATES THIMBLES THAT HAVE WEAR AT THE FLOW LIMITER
AND A SECOND ELEVATION
