ATTACHMENT 1
ST-HL-AE-2652
MAY 12, 1988
HOUSTON LIGHTING & POWER COMPANY

EVALUATION OF THE ESSENTIAL
COOLING WATER SYSTEM AT THE
SOUTH TEXAS PROJECT ELECTRIC GENERATING STATION

Revision 0
May 12, 1988

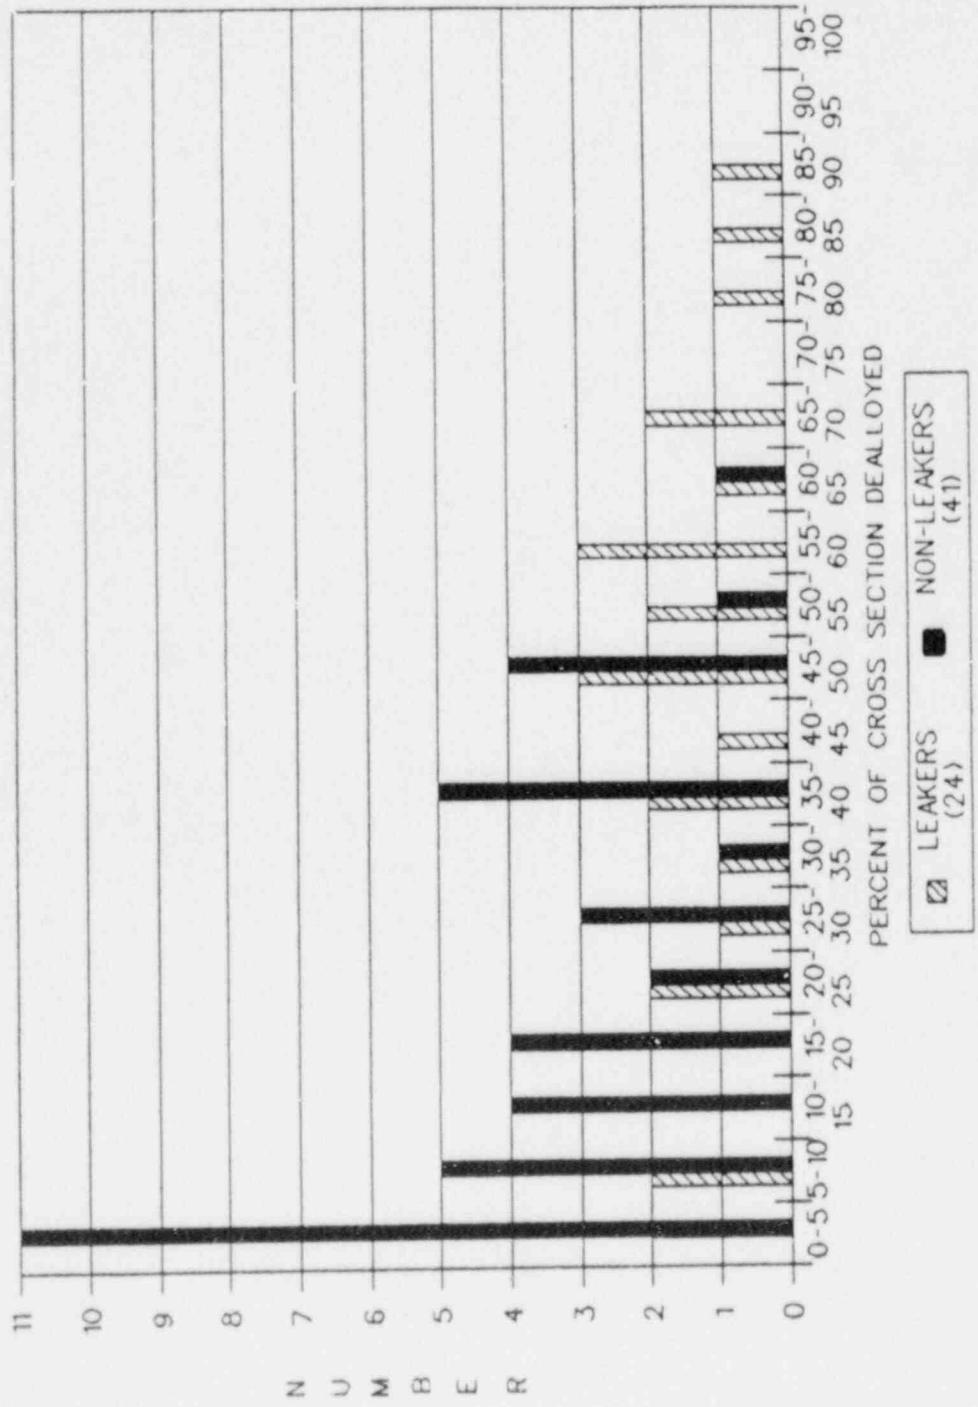
FIGURE 2

Removed components were sent to Bechtel Materials & Quality Services for evaluation of area of dealloying. While most of the components removed had at least one socket end leaking, the sample included some components which had neither side leaking, as a result of the location of the cuts in the piping system. The sample was thus randomly selected.

The socket ends were examined for area of dealloying by cutting, polishing and etching. The worst case total area of dealloying was estimated by an iterative process of progressive slicing and etching. Figure 2 shows, in summary, the distribution of socket ends that were cut and evaluated in this fashion.

It has been observed that fittings were, in general, less dealloyed than valves, which is attributed to the lower aluminum content of the CA952 alloy used in small bore fittings. The total sample of susceptible cast materials, contained mostly leaking valves of the CA954 alloy and is thus biased in the conservative direction.

STP UNIT 1 ALUMINUM/BRONZE ECWS
DISTRIBUTION OF SAMPLED FITTINGS

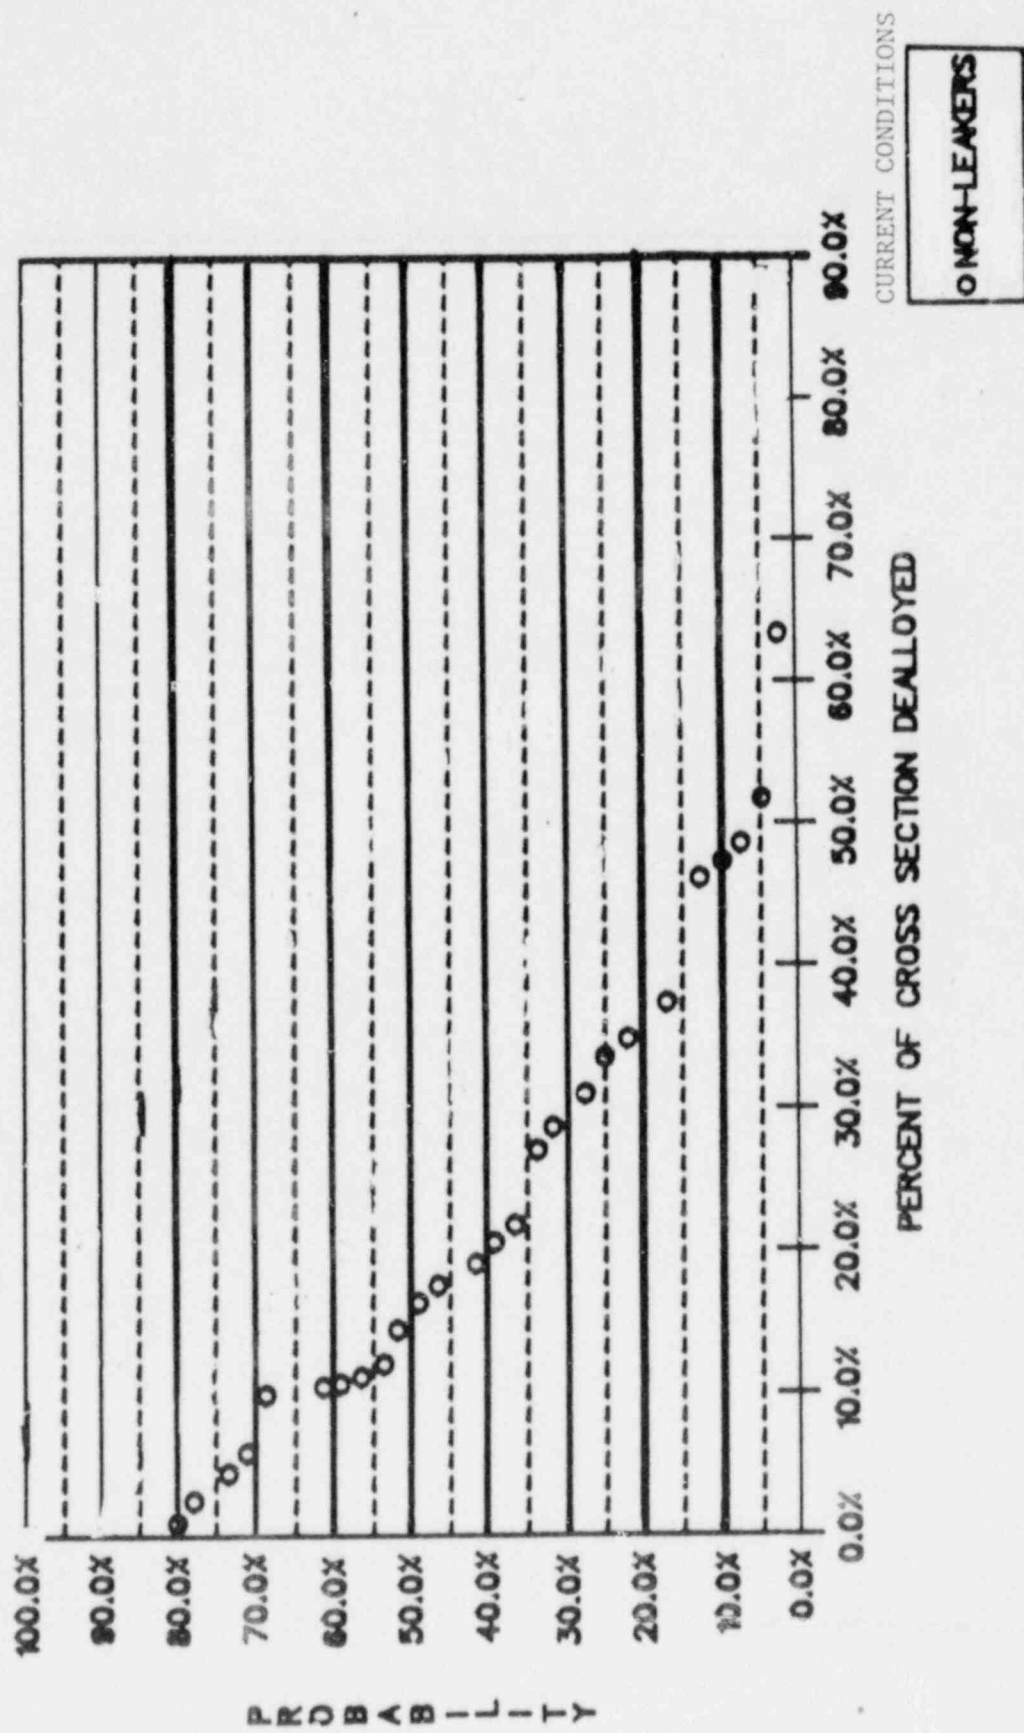
FIGURE 3

The results of the measurement of dealloyed area in the sample of 24 leaking and 41 non-leaking socket ends were statistically analyzed to project the worst case dealloyed area in a previously leaking (replaced) socket end, and in a non-leaking socket end. It was determined with 95% probability and 95% confidence level that a socket end in the present non-leaking population has no more than 55% area dealloyed. The mean area dealloyed is 20% as shown in Figure 3.

STP UNIT 1 ALUMINUM/BRONZE ECWS
 PIPING CUMULATIVE PERCENT DEALLOYED

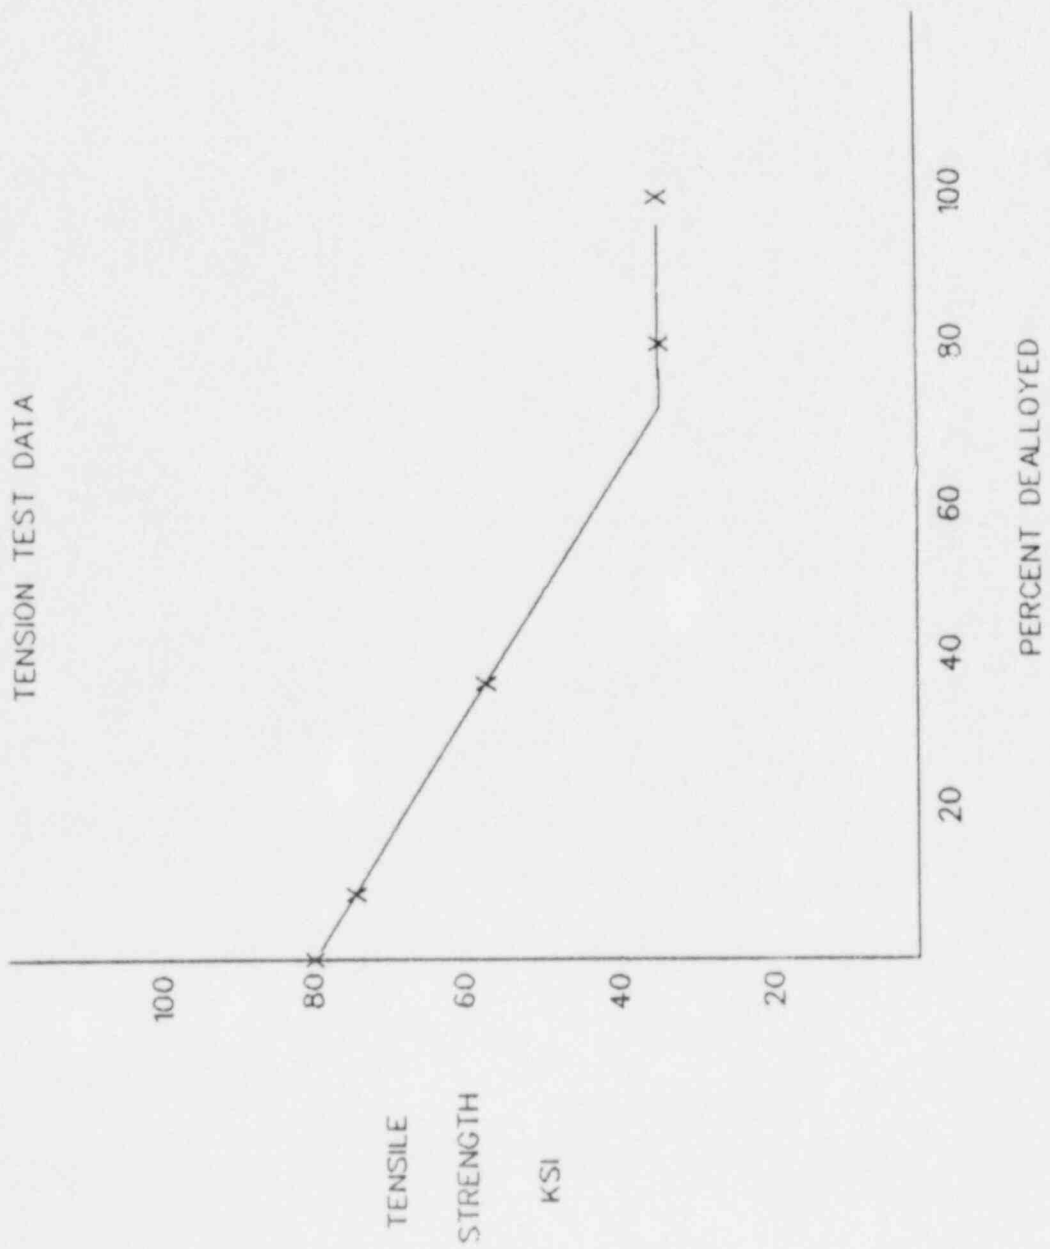
FIGURE 5

Tensile tests measured the strength of the composite partially dealloyed cross section and of the dealloyed material itself. Figure 5 is a summary of these tests. Based on this, it can be seen that the dealloyed section has substantial strength, and contributes to the overall load carrying capacity.
