MEMORANDUM FOR: William F. Kane, Director, Division of Reactor Projects

FROM: Roy L. Fuhrmeister, Reactor Engineer, RPB No. 1, DRP

SUBJECT: PILGRIM RESIN RELEASE IN JUNE 1982

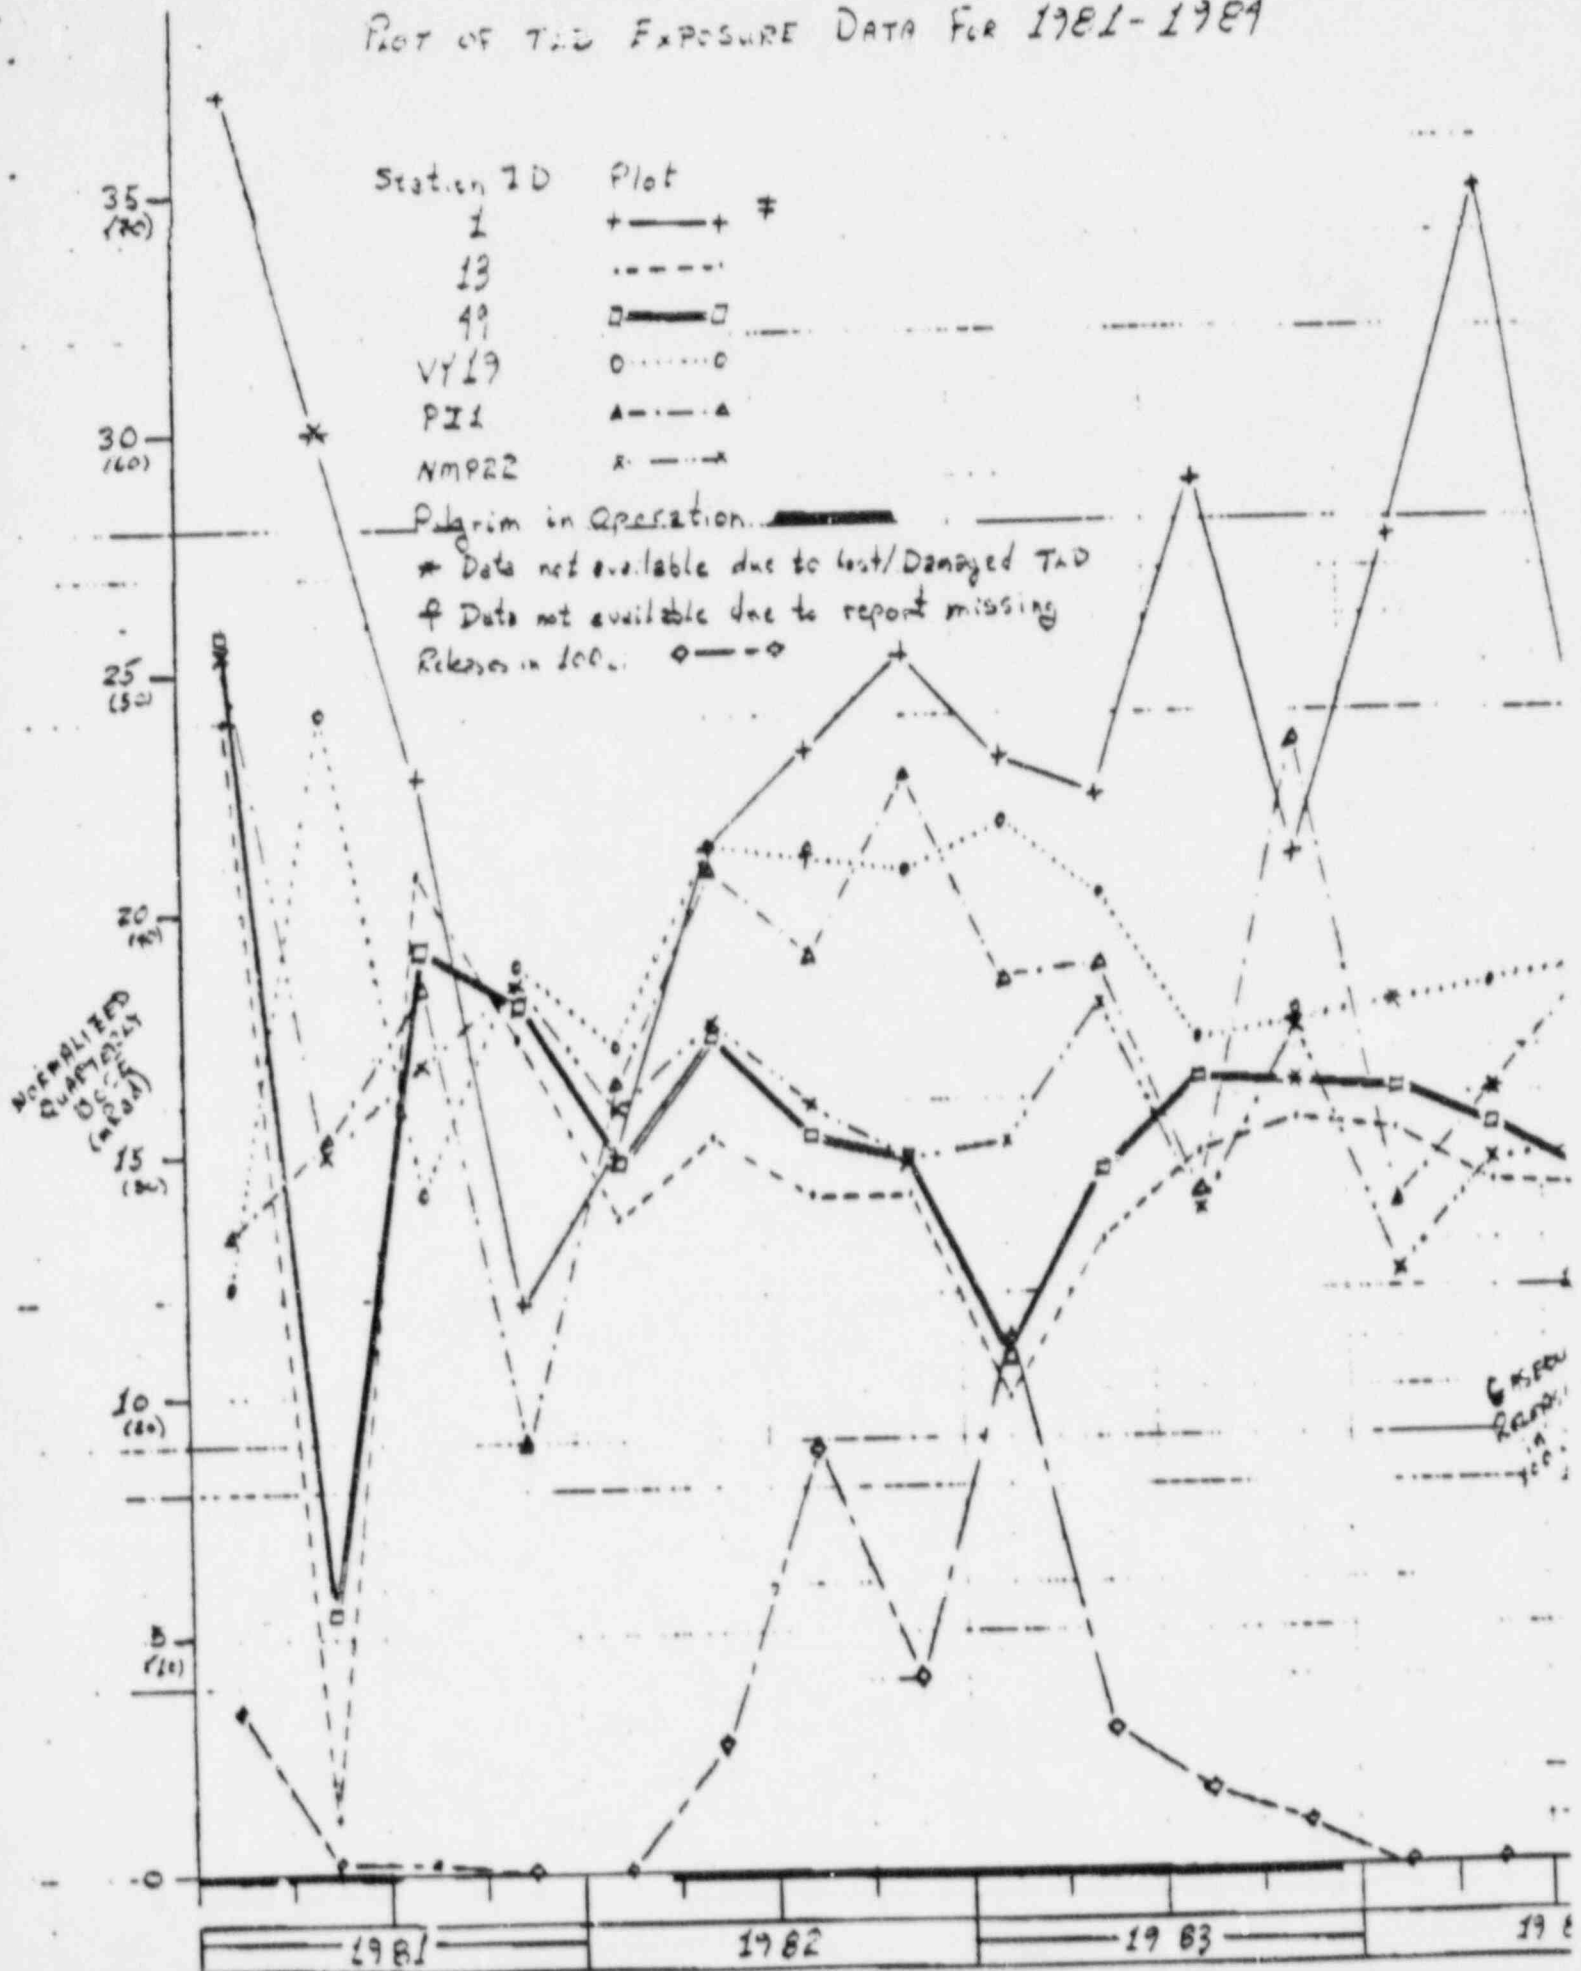
Plot of TLD Exposure Data For 1981-1984

It is interesting to note that during the first half of 1984, while the plant was shut down, TLD 1 from Pilgrim showed striking increases in the dose. Also of note is the fact the TLD 49 from Pilgrim, located in Weymouth, Massachusetts, shows a consistently higher dose than TLD 13, which is only 0.7 miles from the plant.

As a check on TLD 1, the plant operation time-line and quarterly release data are also included in the figure. No correlation with plant activities is readily apparent. In fact, the high reading in early 1984, with the plant shut down and no releases being made is inconsistent with Mr. Abbott's contentions.

In conclusion, it can be seen that the off-site dose in the vicinity of Pilgrim Nuclear Power Station followed the general trend of the other sites in the Northeastern United States. This trend includes a significant drop in doses during the first quarter of 1982. This drop, if narrowly construed, could lead one to the conclusion that the second quarter 1982 dose was significantly higher. This would be an erroneous conclusion, since second quarter 1982 dose is lower than the fourth quarter 1981 dose. In general, it appears that from mid-1981 to mid-1983, Eastern Massachusetts dose data followed the decreasing trend evidenced across the Northeast United States. In fact the doses in Eastern Massachusetts, including those measured around the Pilgrim site (with the exception of TLD No. 1 which is exposed to turbine "shine"), were on the order of 70% of expected natural background throughout the period. First quarter 1983 doses show a dramatic drop in Eastern Massachusetts, despite a major release from Pilgrim during that time period (13,200 ci, higher than the 1982 release). It is also worthy of note that with the exception of the third quarter 1981, Weymouth, Massachusetts doses

were higher than those recorded only 0.7 miles from the site. This suggests factors other than operation of and releases from Pilgrim are affecting the results of the environmental monitoring program. This also shows that the 1982 resin release and higher dose readings are strictly coincidental.

The dose readings on TLD 1 are in the range of 1 to 3 times the expected background levels for the area. The cause of the elevated readings was originally thought to be "turbine shine". The 1984 data do not support that conclusion, and further information on plant activities in 1984 is being developed. Particular interest is being paid to temporary on-site storage of materials removed during the recirculation piping changeout.
