Subject: Oyster Creek Nuclear Generating Station (OCNGS)
Docket No. 50-219
License No. DPR-16
Oyster Creek Drywell Containment

ATTACHMENT
OYSTER CREEK
UPPER DRYWELL REGION
SUPPLEMENTAL INFORMATION

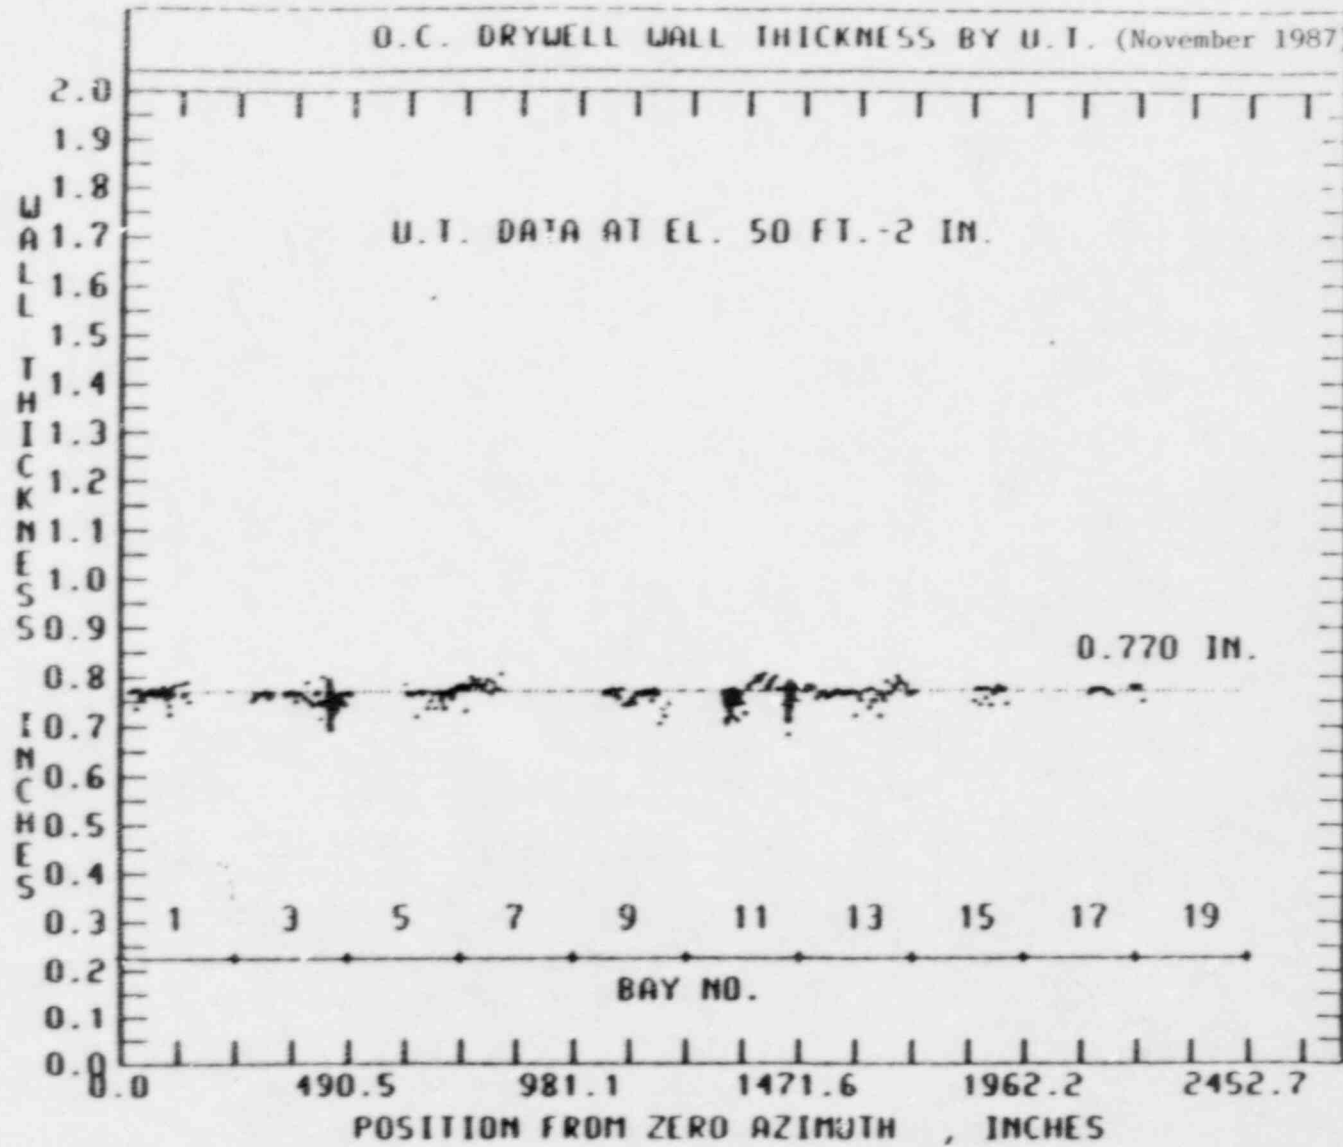
FIGURE 1

UT indicated that, at the 50'2" and 87'5" elevations, the drywell wall had undergone general corrosion at some locations with isolated pits (see figures 1 and 2). Remember that general corrosion of carbon steel is merely a progression of pits. The lowest average grid thickness at elevation 50'2" was 0.757" and at elevation 87'5" was 0.619". The conservatively estimated wall losses were 33 and 46 mils, respectively. We conservatively applied the corrosion estimates, for safety evaluation purposes, to the entire region (circumference and height) at all elevations above the sand bed, even though we know that this extent of corrosion clearly does not exist.
