LICENSEE EVENT REPORT (LER)

FACILITY NAME (1) Limerick Generating Station Unit 1	DOCKET NUMBER (2) 0 5 0 0 0 3 5 2	PAGE (3) 1 OF 0 5
---	--------------------------------------	----------------------

TITLE (4) Reactor Water Cleanup Isolation due to High Regenerative Heat Exchanger Room Temperature Caused by a Pressure Relief Valve Lifting

Abstract: LER 88-009 Rev. 01

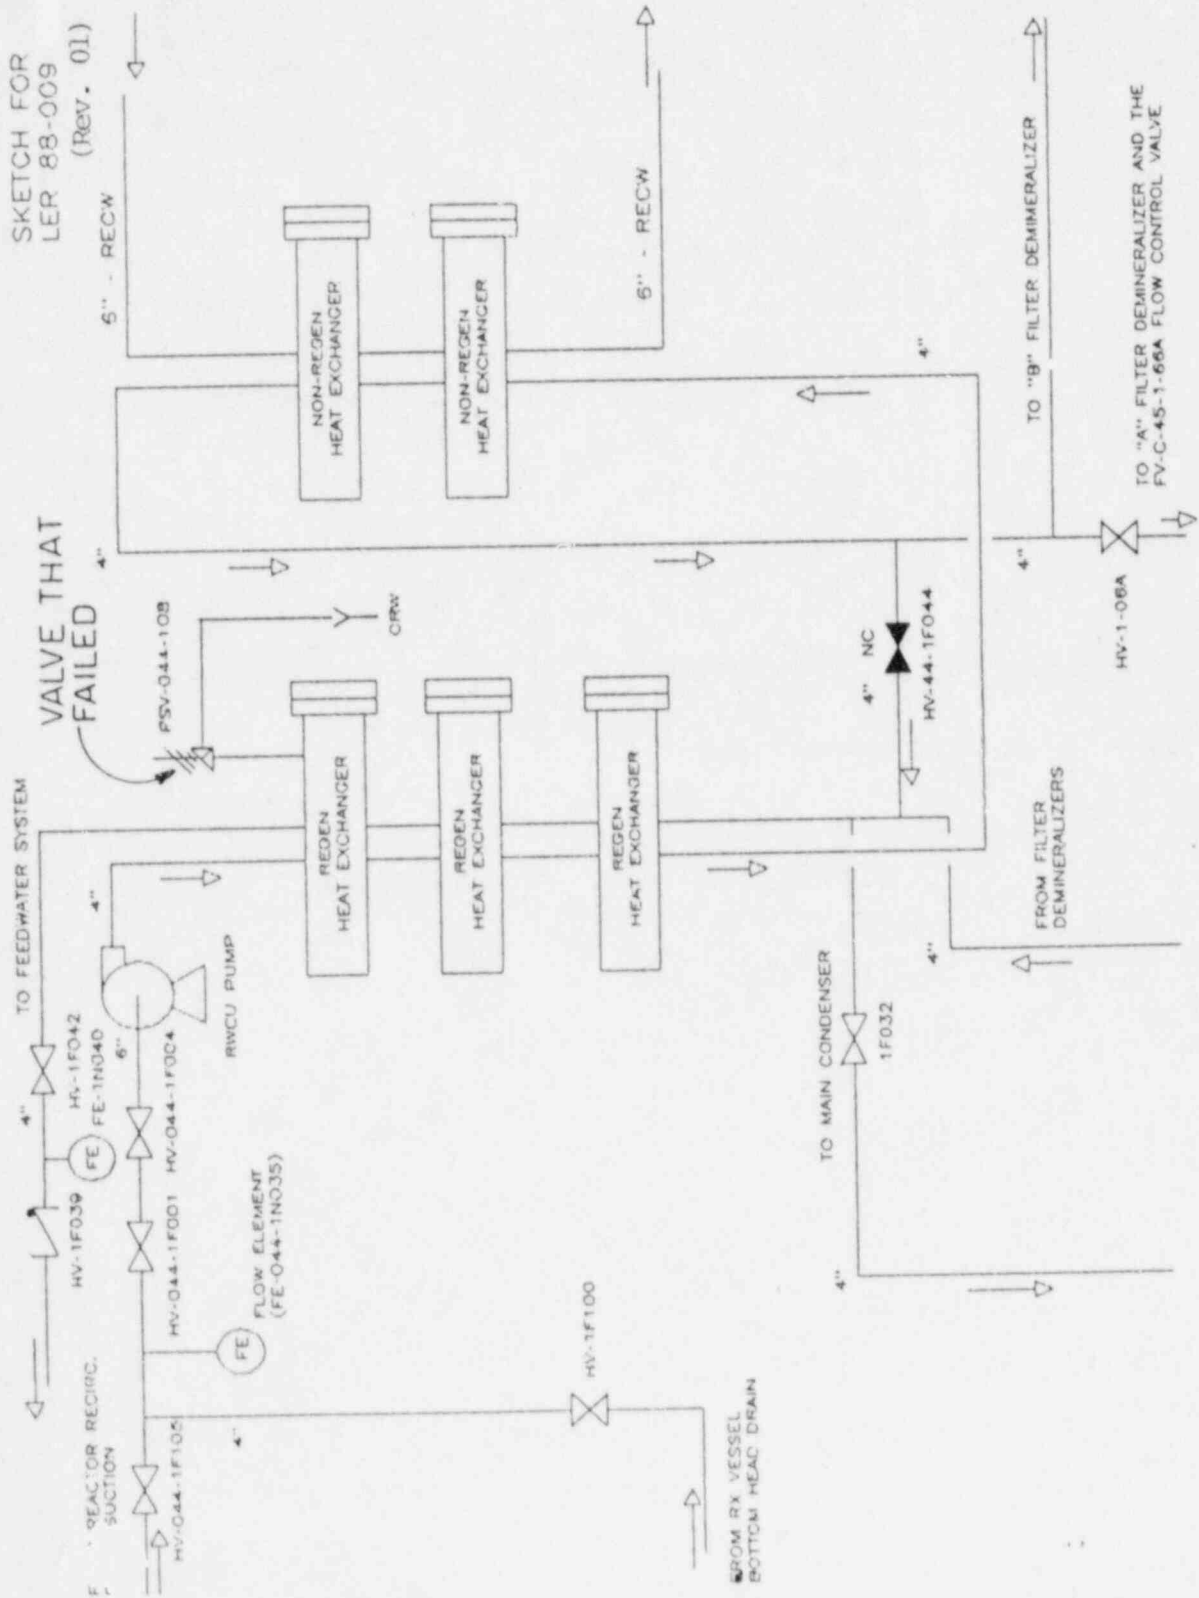
SKETCH FOR
LER 88-009
(Rev. 01)

On March 24, 1988 at 0448 hours, an isolation of the Reactor Water Cleanup (RWCU) system occurred. The isolation occurred when the regenerative heat exchanger room temperature sensing element (TE-44-1N016A) sensed a temperature above its 122 degree Fahrenheit setpoint and initiated a Nuclear Steam Supply Shutdown System (NSSSS) Group III, Division 1 "steam leak detection high temperature" isolation. Upon receipt of the isolation signal, the inboard isolation valve (HV-044-1F001) closed and the 'A' and 'B' RWCU pump tripped, as designed, on the closure of the inboard isolation valve (HV-044-1F001). The isolation was reset at 1207 hours and the RWCU system was blocked to investigate and replace the leaking pressure relief valve PSV-044-108 (Lonergan model D72G), located on the regenerative heat exchanger (see attached sketch). The duration of the isolation signal was 7 hours and 19 minutes.

The isolation occurred when the regenerative heat exchanger room temperature sensing element sensed a temperature above its 122 degree Fahrenheit setpoint. Water from the shell side of the first regenerative heat exchanger flashed to high temperature steam in the regenerative heat exchanger room when pressure relief valve PSV-044-108 (Loneragan model D72G) lifted. The cause of the valve lifting has not been determined and additional investigations are required. A supplemental report will be issued after a cause for the failure has been determined. The temperature sensing element sensed the steam temperature and initiated an NSSSS Division 1 "steam leak detection high temperature" alarm.

VALVE THAT
FAILED

Following the isolation, the RWCU system was blocked. Reactor water chemistry grab samples were taken on a periodic basis, in accordance with procedures, to ascertain reactor water purity following the isolation. Pressure relief valve PSV-044-108 was replaced on March 25, 1988.

Engineering has been requested to determine the failure mode of the pressure relief valve and suggest corrective actions to prevent recurrence of this event. A progress report will be issued by June 30, 1988.
