Subject: LaSalle County Station Unit 2  
Response to Confirmatory Action Letter  
NRC Docket No. 50-374

ATTACHMENT A

COMMONWEALTH EDISON COMPANY RESPONSE TO

THE MARCH 17, 1988, CONFIRMATORY ACTION LETTER (CAL)

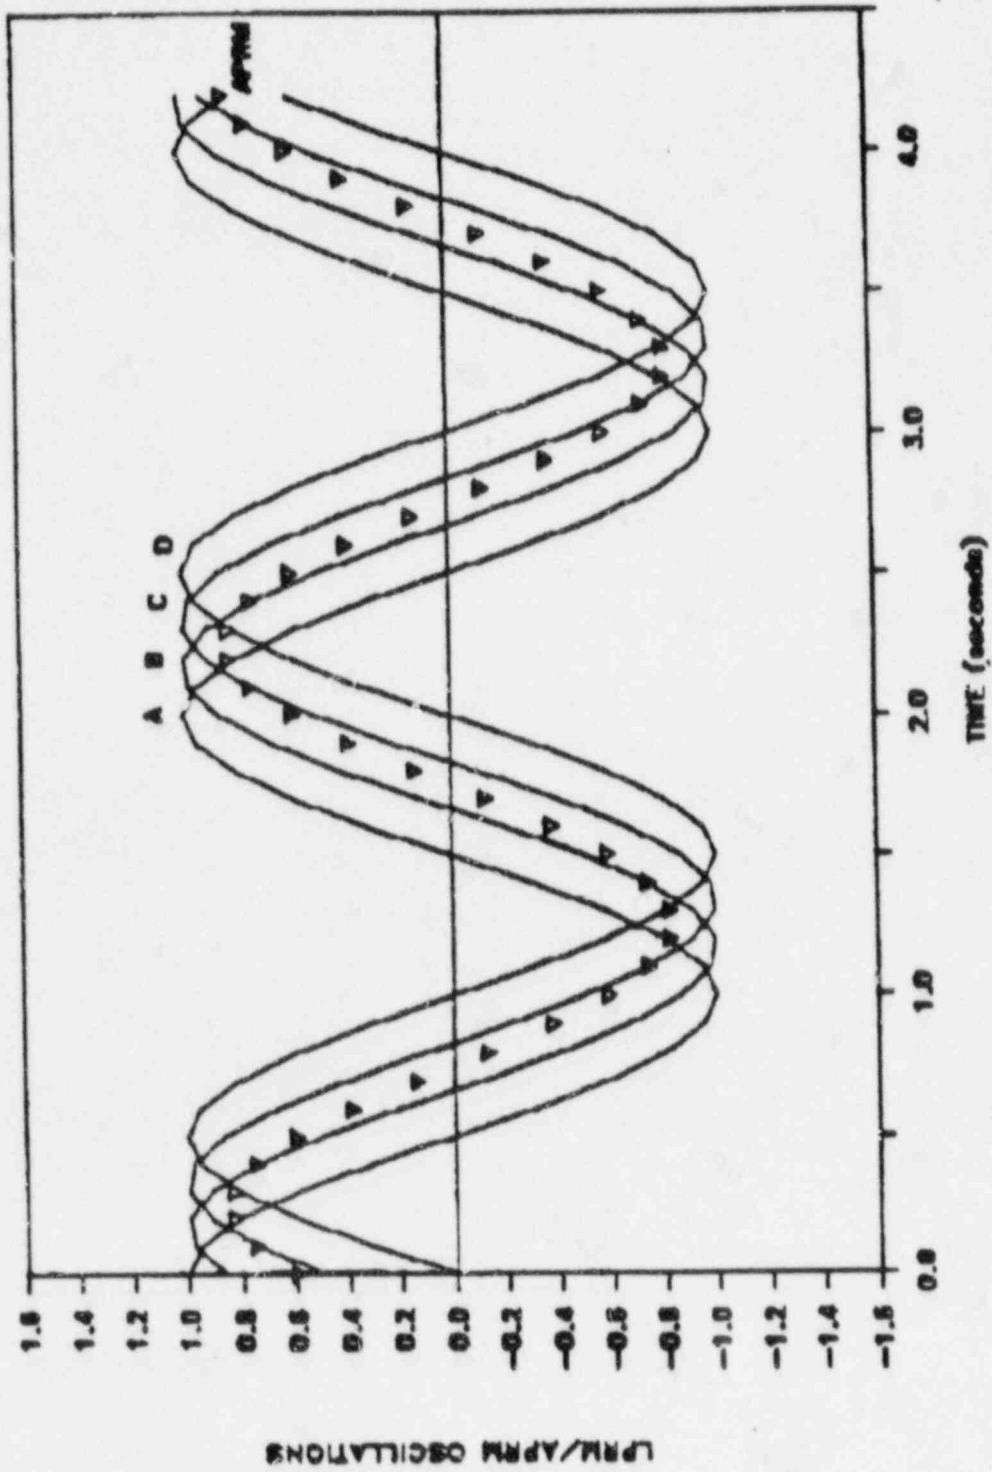
FIGURE 3  
LPRM AXIAL PHASE RELATIONSHIP

Another factor that must be considered in the relationship between the LPRM and APRM signal is the phase lag that occurs from the bottom to the top of the core during density wave oscillations. Since the oscillations are caused by a perturbation in the coolant density, the effect of the perturbation must travel up the channel before impacting the higher level LPRMs. This propagation of the perturbation causes a phase shift between the signals at the four LPRM levels. The effect on the APRMs is that each LPRM level does not react its peak at the same time and therefore the APRM to LPRM relationship during these transient conditions is not the same as it would be during steady state operation. Figure 3 shows an example of how the phase relationship affects the APRM to LPRM relationship. Four LPRMs (Levels A, B, C and D) are assumed to be oscillating with the same magnitude but 90° out of phase (A to D level). The average of the four signals (indicative of what an APRM signal would do) oscillates at the same frequency but its peak magnitude is not as high as the peak of each individual LPRM since the four peaks do not occur at the same time. However, since the LPRMs are indicating a true phase lag between the oscillations at different axial locations, the APRMs are correctly measuring the core average neutron flux during core wide oscillations.

An analysis has been performed for the LaSalle-2 conditions at the onset of oscillations. The response of the LPRMs assigned to APRM Channel A have been modeled by a higher order sine wave (necessary to match the known non-linear characteristics of the oscillations). The LPRM with the highest average reading is assumed to oscillate up to 100% of scale (LPRM Upscale alarm setpoint) and the remaining LPRMs in APRM Channel A are assumed to oscillate with the same relative magnitude. This assumes that the peak-to-peak magnitude normalized to the average value is relatively constant for all LPRMs in the core (i.e., no shift in "peaking" during the oscillations). This assumption has been previously proposed and supported by data from the Vermont Yankee Stability tests. For the LPRM levels above the boiling boundary (B, C and D), the relative oscillation magnitude is assumed to be 1.2 times the relative magnitude for the A level LPRMs to account for the increased sensitivity to density perturbations in the voided regions (higher void coefficient). This relationship was also determined from the Vermont Yankee test data.

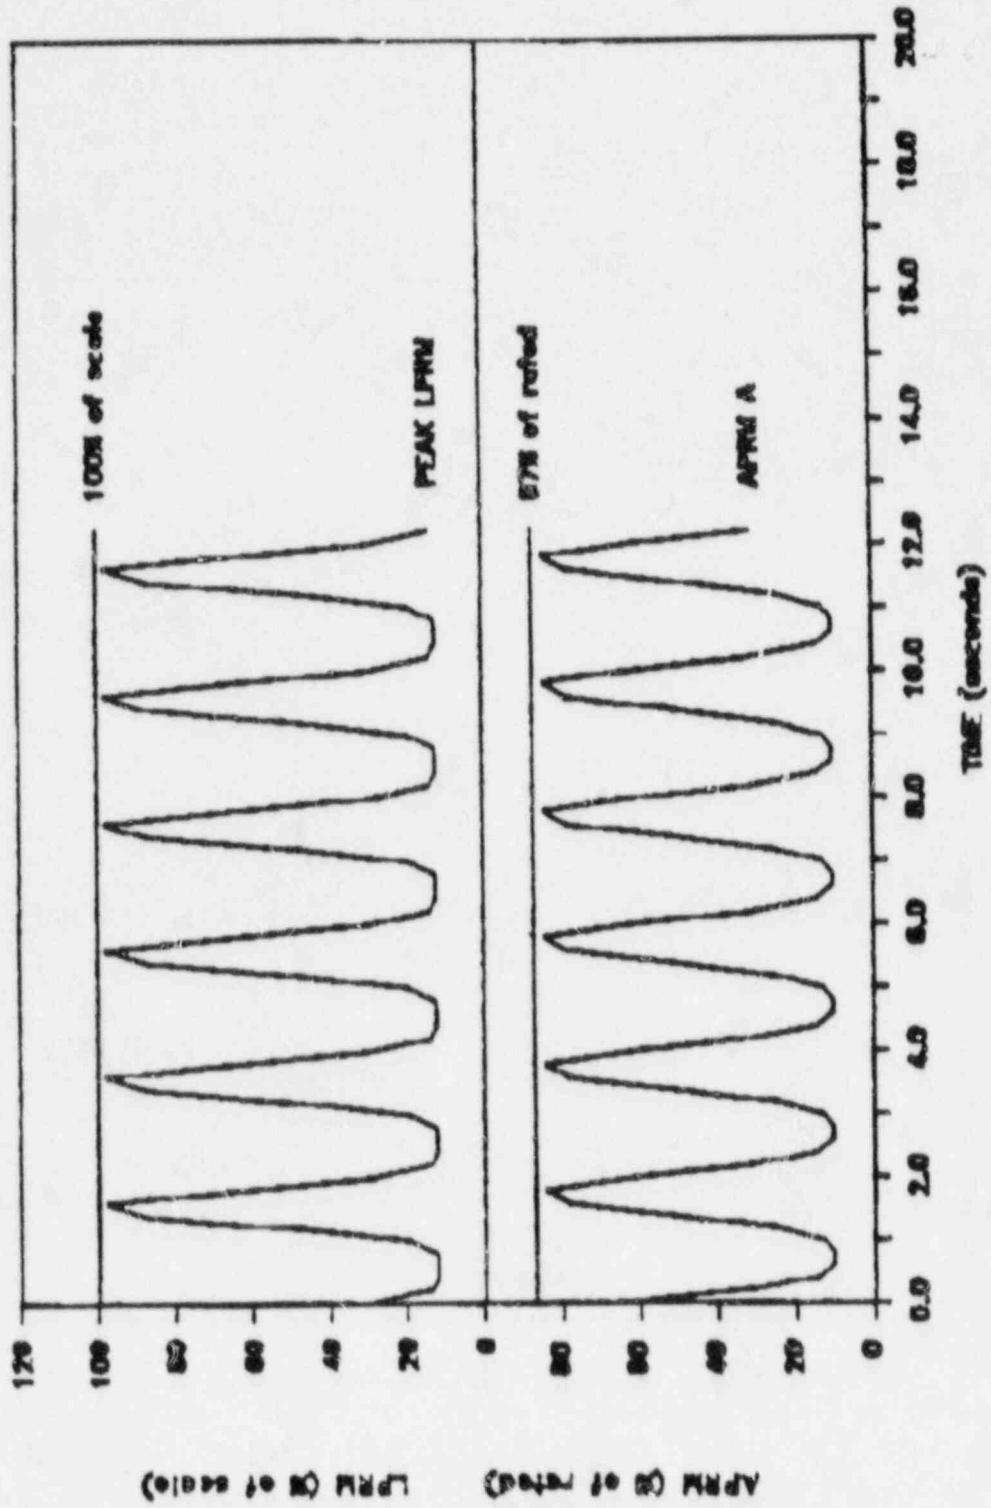
FIGURE 4  
LPRM/APRM RESPONSE DURING OSCILLATIONS

The occurrence of LPRM Upscale and Downscale alarms during the LaSalle-2 instability are consistent with the expected response of the core based on the APRM response. Because of a shift in power distribution following the recirculation pump trip and the phase relationship between LPRMs at different axial locations, LPRM alarms occurred at lower APRM levels than would be expected during steady state operation. The increase in power distribution was caused by the reduction in core flow following the recirculation pump trip which moves the boiling boundary lower resulting in a more bottom peaked axial power distribution. The phase relationship between the LPRM levels is a result of the density wave oscillation that is causing the core nuclear-thermal/hydraulic instability. Perturbations in coolant density must travel the length of the channel and therefore the neutron flux response to the perturbations is delayed in time at the higher levels in the core. These two factors are shown to explain why the LPRM alarms were triggered at the 87% APRM level.

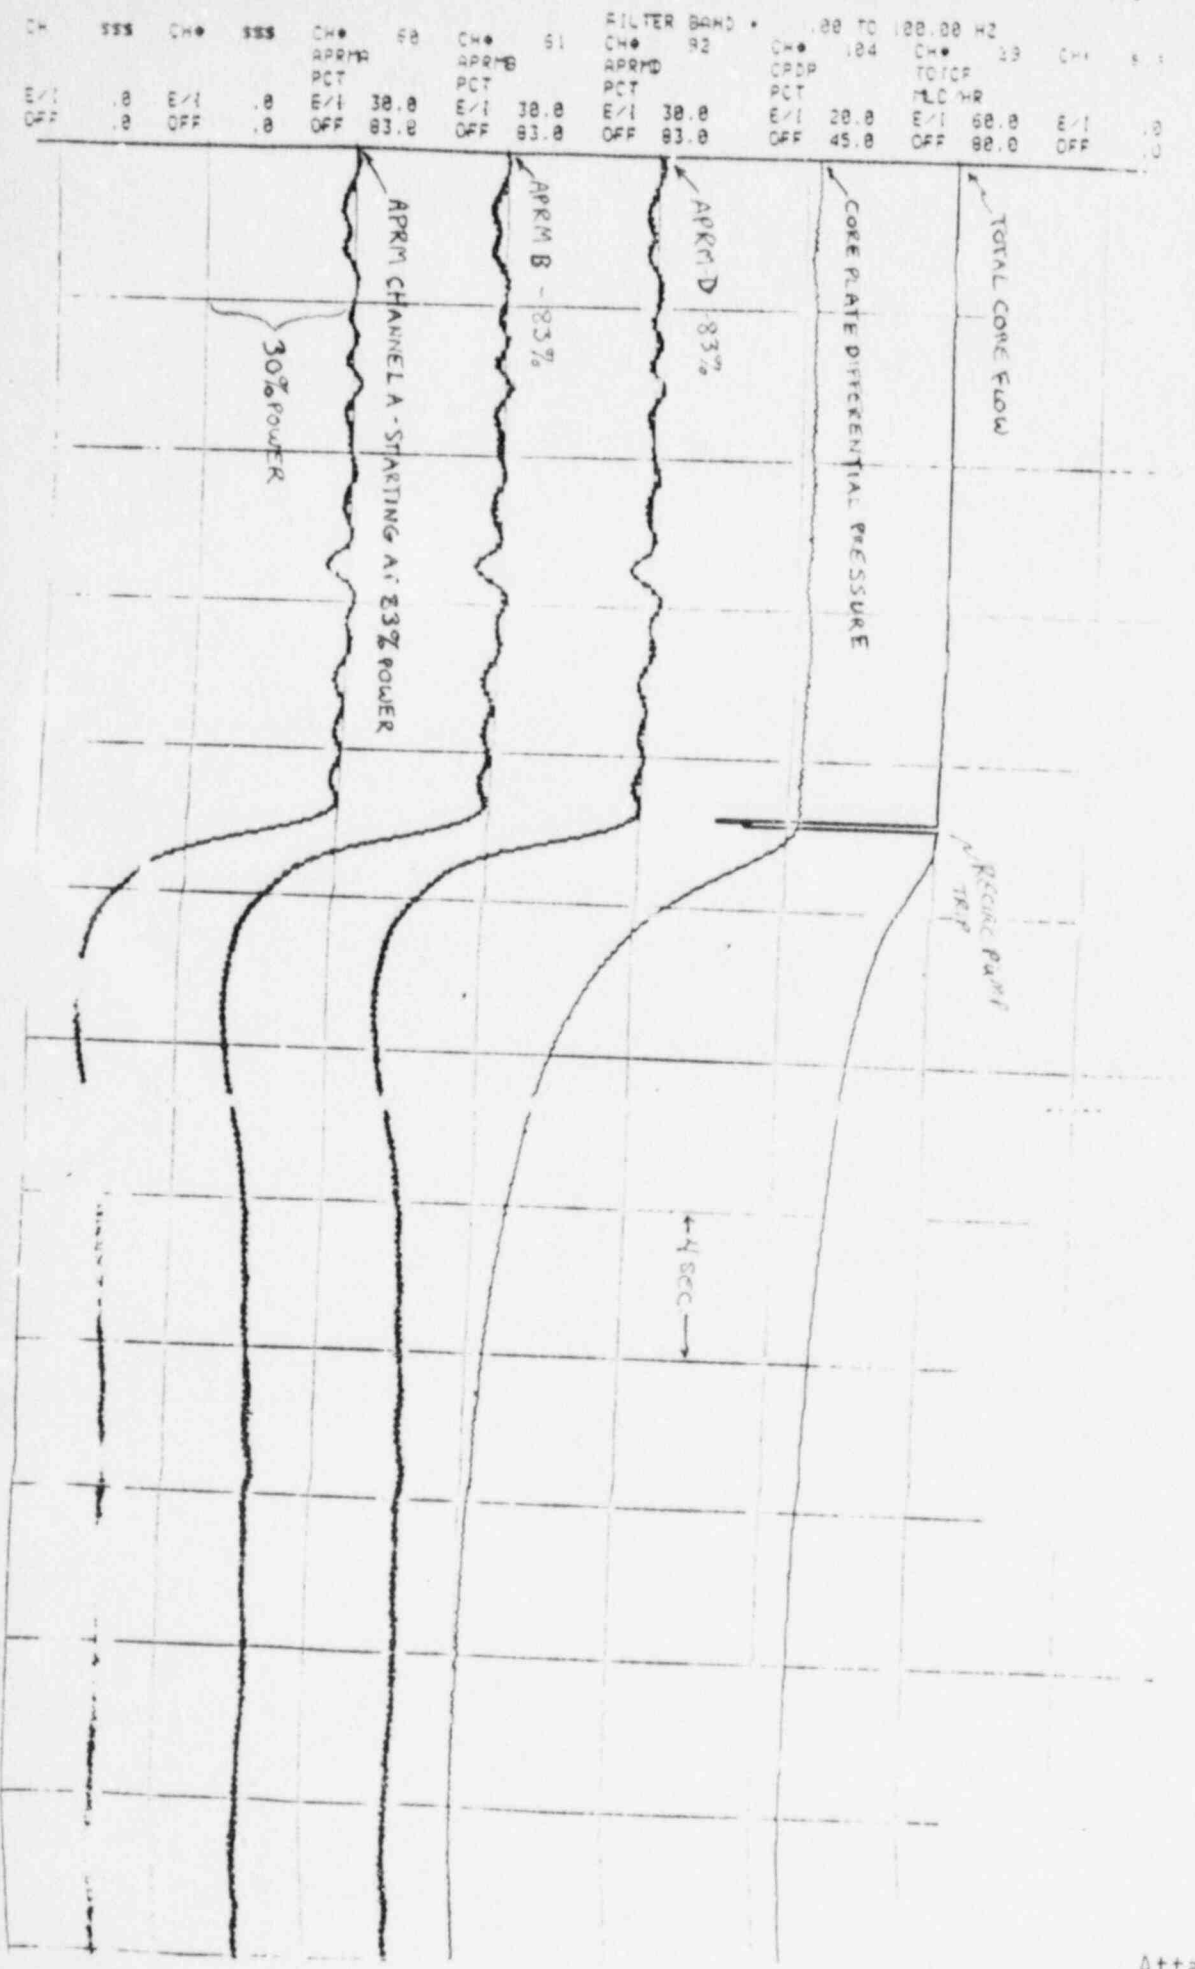
Attachment 3  
Figure 2

Available sensitivity studies indicate that variations in total core flow and power distribution had the most effect on the stability margins. From STARTREC traces recorded during the oscillations, the core flow varied by as much as 3% of rated with a minimum indicated flow of approximately 27% of rated. This value is 3% of rated below the value assumed in the licensing calculations and is a large contributor to the reduced stability margins at the actual plant conditions.
