Metallurgical Laboratory Note No. 85-990

Metallurgical Analysis of the 3A and 3C Wear Rings
Removed from the Residual Heat Removal Pump Impellers,
Peach Bottom Unit #3

Testing & Laboratories Division

January 8, 1986

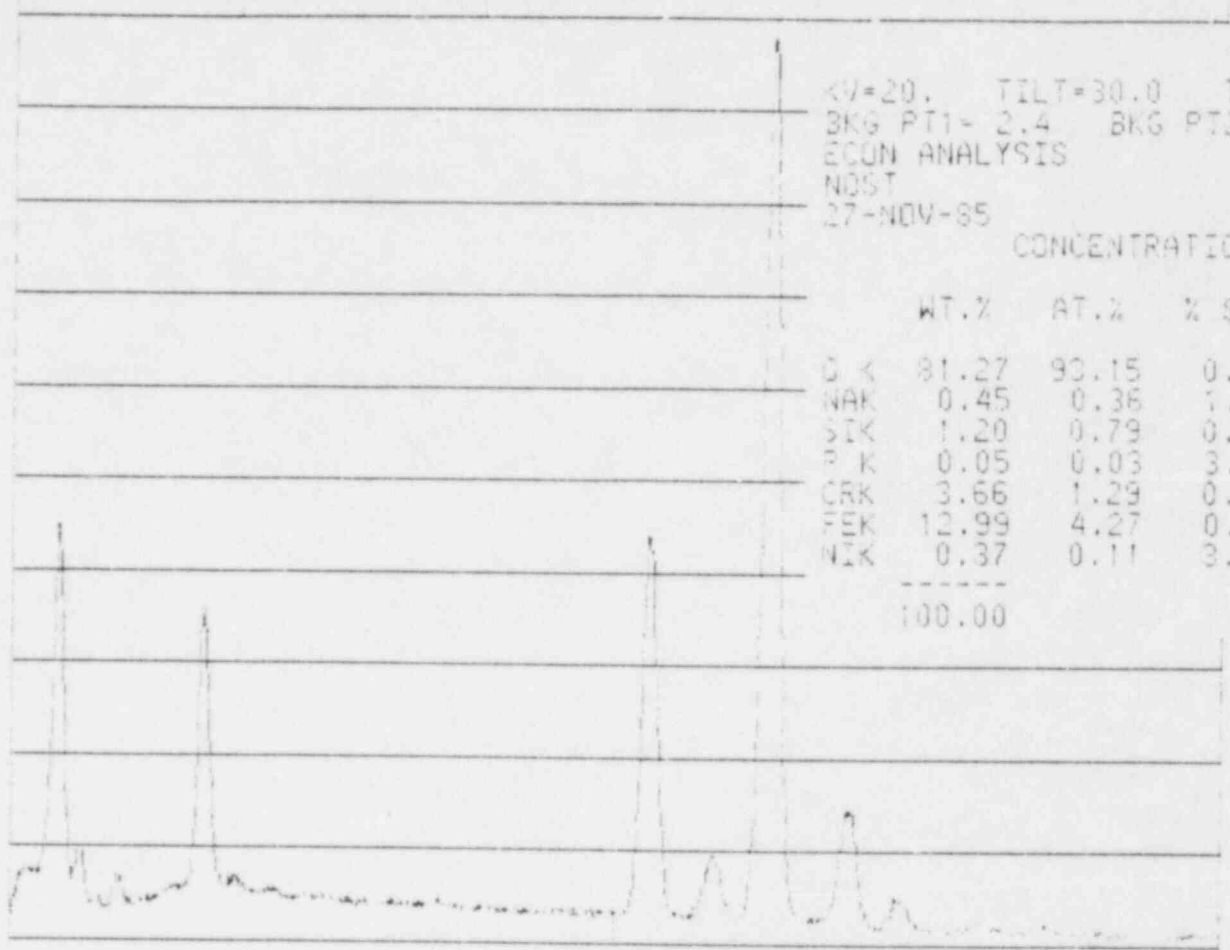
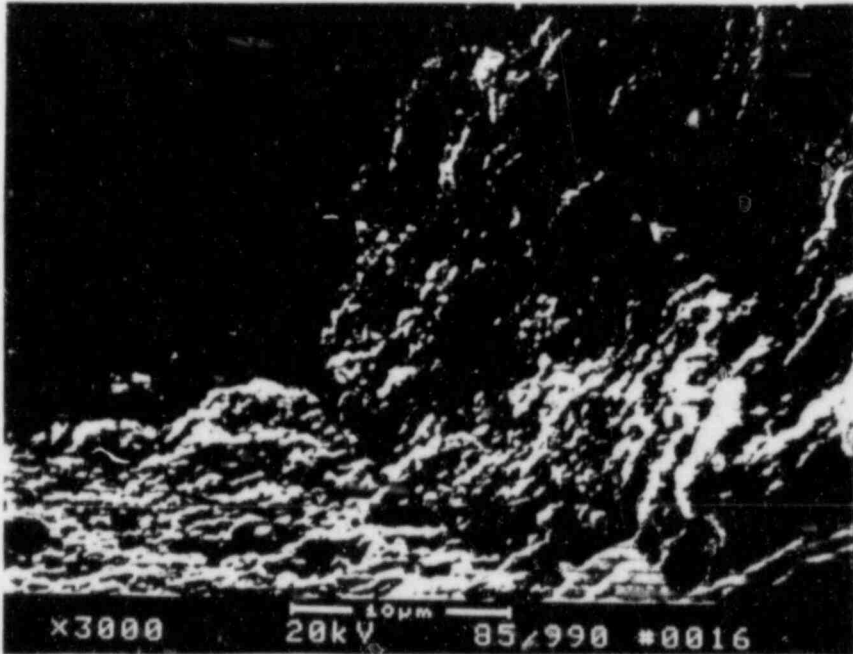
FIGURE ⑦

4. Debris within the O.D. surface discontinuities and corrosion deposits on the fracture surface were examined by x-ray microprobe. The presence of harmful contaminants were not detected. (Figures 6 & 7)
5. The material was verified to be ASTM A182 grade F6A (410) as specified by Bingham-Willamette. (Figure 8)
6. The mode of fracture, observed by electron microscopy and metallography, was intergranular cracking. (Figures 9 & 10)
7. The O.D. of the wear rings contained undesirable indications which appeared to be folds or laps typical of a machining operation and possible quench cracks from fabrication heat treatment. (Figures 11, 12, 13, & 14)
8. The microstructure was characteristic of a 410 Martensitic stainless steel in the quenched and tempered condition. There was no evidence of elongated or worked grains on the I.D. or O.D. surface. (Figure 15)

DEPOSITS ON # 16
3000X

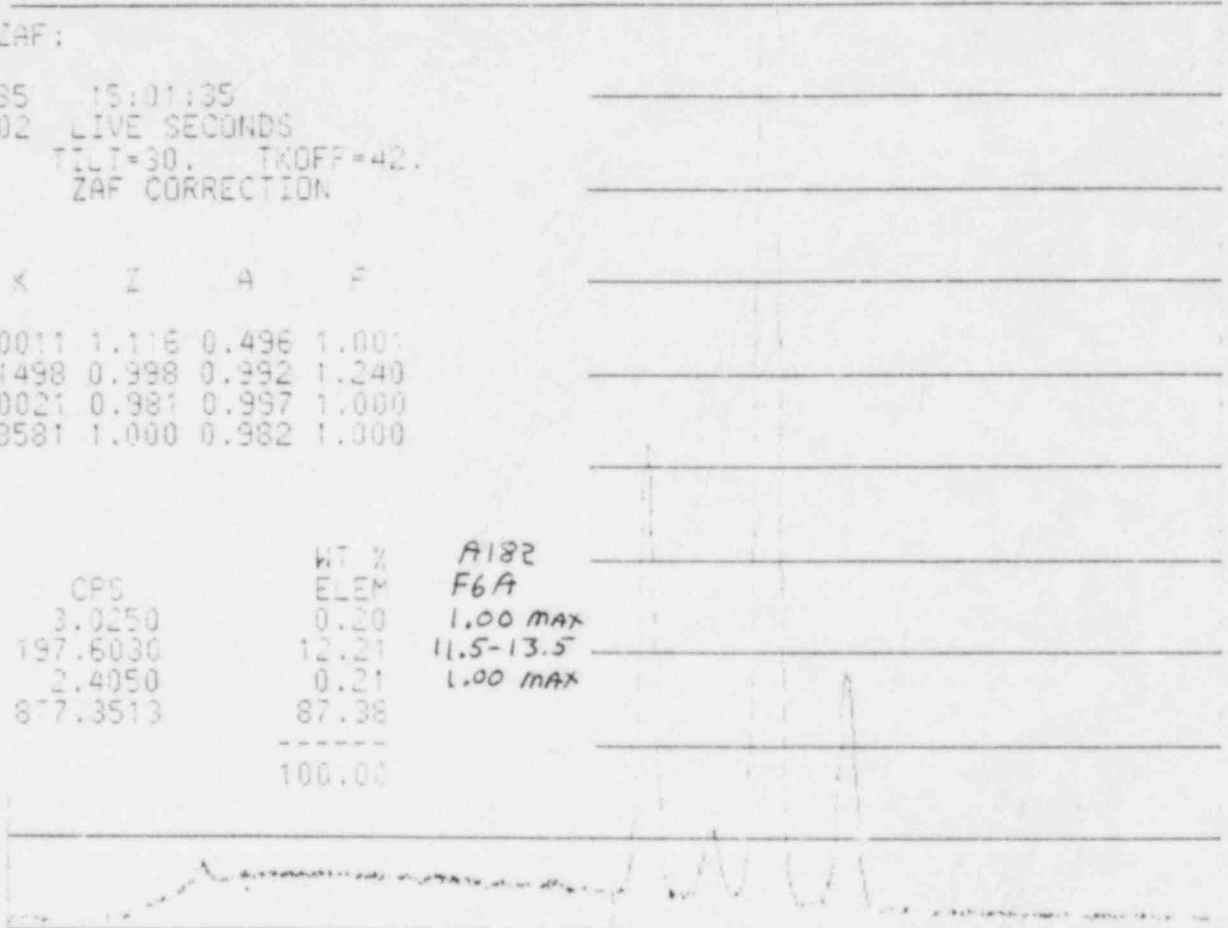
FIGURE ⑧

BASE MATERIAL FROM MOUNTED
 SAMPLE AT 200X

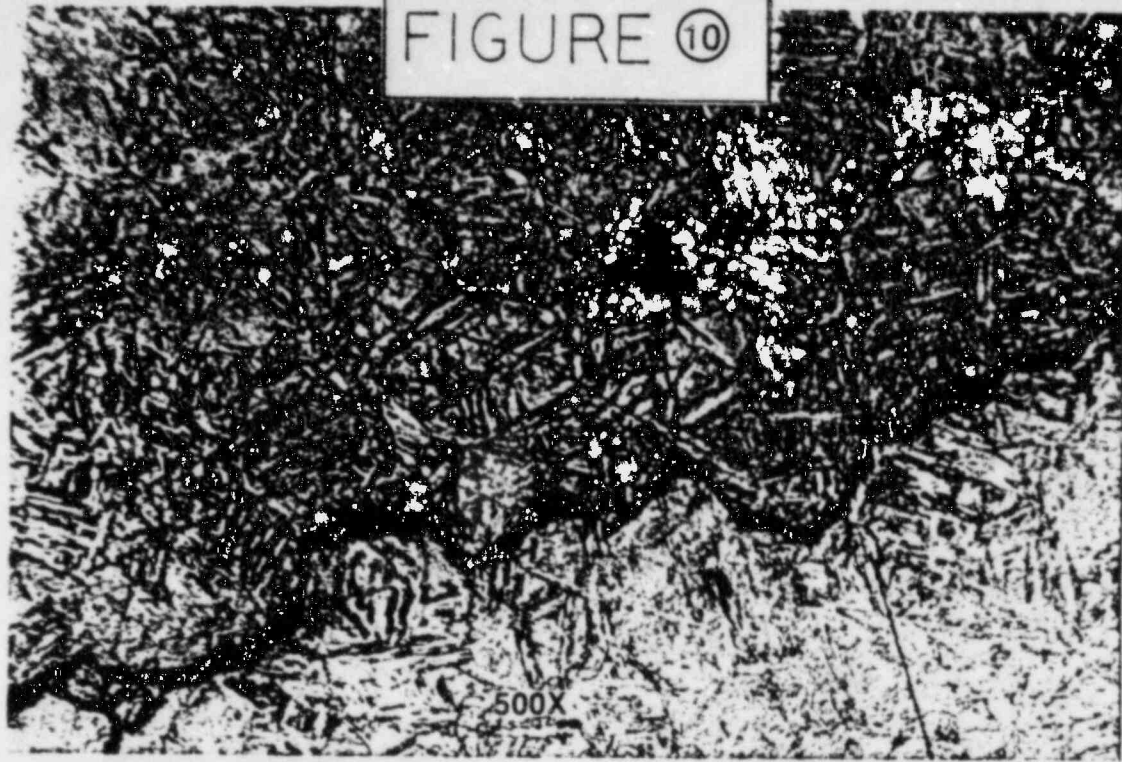
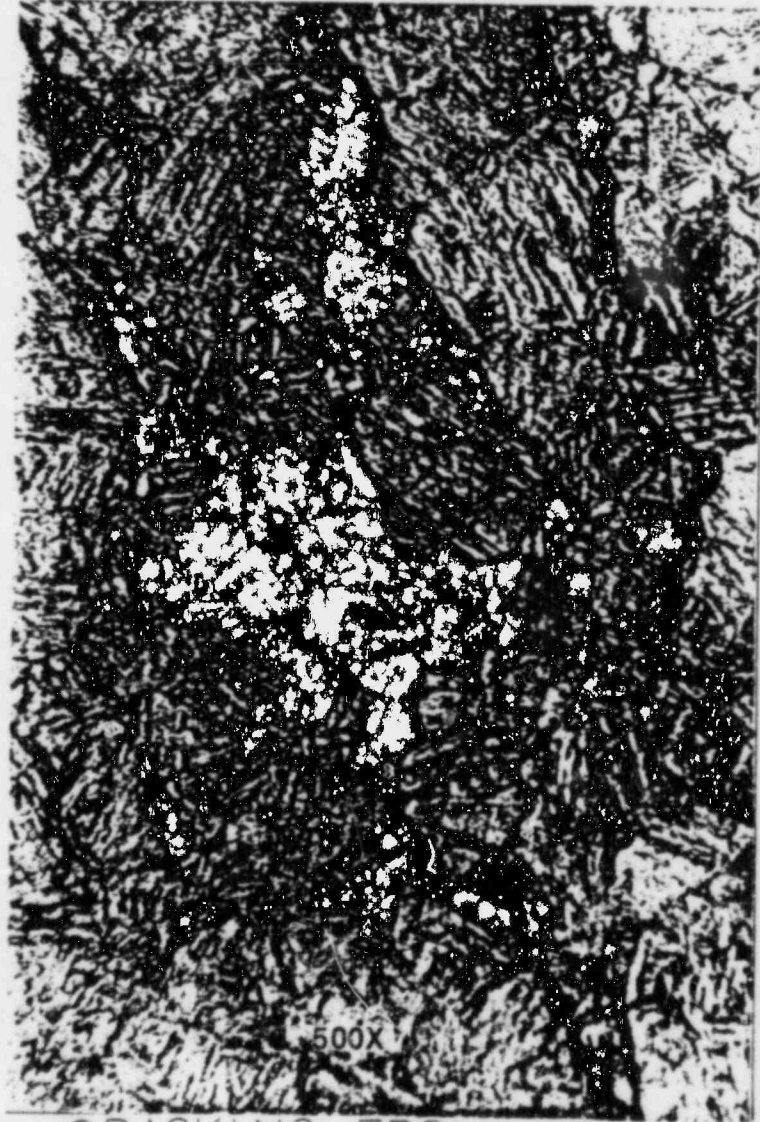
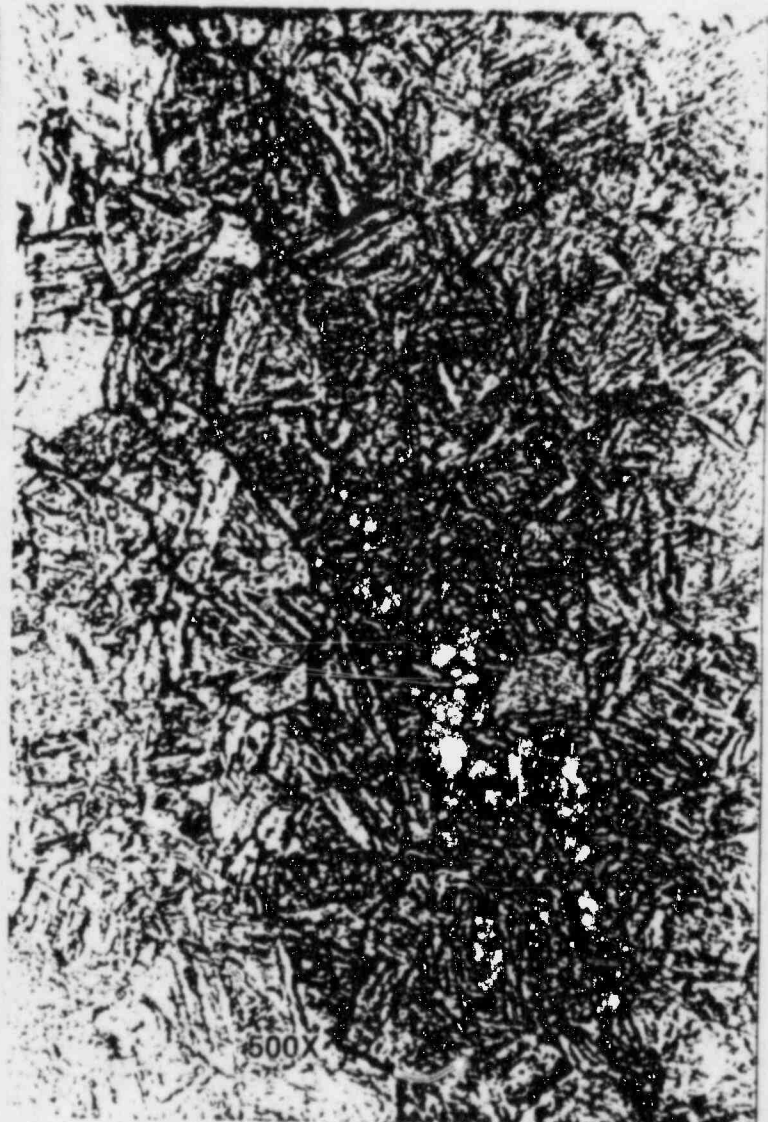
FIGURE ⑪

CRACKING FROM MAIN FRACTURE
