Precursors to Potential Severe Core Damage Accidents: 1986 A Status Report

Appendixes D, E, and F

Prepared by J. W. Minarick, J. D. Harris, P. N. Austin,
J. W. Cletcher, E. W. Hagen

Prepared for
U.S. Nuclear Regulatory
Commission

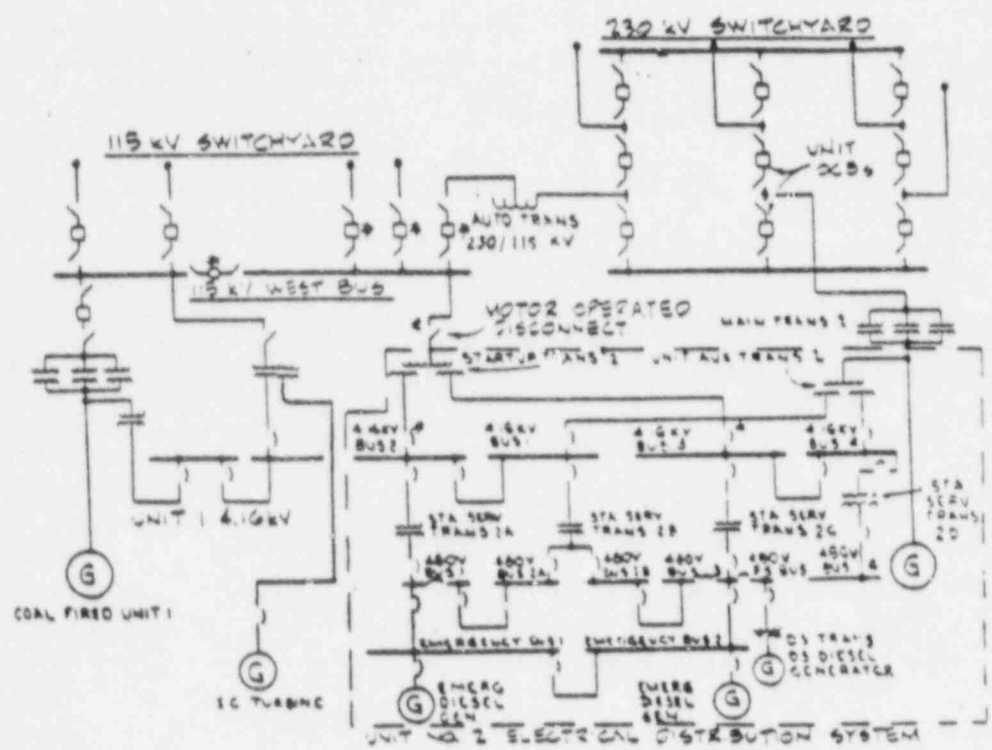
FIGURE 1
H. B. ROBINSON ELECTRICAL DISTRIBUTION SYSTEM

The investigations conclude that two major events (loss of emergency bus E-2 and the loss of offsite ac power) were separate and independent from one another. An extensive investigation of the EDG B output breaker, bus E-2 control cabinet, associated circuits, and wiring was performed. No unusual conditions were found that would have caused the blown fuse. Later, while in the process of energizing E-2 via E-1 (cross tie E-1 and E-2), degraded voltage relay actuation caused the E-2 normal supply breaker to trip open.

* BREAKERS THAT OPEN ON WEST BUS LOCKOUT

The installation of the 10-cycle time delay to eliminate susceptibility to DC saturation was accomplished August 8, 1986. Replacement of the 4000/5 CTs to eliminate the potential for DC saturation is currently planned for 1987.

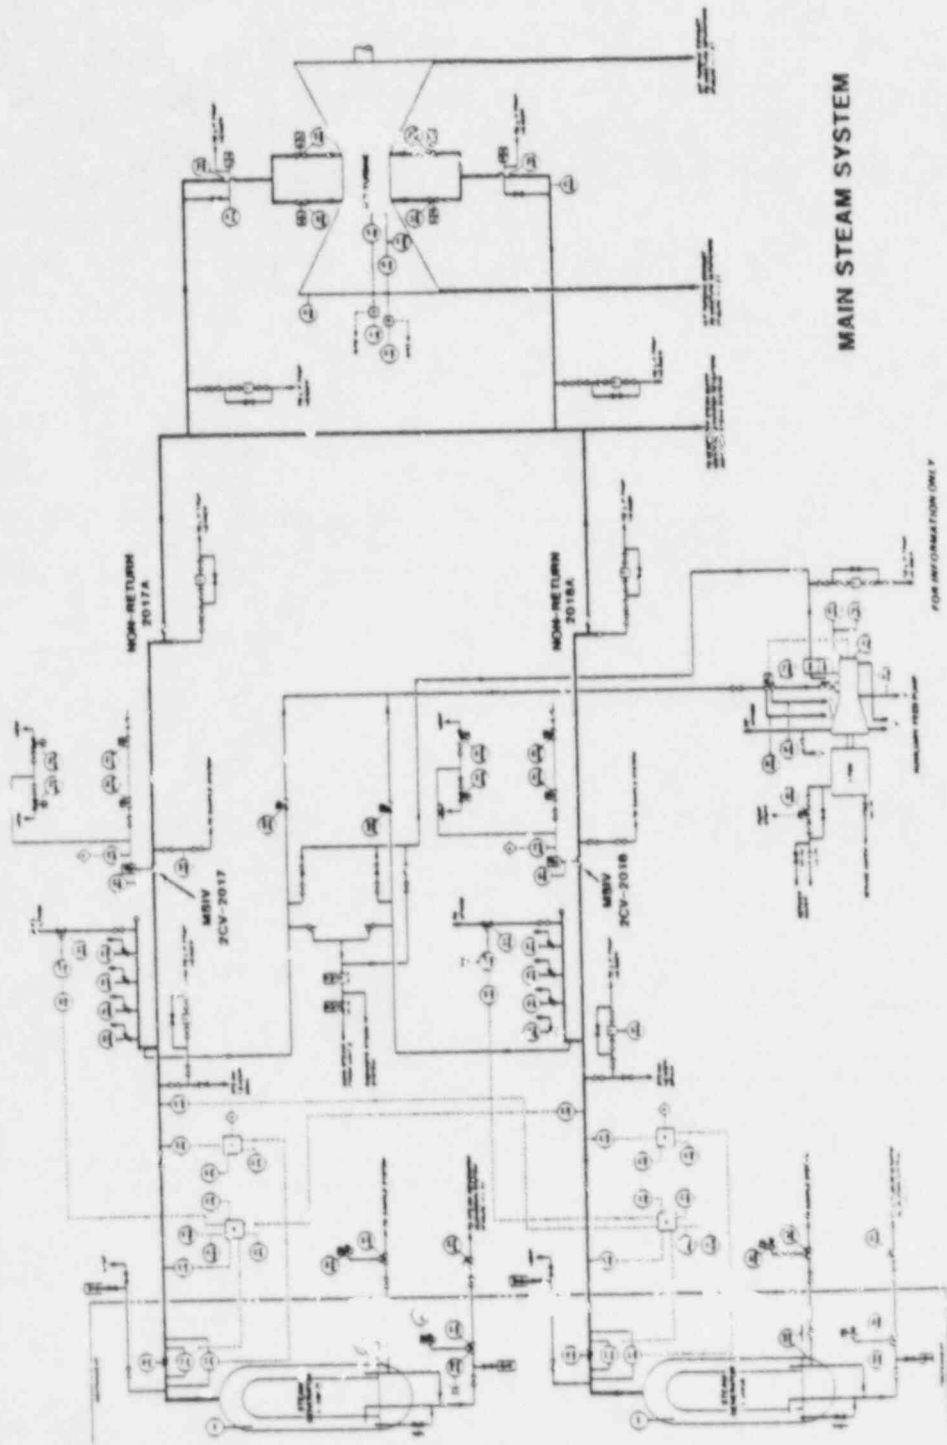
MAIN STEAM SYSTEM

This is the first case of a broken stop found in an MSIV.
