# Loss of Integrated Control System Power and Overcooling Transient at Rancho Seco on December 26, 1985

U.S. Nuclear Regulatory  
Commission

## ABSTRACT

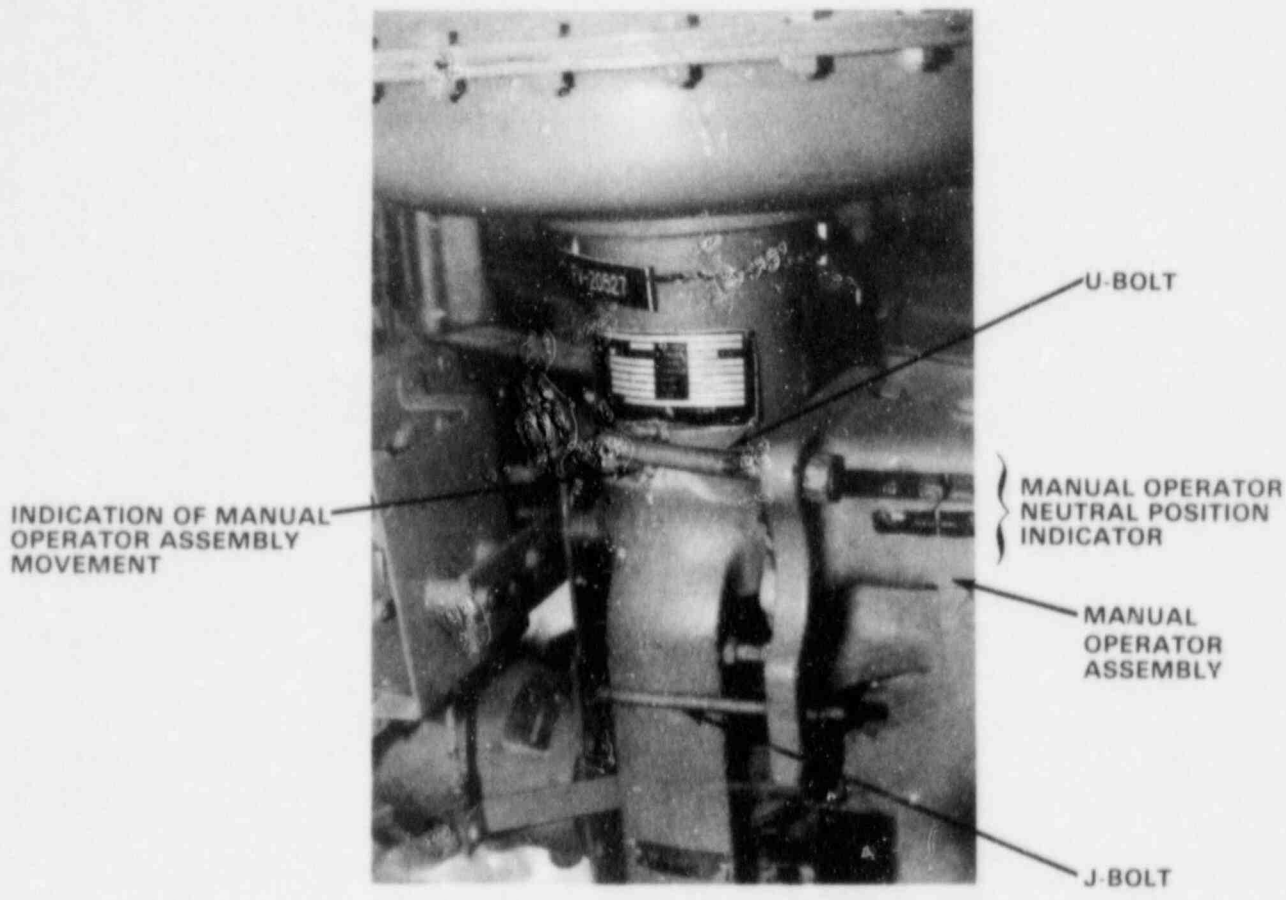
Figure 5.4 Damage to the A AFW(ICS) flow control valve

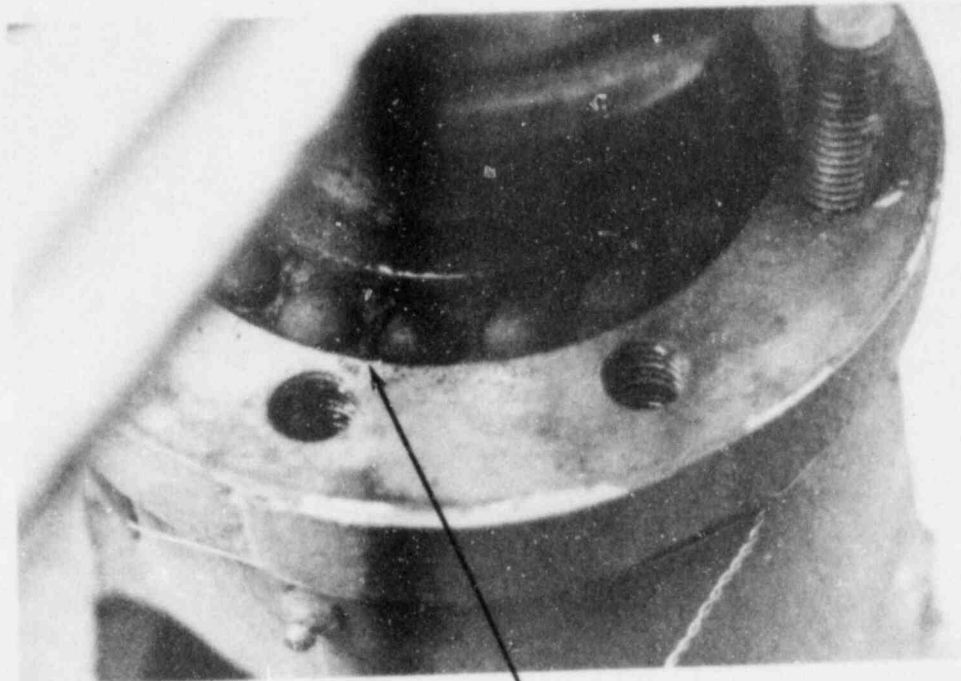
UPPER BEARING

Figure 5.6 AFW manual isolation valve (FWS-063) upper bearing

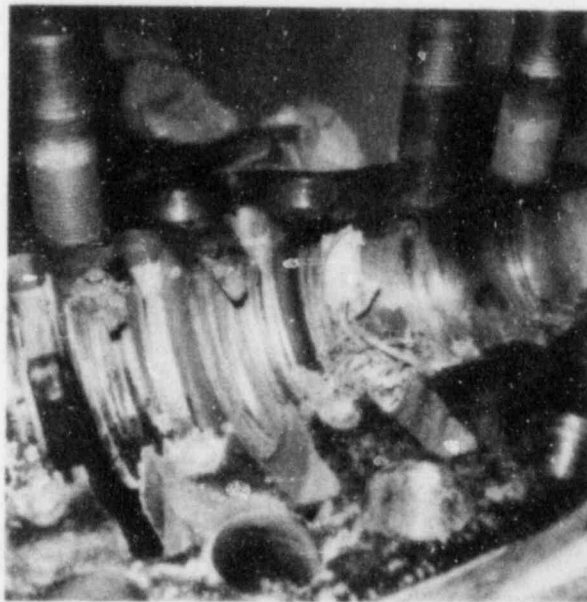
Figure 5.7 Makeup pump lower casing

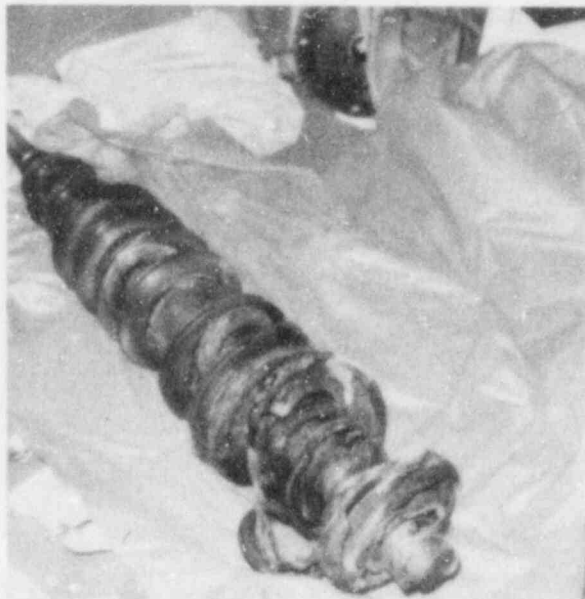
Figure 5.8 Makeup pump impeller and wear rings

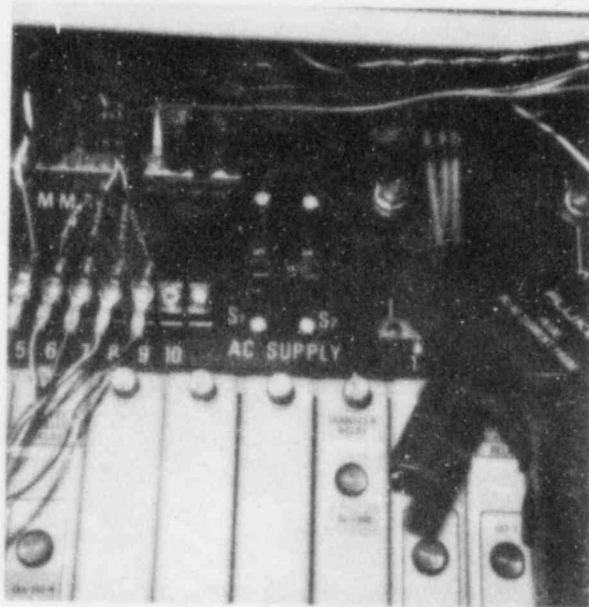
On December 26, 1985, the ICS suffered a complete loss of its dc power and the switches S1 and S2 were later found in the OFF position. This loss of ICS dc power was the transient initiator.

Figure 6.1 Switches S1 and S2 in the tripped (OFF) position

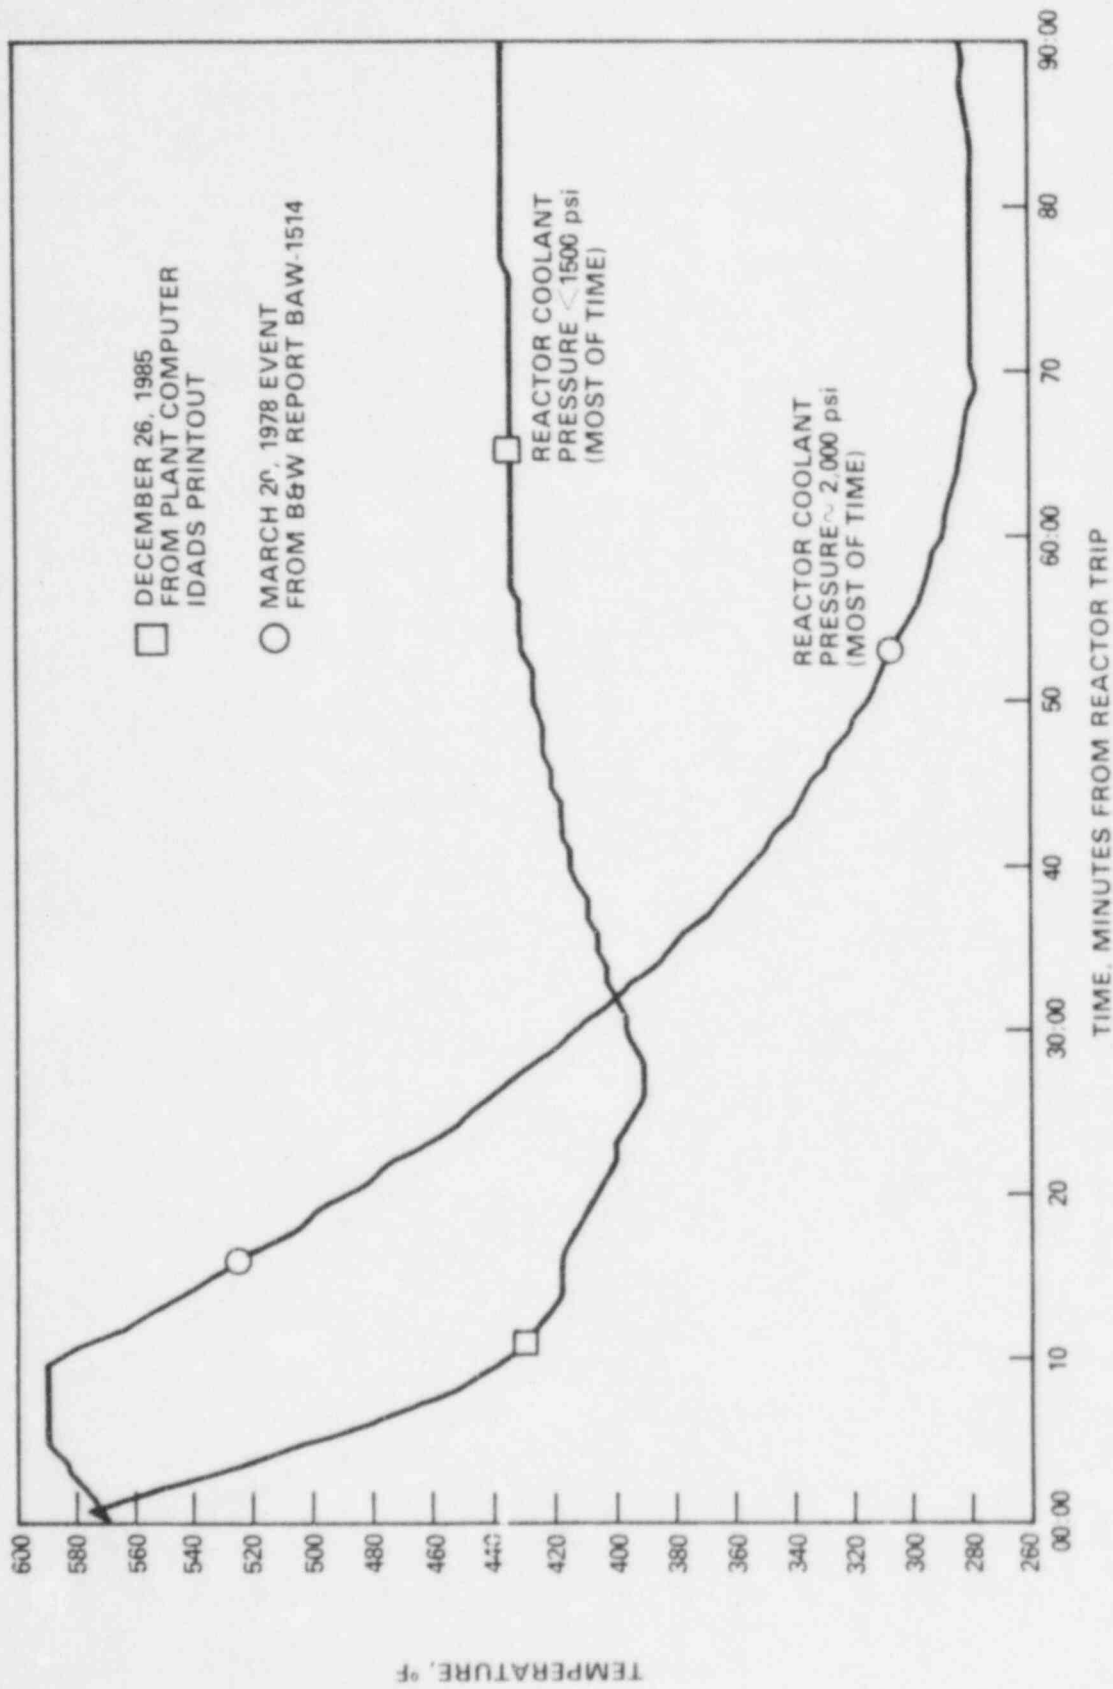
The December 26, 1985 overcooling incident does not appear to have seriously threatened the integrity of the Rancho Seco reactor vessel. However, the plant has had a number of overcooling incidents in its 12-year operating history. Each time this occurs the potential exists for additional operator errors and equipment failures that might exacerbate the event and seriously threaten reactor integrity. Thus, the significance of this incident lies in the fact that under alternate scenarios more serious consequences could occur.

Figure 8.1 Overcooling incidents at Rancho Seco
