LICENSEE EVENT REPORT (LER)

FACILITY NAME (1) CRYSTAL RIVER UNIT 3	DOCKET NUMBER (2) 05000302	PAGE (3) 1 OF 07
--	--------------------------------------	----------------------------

TITLE (4)
Incorrect Design Input and Misapplication of Qualification Requirements Cause Failure to Environmentally Qualify Equipment, Resulting in a Condition Outside Plant Design Basis

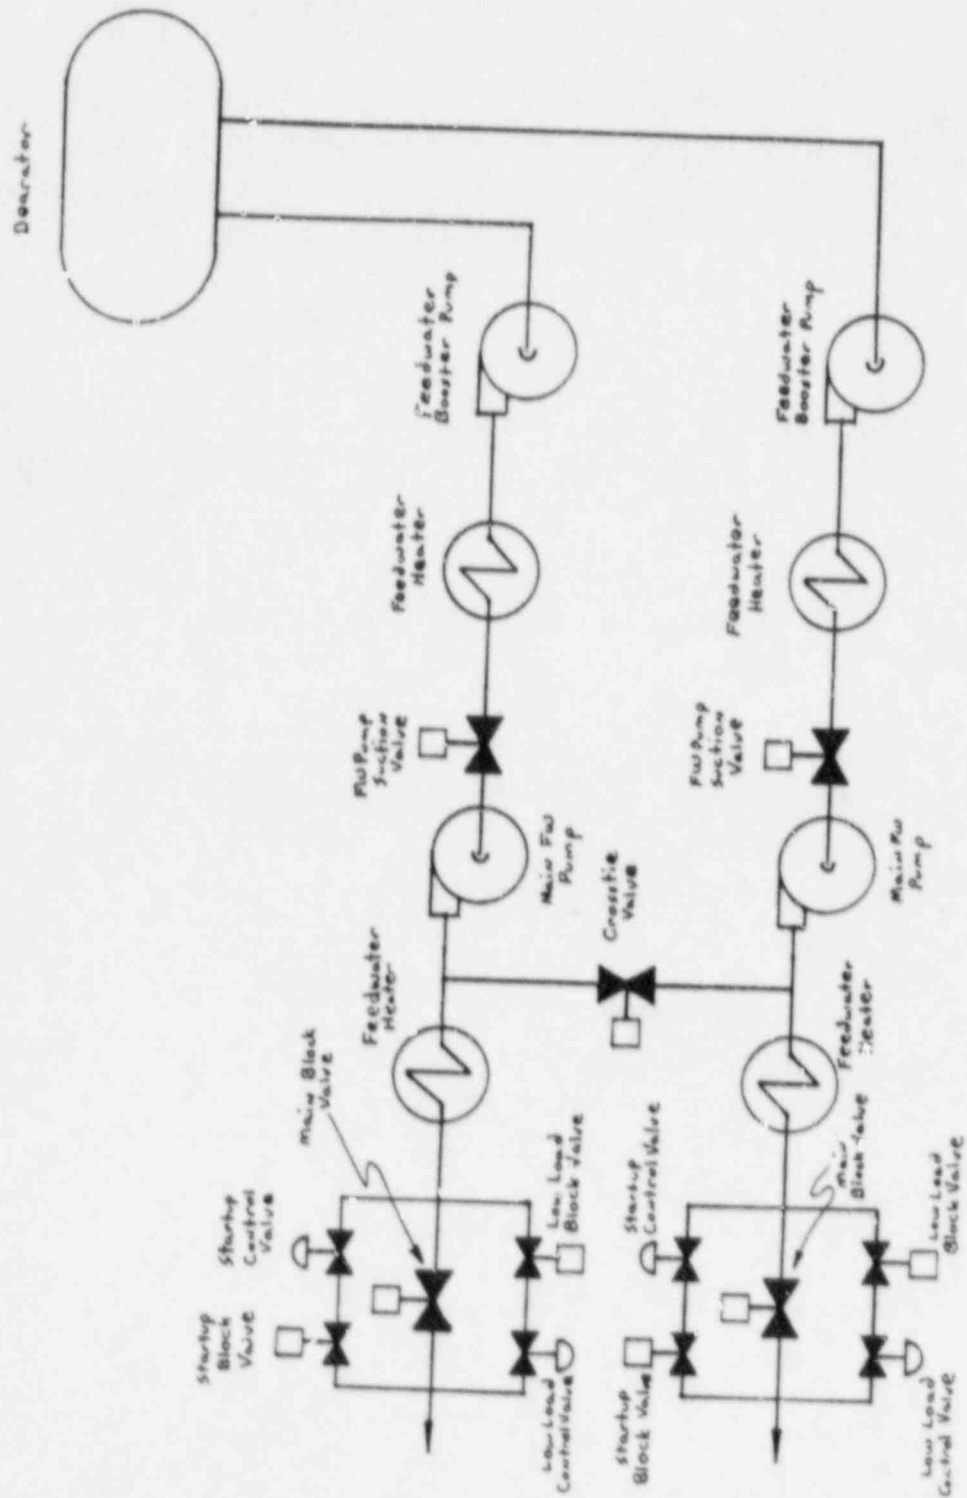
Figure 1 - Simplified Feedwater System Diagram

Crystal River 3 design incorporates two Main Feedwater trains. Each train contains three parallel block valves sized for different flow capacities. (Please refer to Figure 1.) The Startup Block Valves supply feedwater during operations below 15% of full power. Block valves are normally opened and closed by the Integrated Control System [JA] during power increases and decreases. Block valves also receive commands to close from the Emergency Feedwater Initiation and Control (EFIC) system [BA] when it becomes necessary to isolate a Steam Generator (SG) [AB,BLR]. In order to isolate Main Feedwater, the EFIC system also trips the Main Feedwater Pump (MFWP) [SJ,P], and closes the crosstie and MFWP suction valves.
