LICENSEE EVENT REPORT (LER)

FACILITY NAME (1)
MONTICELLO NUCLEAR GENERATING PLANT

TITLE (4)
Manual Scram Inserted Following Pressure Transient Closes Air Ejector Suction Isolation Valves and Trips Offgas Recombiners

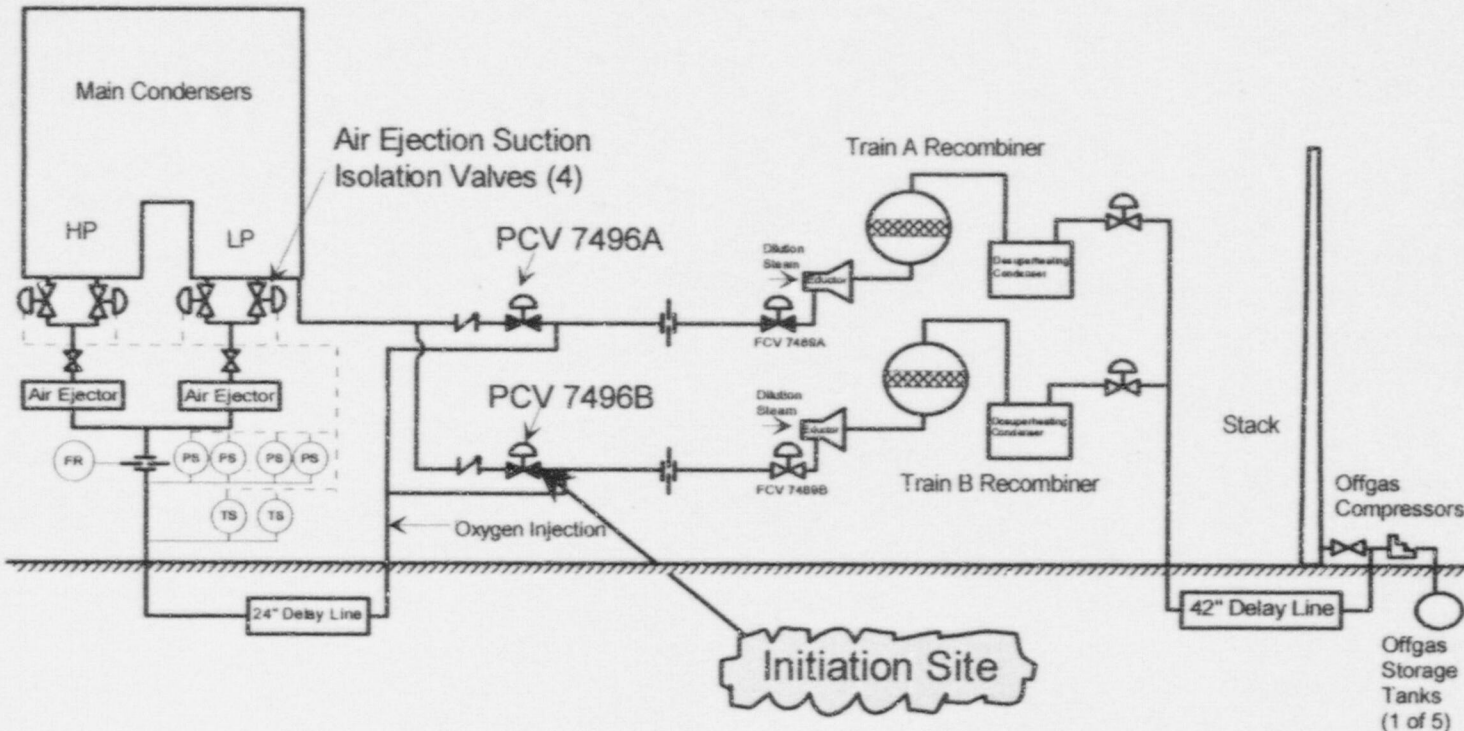
Simplified Drawing of the Offgas System

The air ejector suction isolation valves are located between the main condenser and the air ejectors (See attached figure). The offgas recombiners are located downstream of the air ejectors and function to recombine hydrogen and oxygen gases.
