LICENSEE EVENT REPORT (LER)

FACILITY NAME (1)  
River Bend Station

TITLE (4)  
Inadvertent Start of Division I Diesel Generator

FACILITY NAME (1)  River Bend Station	DOCKET NUMBER (2)  0   5   0   0   0   4   5   8   8   6	LER NUMBER (6)			PAGE (3)	
		YEAR	SEQUENTIAL NUMBER	REVISION NUMBER		
		86	014	00	02	OF 04

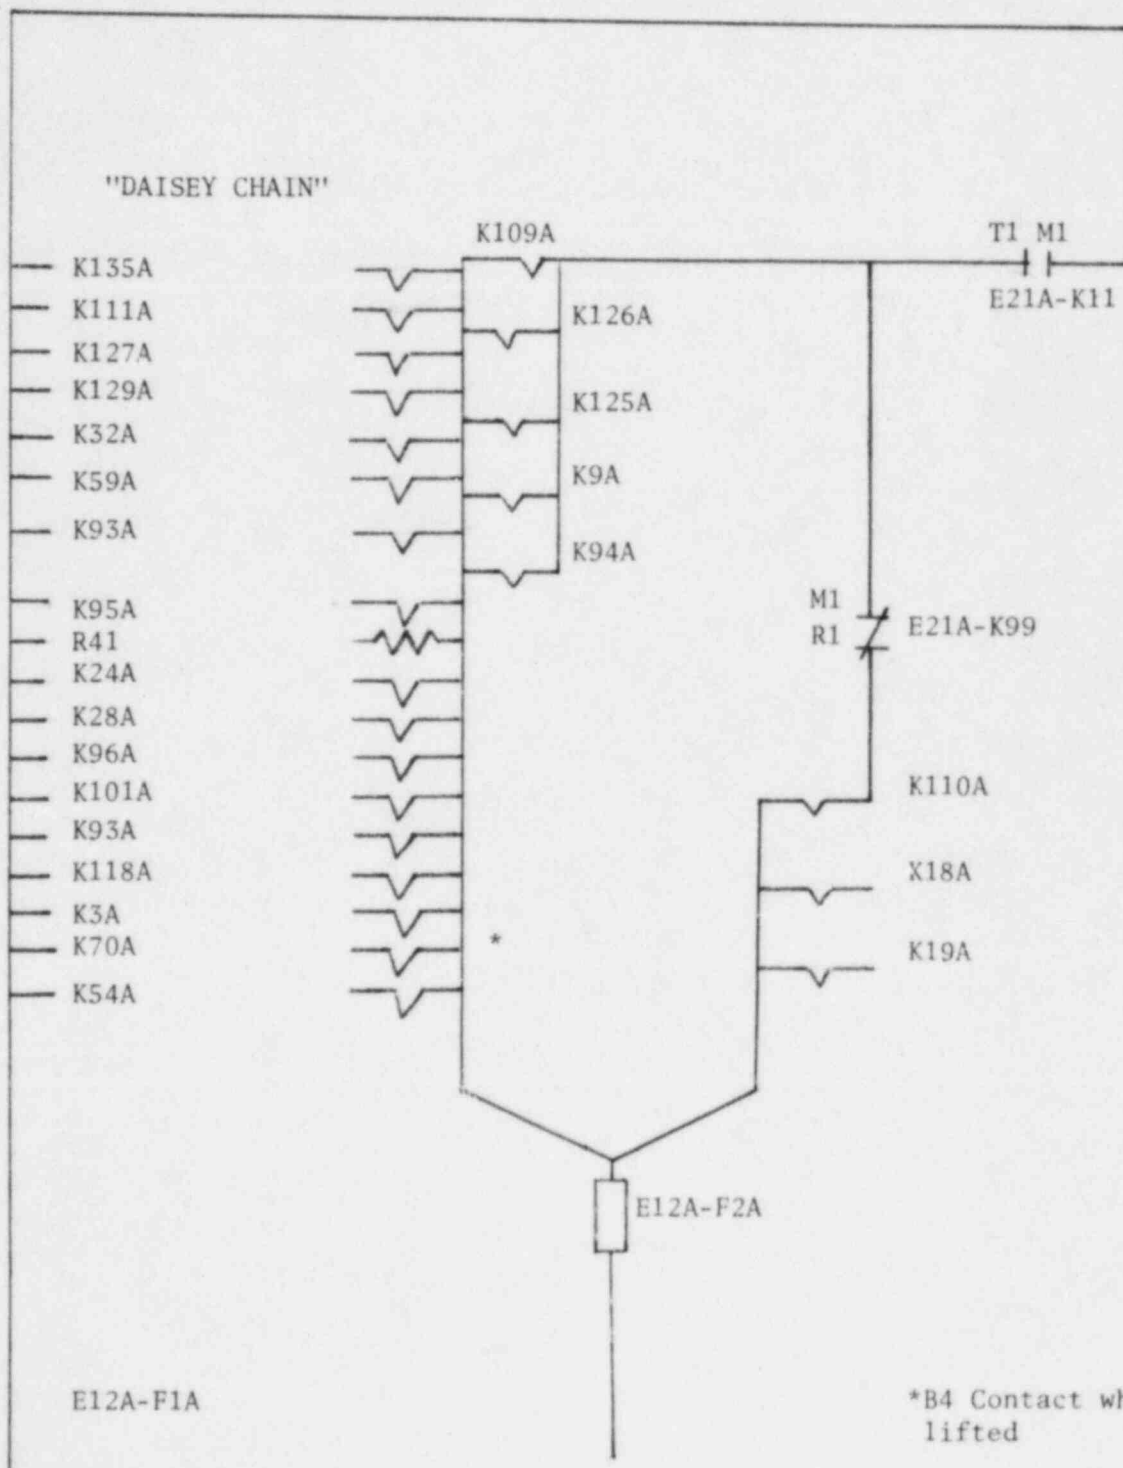
FIGURE 1

Lifting the wires terminated on terminal B4 of relay 1E12A-K70A interrupted the neutral "Daisy Chain" as indicated on Figure 1 (attached). The only available path to the neutral bus for the energized circuits was back through the coils of relays 1E12A-K125A, K126A, K109A, K94A, and K9A through the M1-R1 contact of relay 1E21A-K99 thus providing voltage to the coil on relay 1E12A-K110A which initiated an unexpected LOCA signal.

A review of MWR 19011 determined that the current path described above was not identified on the job plan. Investigation into the cause for this deficiency with the job plan is ongoing. Once the root cause has been identified, corrective action will be taken. Completion of this investigation is expected by 05/01/86 at which time a supplemental report will be provided.

\*B4 Contact which was lifted
