LICENSEE EVENT REPORT (LER)

FACILITY NAME (1) Prairie Island Unit 1	DOCKET NUMBER (2) 0 5 0 0 0 2 8 2	PAGE (3) 1 OF 4
--	--------------------------------------	--------------------

TITLE (4)
Auto Start of Diesel-Driven Cooling Water Pumps

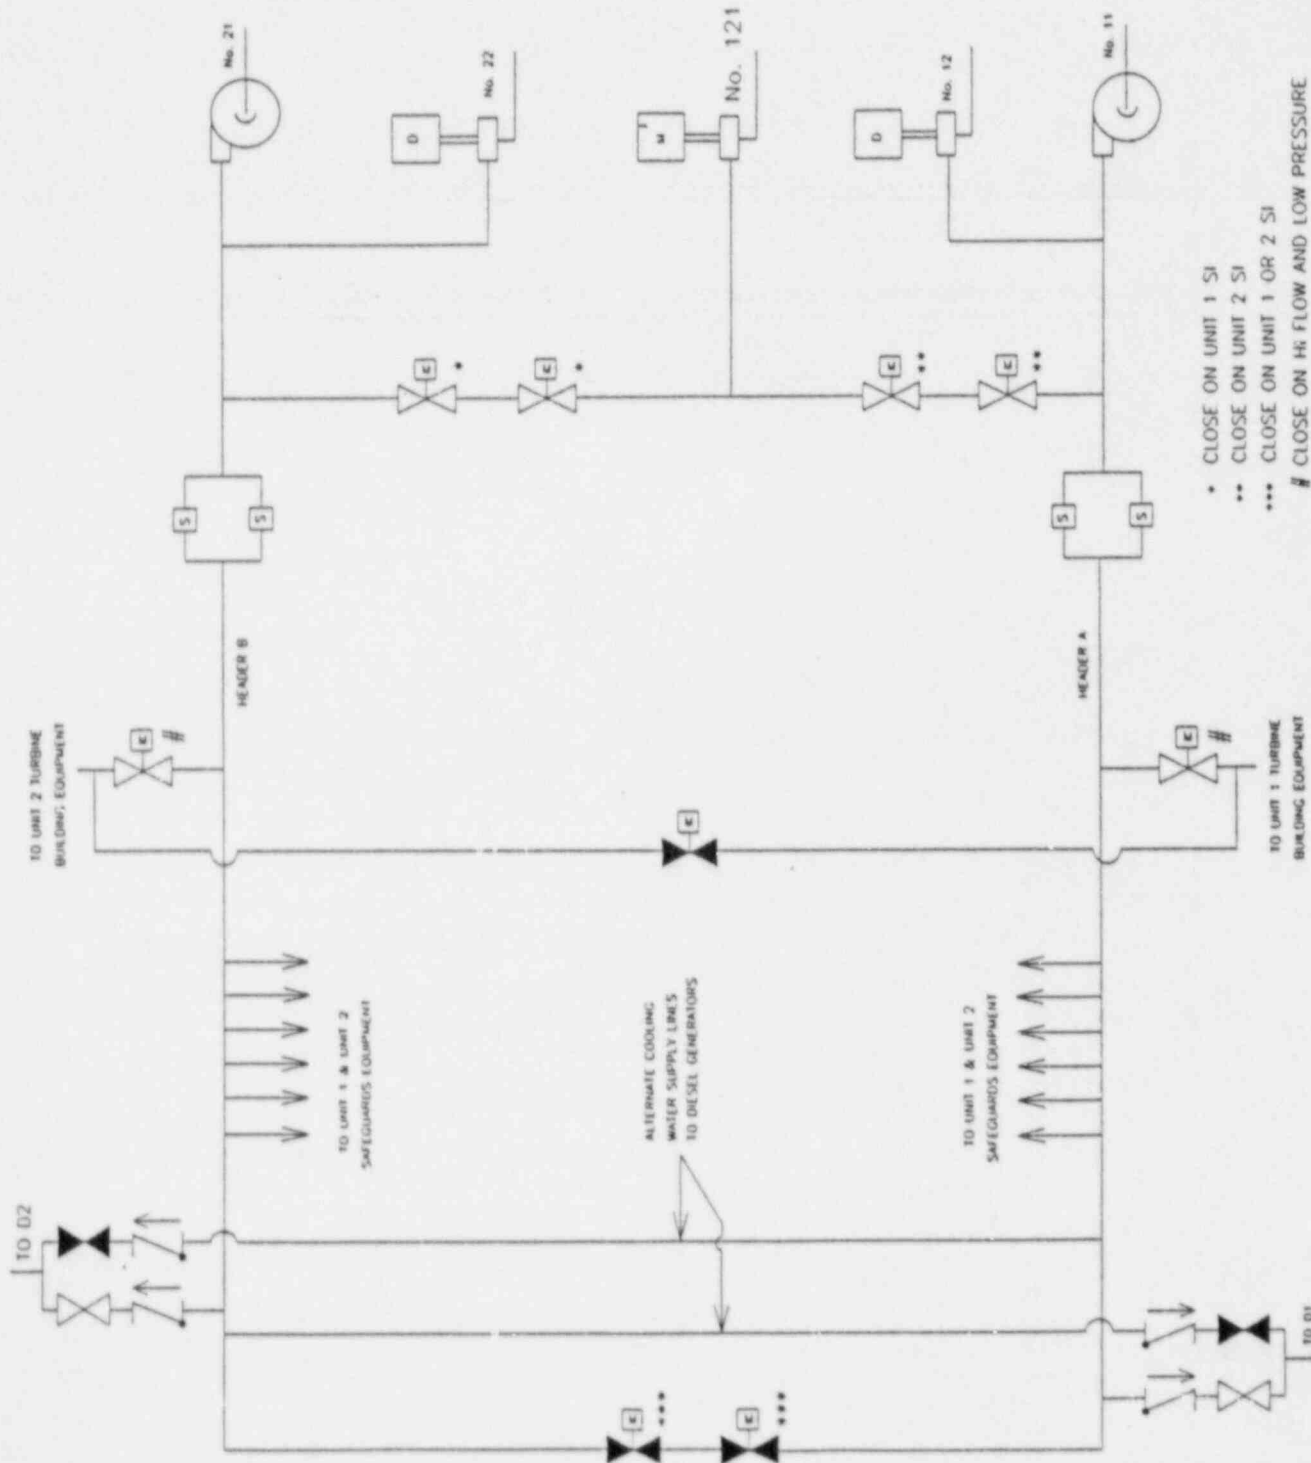
Prairie Island Cooling Water System

When No. 121 pump was shut down, both Nos. 12 and 22 diesel-driven cooling water pumps started automatically when low cooling water header pressure was sensed. This is a non-ESF actuation of ESF equipment.

Investigation quickly determined that No. 11 pump had lost prime and was not pumping. No. 11 pump was then stopped. Pump packing was adjusted, the eductor trap was replaced, and eductor vacuum was increased. (At this point in the event, No. 121 pump was restarted and the diesel-driven pumps were shut down.) The pump suction bay was inspected; cleaning of the screenhouse trash rack was begun. Inspection of the eductor piping sight glass showed that No. 11 pump had regained prime, so it was started and it ran normally.

Cause of the event is not known at this time, though loss of prime of No. 11 Cooling Water Pump was most likely caused by excessive seal leakage.

The event occurred when operations personnel removed No. 121 Cooling Water pump from service without recognizing that No. 11 Cooling Water Pump was not pumping. Discharge pressure indicators were checked prior to stopping No. 121 pump and they appeared to be satisfactory. The discharge pressure gauge for No. 11 pump is located between two check valves on the discharge piping; seat leakage through the downstream check valve apparently caused the gauge to indicate cooling water header pressure even though No. 11 pump was not pumping.

Pump packing was adjusted, the eductor trap was replaced, and eductor vacuum was increased.

The discharge pressure gauge for No. 11 pump will be moved so that it is upstream of the first discharge check valve to give a more reliable indication of pump discharge pressure.

Special instructions were issued for operation of the eductor system for checking for proper operation of the motor-driven cooling water pumps.
