PLANT VOGTLE - UNIT 1  
NRC DOCKET 50-424  
OPERATING LICENSE NPF-68  
REPLY TO A NOTICE OF VIOLATION

PLANT VOGTLE - UNIT 1  
NRC DOCKET 50-424  
OPERATING LICENSE NPF-68  
NRC NOTICE OF VIOLATION 88-24-01 AND GPC RESPONSE

VIOLATION 50-424/88-24-01

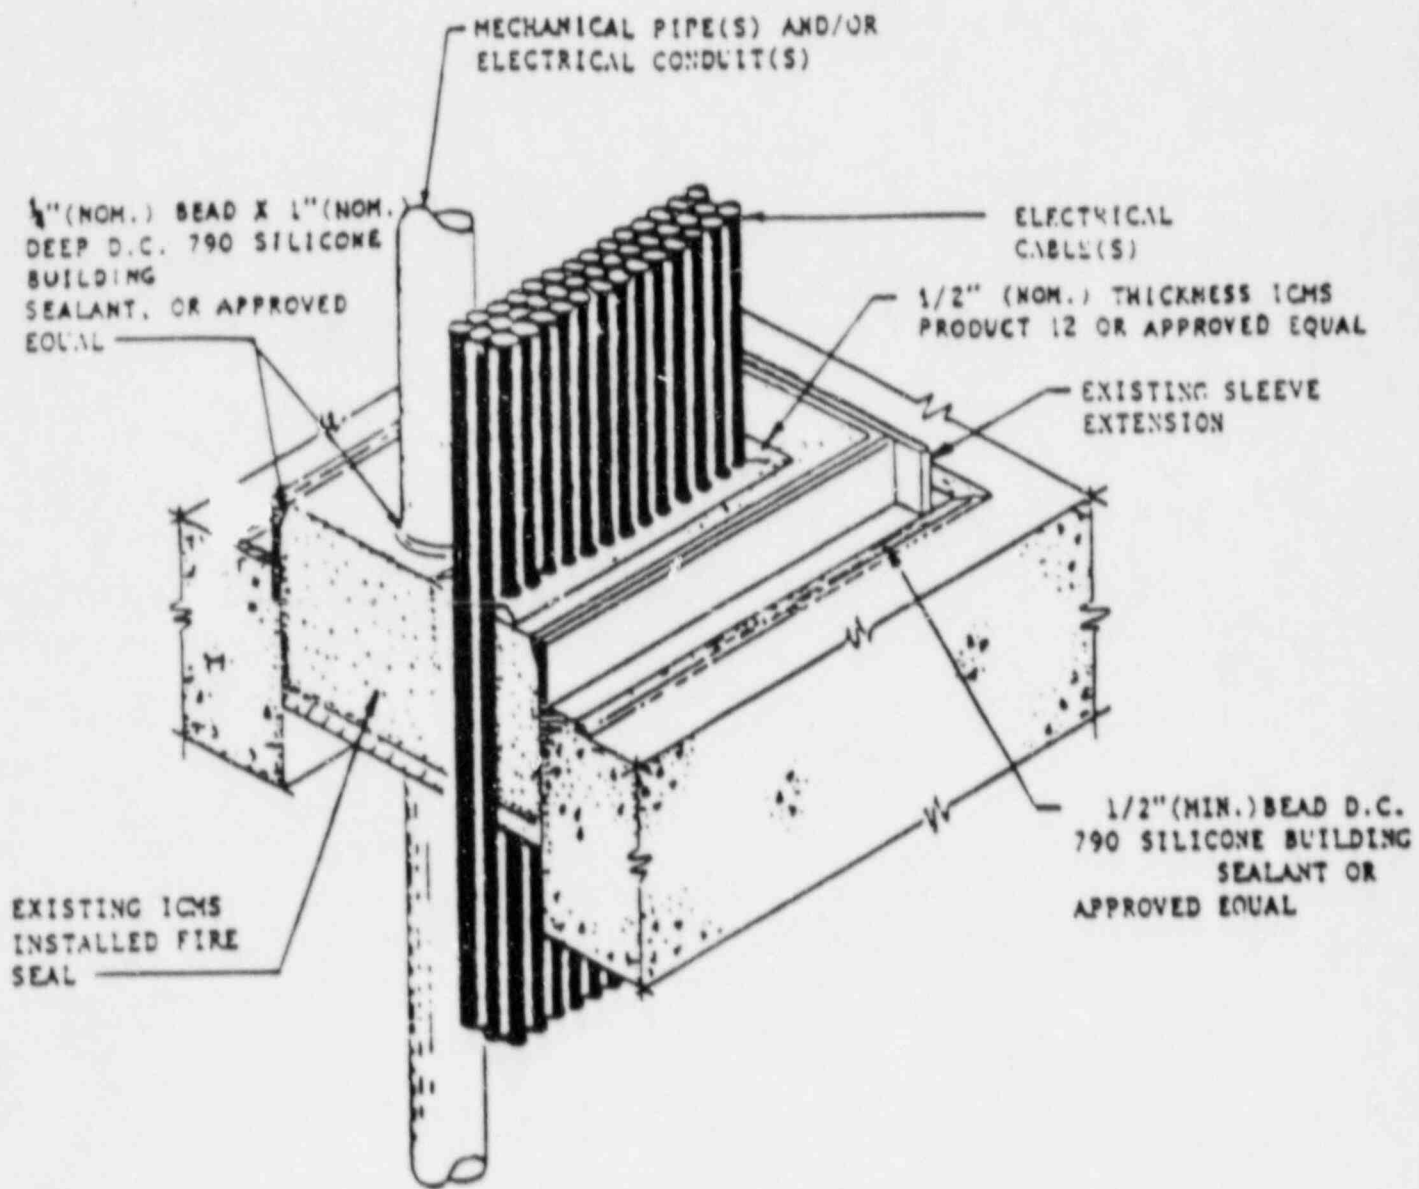
FIGURE 1

The violation occurred due to an inadequate design in that the vendor's qualification test report for the penetration seal detail did not represent typical Upper Cable Spreading Room (UCSR) penetration. The detail that was qualified did not contain a high density cable fill within the penetration whereas the typical UCSR penetration contains a high density cable fill. Further, the architect engineer assumed that the seal weld at the interface of the embedded bottom angle to the top angle would provide an adequate water stop in the event that the UCSR had water on the floor. Testing in Unit 2 (described in detail in the Licensee Event Report (LER) 88-016 dated June 29, 1988) showed that a flowpath existed for water to flow between the top angle and the floor and underneath the embedded angle and into the control room. This has been attributed to the potential deformation of the embedded angle iron caused by the seal welding of the embedded angle to the top angle during installation.

- (1) A full scale prototype test assembly was fabricated on-site to qualify the new penetration seal detail to be used for seals of the type used in the UCSR that would be water-tight. Figure 1 represents a schematic of the current penetration seal configuration in the UCSR. The following methodology was used to determine the materials to be used:

A sealant (Dow Corning RTV 790) was applied around the concrete/angle iron interface and the foam/angle iron interface. The test assembly was then subjected to water to check for leaks. No leakage was observed beneath the penetration.

material, P-12 (a 50/50 blend of Dow Corning 3140 and 3145) was poured around the cables. Once the material had cured, water was poured on the top of the material and observations were made beneath for leakage. No leakage was observed. To confirm that the P-12 material selected for use did in fact flow around cables before applying it to the prototype for qualification, the bucket was dissected. The P-12 material was found to penetrate between the foam and the cables and had tightly adhered to the cable jacket and the foam.

The P-12 material was then applied around cables in the prototype test assembly. Once the material had cured, the entire test assembly was then subjected to a water spray directly on top of the penetration seal. Water was sprayed on the test assembly until 2 inches of water was above the top of the seal. This configuration was held for one hour at the end of which time the bottom of the seal was inspected for leakage. No leakage was observed.

A second full size prototype test assembly which simulates typical foam penetrations in the plant will be water tested. The testing is scheduled for completion on September 30, 1988. As a result, the leaktightness of various types of penetration commodities (i.e., items passing through the penetration) other than the ones shown in Figure 1 will be verified.
