NRC DOCKET 50-321
OPERATING LICENSE DPR-57
EDWIN I. HATCH NUCLEAR PLANT UNIT 1
INSERVICE INSPECTION OF CLASS 1 STAINLESS STEEL
PIPING AND COMPONENTS - 1985 MAINTENANCE/REFUELING OUTAGE

Inspection of Hatch Unit 1 Class 1 Recirculation,
RHR, and RWCU Stainless Steel
Piping and Components -
1985 Maintenance/Refueling Outage

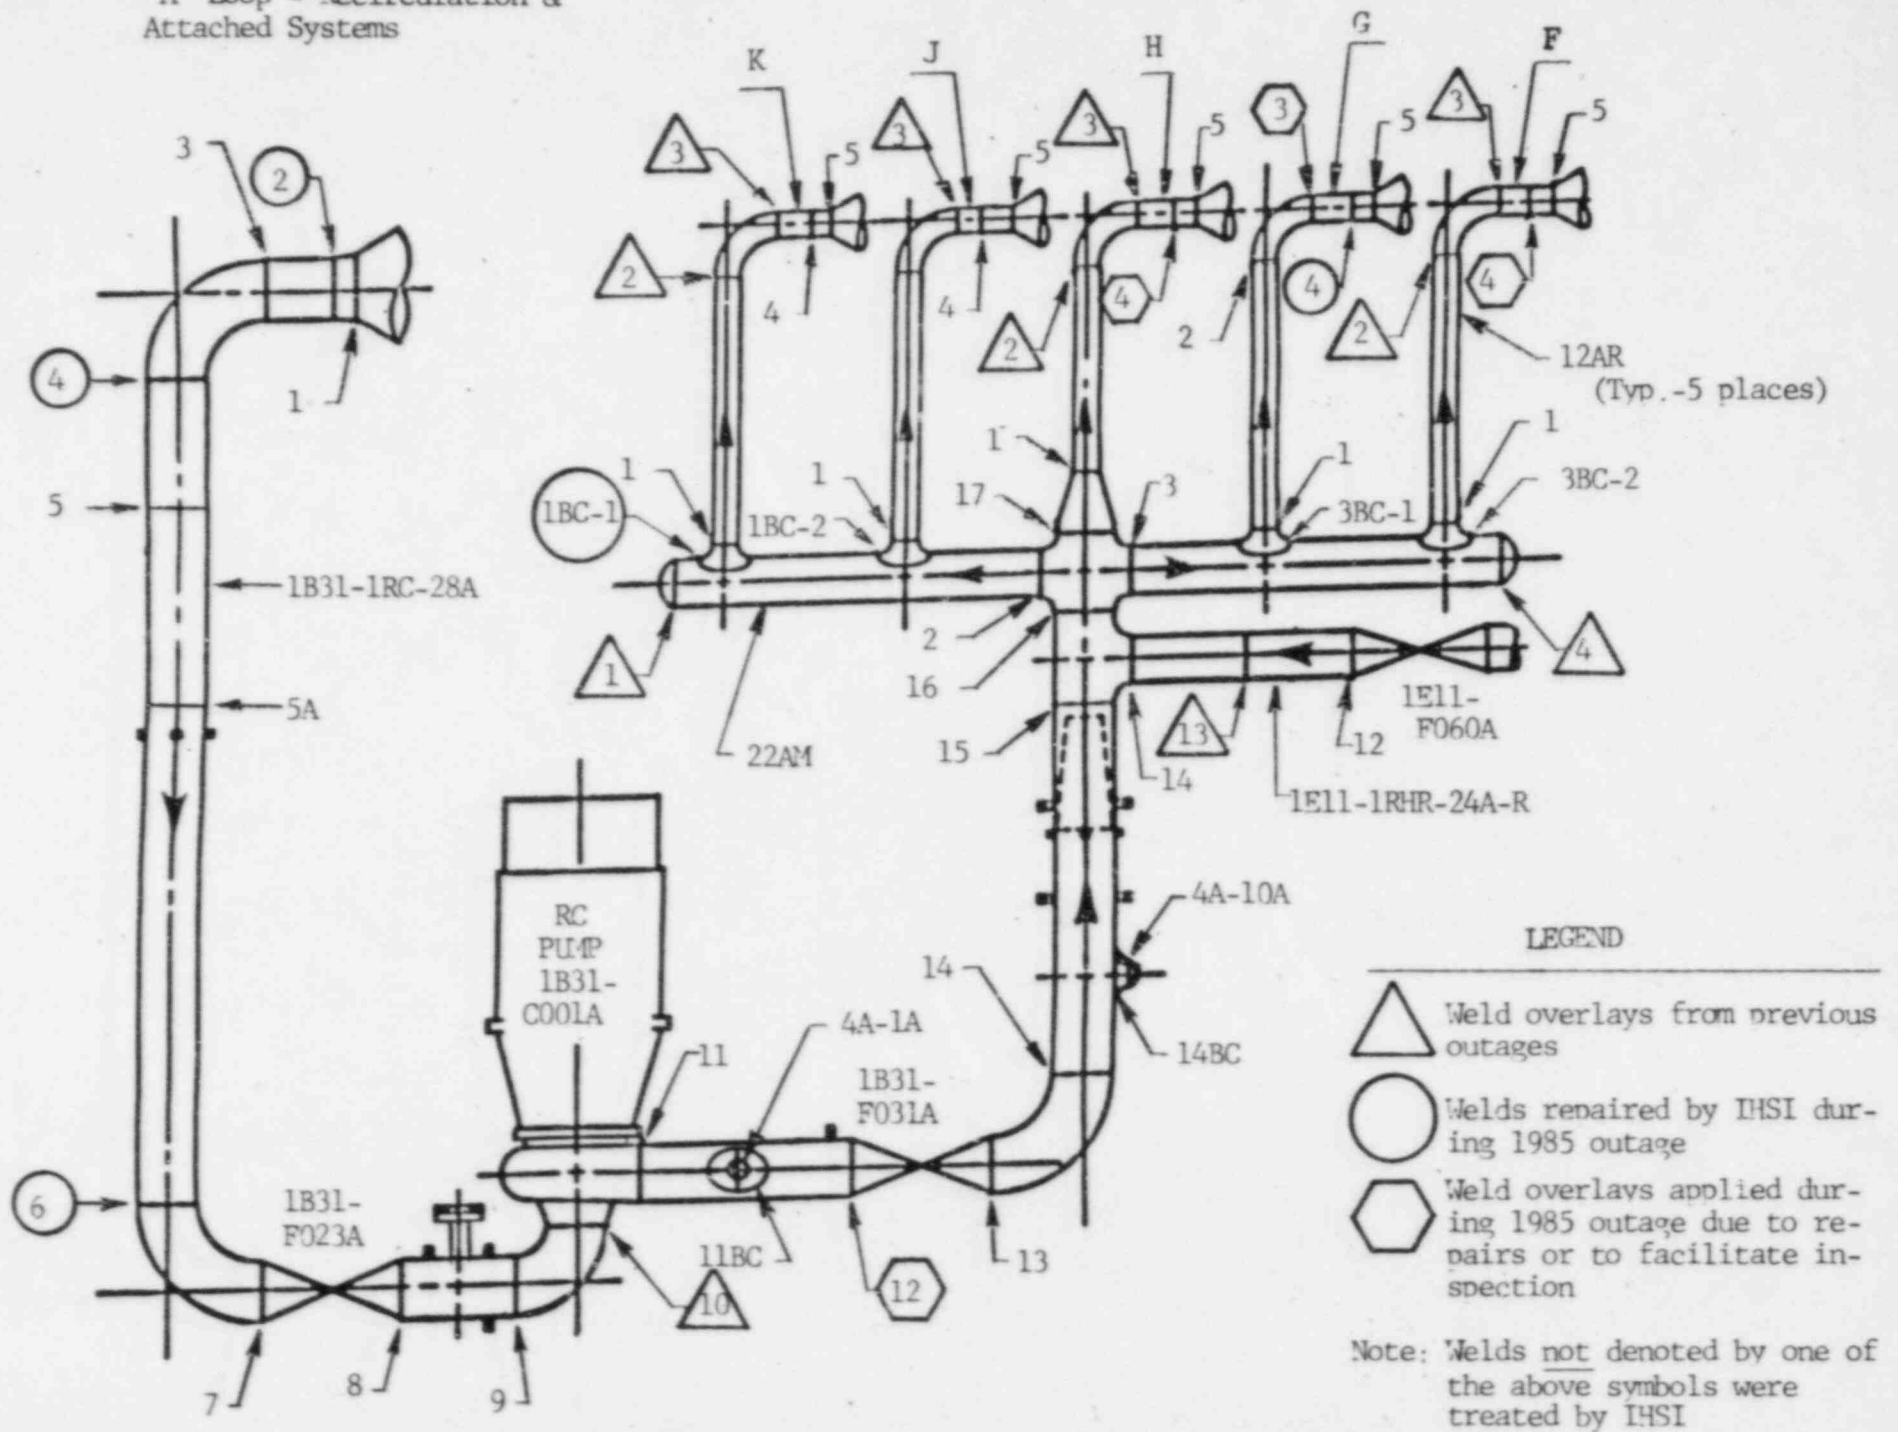
FIGURE 7.1

As noted in Section 7.0 of this report, eleven piping welds and one safe end-to-nozzle weld had reportable indications pre- and/or post-IHSI, but were of such a size to warrant leaving them "as is". The IHSI on the affected weld joints constitutes the repair. The examination results of those piping and safe end-to-nozzle welds which were treated with IHSI and were left "as is" typically were weighed against the "NRC staff position" on repairs using IHSI. The "NRC staff position" is described in the January 7, 1986 safety evaluation report issued to Commonwealth Edison Company for Quad Cities Unit 2 and does not mandate repairs for welds not exactly meeting the criteria specified in the "NRC staff position". The welds that are being left "as is" following IHSI and the reasons therefor are addressed in the attached draft SIA report. The welds being left "as is" were identified in Section 7.0 of this report. Their locations are depicted in Figures 7.1 and 7.2.

As noted in Sections 4.0 and 7.0 of this report, twelve piping welds in the Recirc and RWCU systems required repair by weld overlay. Four of the twelve piping welds were repaired by overlay following treatment by IHSI. The affected piping welds were overlaid by WSI in accordance with design provided by SIA. The piping welds which were required to be repaired by overlay were identified in the aforementioned sections of this report. Figures 7.1, 7.2, and 7.3 depict the location of piping welds repaired by overlay during the 1985 maintenance/refueling outage at Hatch Unit 1. Those overlays which were applied during the 1982 and 1984 maintenance/refueling outages are also noted on the aforementioned figures.
