LICENSEE EVENT REPORT (LER)

FACILITY NAME (1): Peach Bottom Atomic Power Station - Unit 3
DOCKET NUMBER (2): 050000278
PAGE (3): 1 OF 05

TITLE (4) PCIS Group II Reactor Water Cleanup System Isolation Signal as a Result of a Loss-of-Power Caused by a Tie Breaker Malfunction

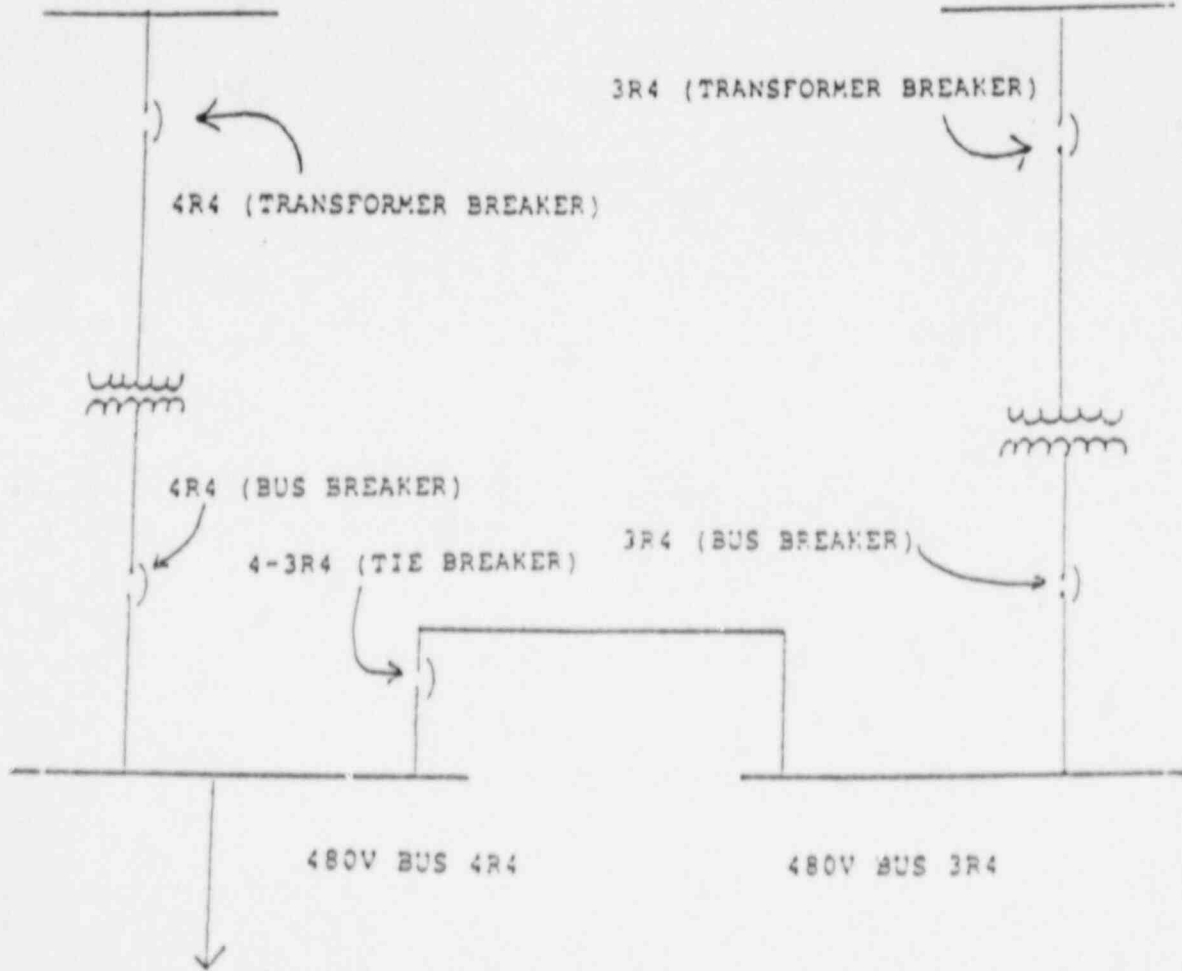
FIGURE 1

At 0900 hours, a Control Room Operator was attempting to remove the 13kV circuit breaker 3R4 (transformer breaker) from service in order to accommodate preventive maintenance of the breaker. This action was being accomplished by switching the power source for the 480V 3R4 Bus from the 3R4 bus breaker to the 4-3R4 tie breaker (Figure 1). While initiating the "dead bus transfer" of the 3R4 Bus, the Control Room Operator attempted to close the 4-3R4 tie breaker from the Control Room. However, the 4-3R4 tie breaker position light on the control panel indicated the breaker remained open. Assuming that the tie breaker had not closed, the Operator moved the tie breaker control switch to the "trip" position then reclosed the previously opened 3R4 bus breaker in order to restore power to the 3R4 Bus. Approximately one minute later, both the 3R4 and 4R4 bus breakers tripped, causing loss-of-power to both the 3R4 and 4R4 480V Buses.

At the time of the event, the nonsafety-related 4R4 Bus was temporarily providing power to the safety-related E334-R-B Motor Control Center. The normal source (the E33 bus) was out-of-service for maintenance. The E334-R-B Motor Control Center provides power to the 30C62 RWCU instrument panel which contains the power source for temperature switch TS-3-12-99. The loss-of-power to temperature switch TS-3-12-99 completed the necessary PCIS logic to cause a PCIS Group II RWCU isolation signal. No valve movement occurred as a result of the isolation signal since the RWCU System was out-of-service. The following alarms were received in the Control Room:

The cause of the PCIS Group II RWCU isolation signal apparently resulted from a 4-3R4 tie breaker malfunction.

Inspection of the tie breaker did not reveal any sticking or binding of the mechanical linkage. During the inspection, loose nuts were tightened. It is unknown whether previous cycling of the tie breaker may have resolved any mechanical problems that existed. The circuit breaker is an ITE Imperial Corporation K-1600 (1600 amperes).

TEMP. POWER FEED TO E134-R-B
MCC AND TIS 3-12-99

The 4-3R4 tie breaker was removed from service, inspected, and returned to service. Power was reestablished to the 3R4 and 4R4 Buses as previously described and the "dead bus transfer" was successfully completed.

Procedure A-42 ("Procedure for Control of Temporary Plant Alterations") has been revised to require information tags in the Control Room when temporary power feeds are being utilized. This will aid the Operator in assessing possible consequences of performing plant operations when off-normal plant configurations exist.

Maintenance Procedure M-55.1 ("480 Volt Load Center Circuit Breaker Maintenance") will be revised to ensure that the mechanical linkages associated with the auxiliary contacts are inspected. The procedure will also require the auxiliary contacts to be inspected and cleaned. This revision will be completed by October 1, 1988. This maintenance will be performed on the 4-3R4 tie breaker, 3R4 bus breaker and 4R4 bus breaker prior to restart of Unit 3.
