POWER REACTOR EVENTS

United States Nuclear Regulatory Commission

Date Published: February 1986

1.1 Loss of Offsite Power at Dresden

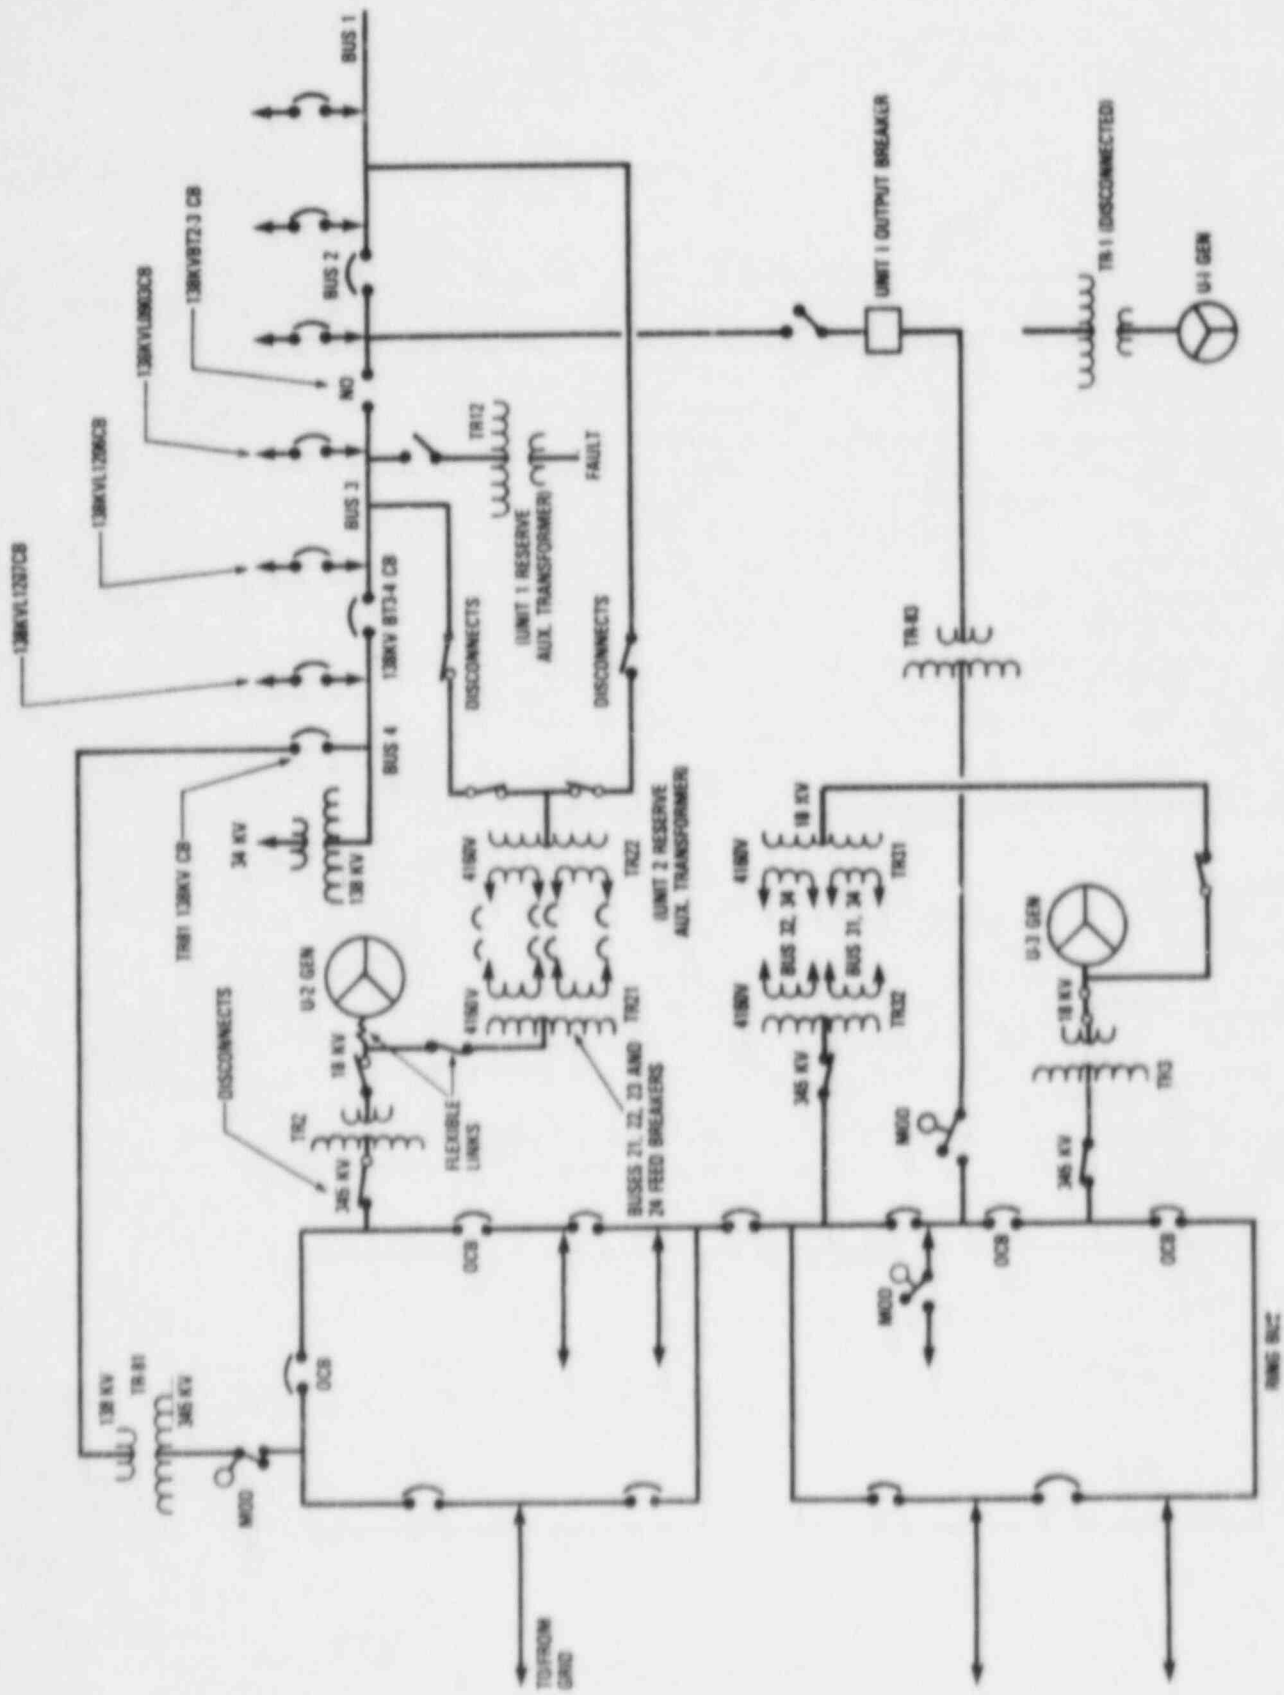
FIGURE 1. 345KV AND 138KV DISTRIBUTION

At 12:21 a.m. on August 16, 1985, Dresden Unit 2 experienced a loss of offsite power which resulted in a scram on low reactor water level from about 70% power. A fault in Unit 1 transformer TR12 caused the Unit 2 reserve auxiliary transformer, which fed associated auxiliary buses 22 and 24, to be isolated from the normal 138 kV offsite power source. Because of a design error, a fast transfer of buses 22 and 24 to the unit auxiliary transformer TR21, which is fed from the main generator, did not occur, and buses 22 and 24, remained without power. This caused a running 2B RFP to trip and prevented the standby 2C RFP from starting. The unit subsequently scrambled on low water level (See Figures 1 and 2 for layouts of the Unit 2 electrical distribution).

The licensee's investigations found that the loss of offsite power was due to a fault that developed on the secondary side of TR12. An insulating board providing support as well as insulation for the A power phase for TR12 failed, causing the conductor to short across the bus duct housing. Transformer TR12 receives offsite power from 138 kV bus 3. Transformer TR22 receives offsite power from 138 kV buses 1 or 3. A normally open bus tie breaker, 138 kV BT 2-3 C₃, electrically separates the two alternative bus sections. At the time of the fault, both TR12 and TR22 were being supplied power from 138 kV bus 3. Protective relaying sensed the fault on TR12 and isolated 138 kV buses 3 and 4, resulting in complete loss of offsite power to TR22 and Unit 2.

- The Unit 1 reserve auxiliary transformer TR12 was placed out of service for repair. The Unit 2 reserve auxiliary transformer remains tied into the 138 kV bus 3 because of the larger number of offsite power feeds to the bus section.

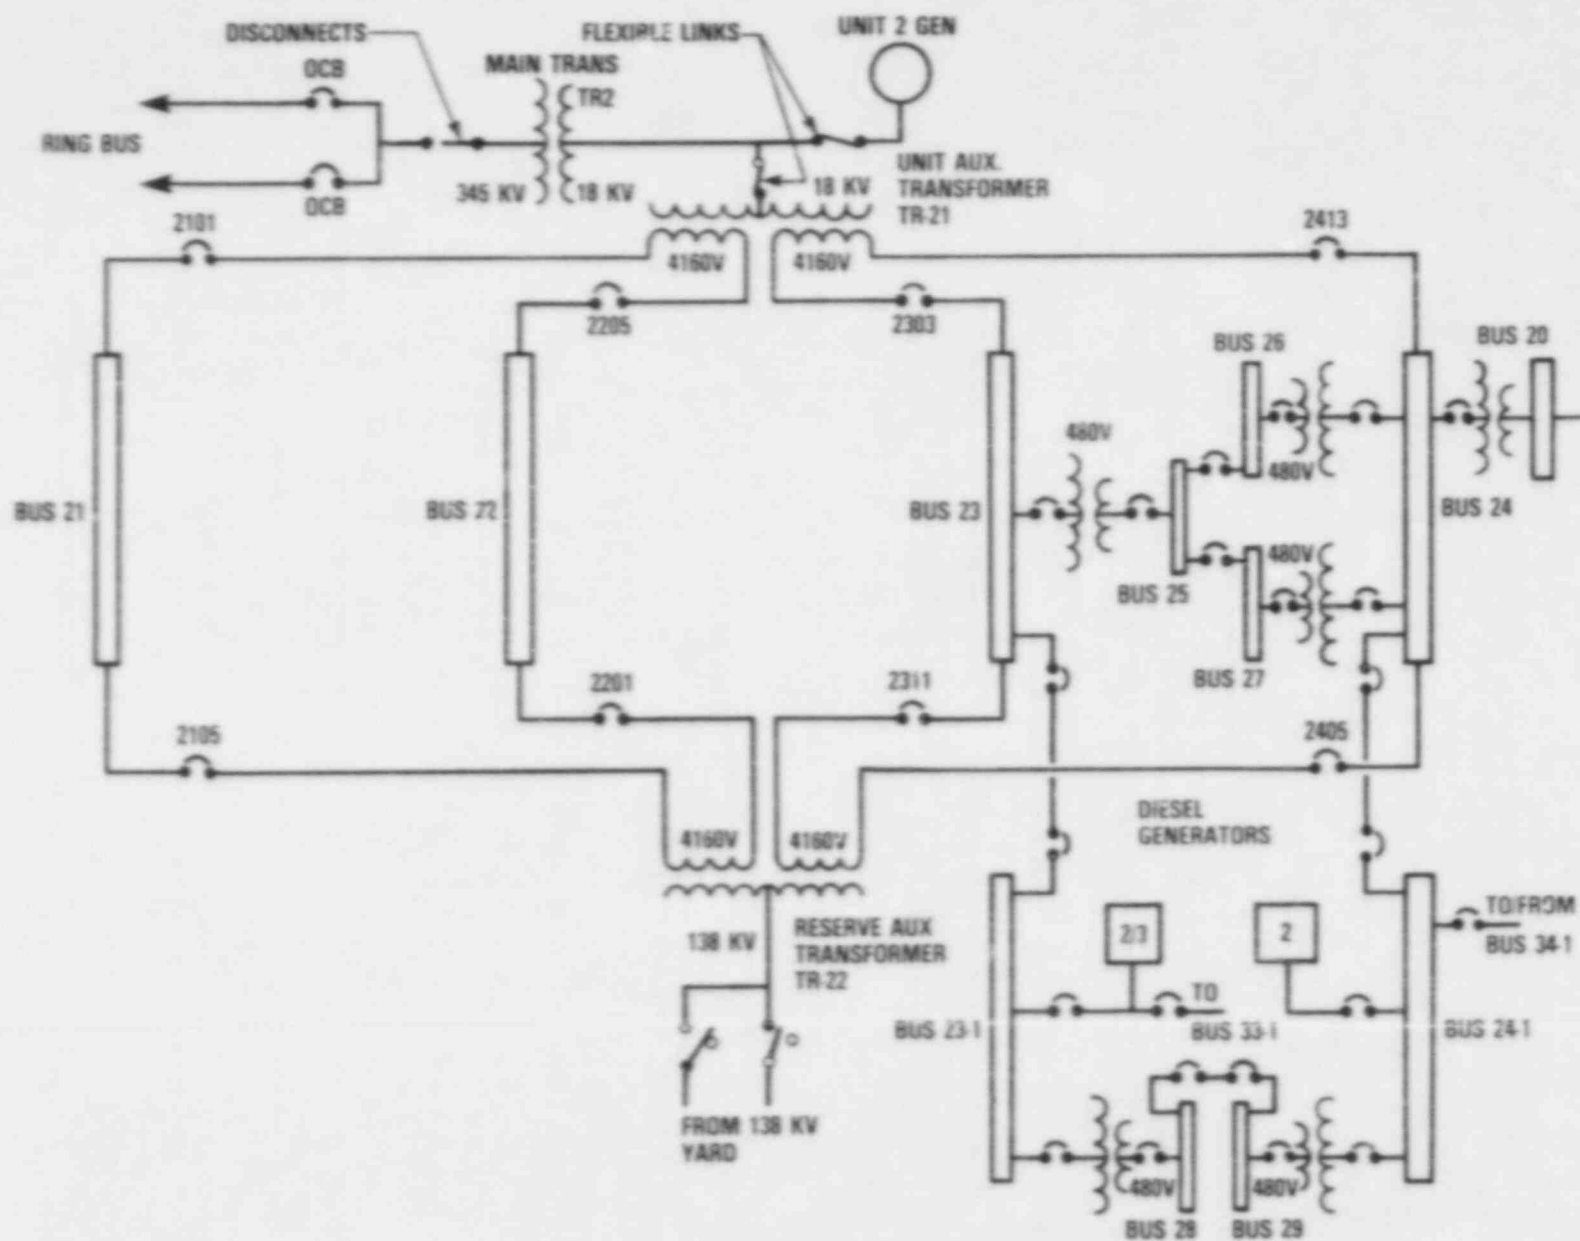
FIGURE 2. DRESDEN 2 ELECTRICAL DISTRIBUTION

A review of the electrical drawings for the circuit breaker power transfer scheme on buses 22 and 24 revealed that the feed breakers (2205 and 2413) from TR21 for both buses were not designed to automatically close under the fault condition that prevailed. For the feed breakers on buses 21, 22, 23, and 24, all contacts must close for power transfer to occur. During this event, all contacts closed except those from the relay whose contacts close only when a lockout condition exists on TR22. Loss of primary feed to TR22 does not result in a TR22 lockout condition. Automatic transfer of power to buses 22 and 24 was not supposed to occur under the fault condition that prevailed.

- Visual and physical inspection of the 4 kV breaker circuitry was performed to verify that the closure circuit wiring matches the design drawings. This was done to prove that the automatic transfer of power to buses 22 and 24 was not supposed to occur under the fault condition that prevailed.

- Modifications were made to the circuit breaker close circuitry to feed circuit breakers 2101, 2205, 2303, and 2413. The modification will allow an automatic transfer of offsite power from TR 22 to TR 21, independent of the cause of power interruption to TR22.
