UNITED STATES
NUCLEAR REGULATORY COMMISSION
WASHINGTON, D. C. 20555

SUBJECT: TRIP REPORT FOR MCGUIRE AND OCONEE SITE VISITS
REGARDING WRONG UNIT/WRONG TRAIN EVENTS

This memorandum documents the activities and findings of an NRC staff visit to the McGuire and Oconee sites on October 21-24, 1985. Members of the NRC team for this visit included A. Ramey-Smith (DHFT), D. Persinko (DHFT), and E. Trager (AEOD). The site visit was conducted as part of the short-term effort to determine whether simple, low cost improvements can be identified and implemented to reduce the frequency of wrong unit/wrong train events occurring at nuclear power reactor facilities. Upon completion of all site visits, the factors contributing to the events will be evaluated and a report issued which discusses causes and recommendations.

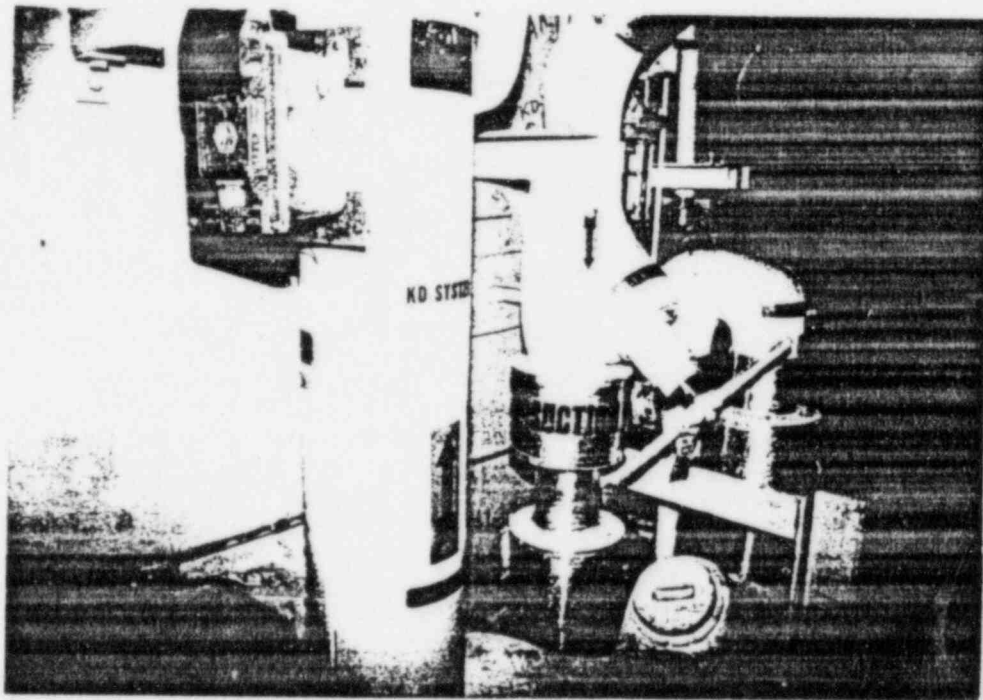
improvement there were still signs of problems. There is no site-specific procedure on labeling and color-coding and many indications of "false starts," in earlier attempts. (Exhibit 1 is an example of one earlier attempt to apply identification information to component and piping surfaces.) Current valve labeling consists of embossed aluminum tags and bailing wire, but there are no standards for the tags. Exhibit 2 is a photograph of identification information written on a wall in "Magic Marker," and is further evidence that personnel at the site need better information on identification.

Exhibit 1. McGuire. Early Labeling Attempt that was Discontinued.

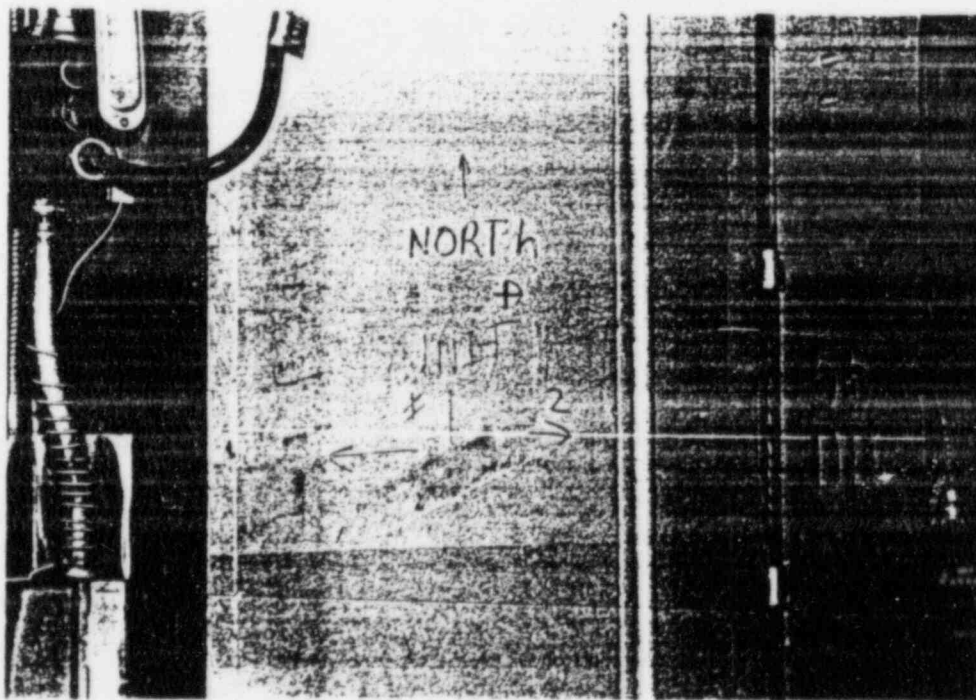
Exhibit 2. McGuire. Information Written on a Wall with "Magic Marker."

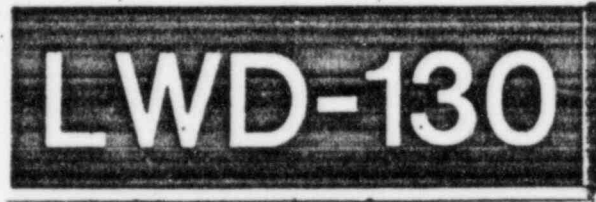
Exhibit 3. Ocone. Actual size of label for a component in the liquid waste drain system (Black Background for station common).

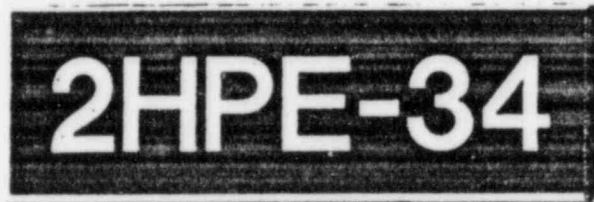
Exhibit 4. Ocone. Actual size of label for a component in the Unit 2 High Pressure Exhaust system (Red Background for Unit 2).

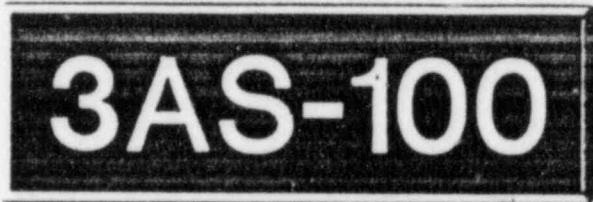
Exhibit 5. Ocone. Actual size of label for a component in the Unit 3 Auxiliary Steam system (Blue Background for Unit 3).

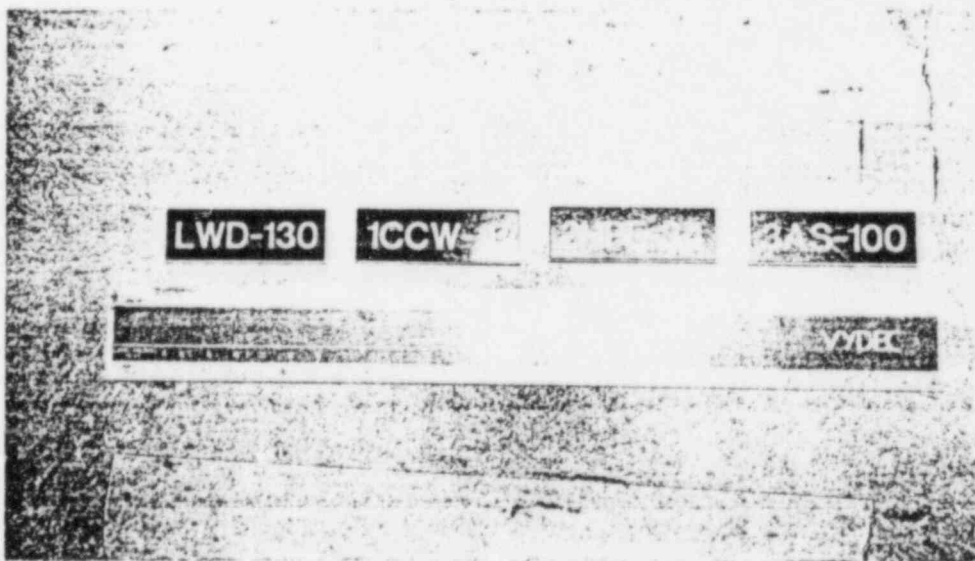
Exhibit 6. Ocone. Component labels compared at a distance.

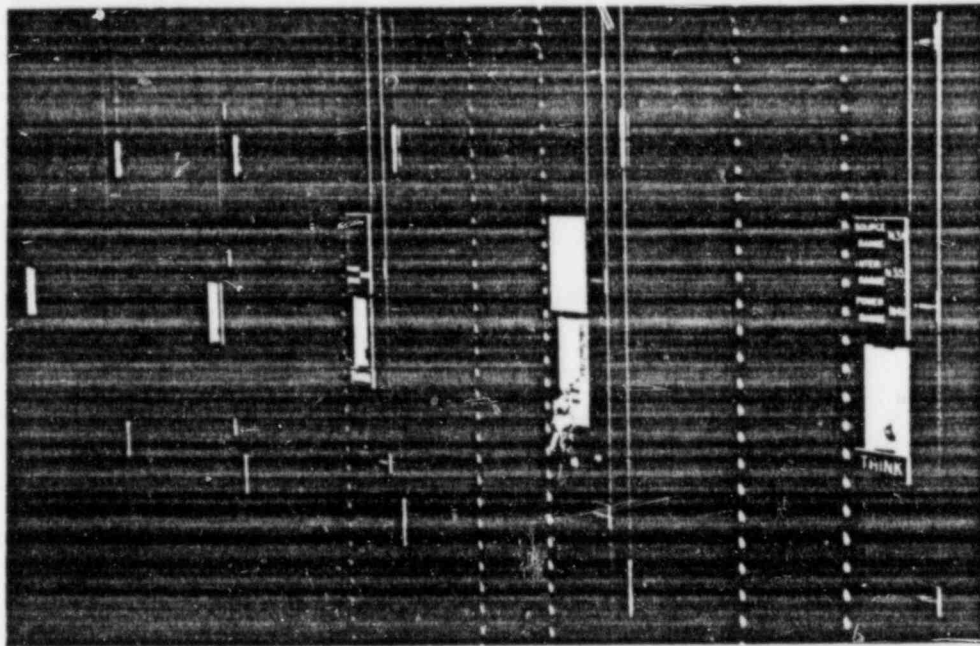
- The orientation of the channels on the front of the cabinets is the reverse of that on the rear of the cabinets. That is, on the front 42 is to the left of 43 and on the rear 42 is to the right of 43. Adequate labeling becomes even more crucial under these conditions.

- One contributing factor was that the label for channel 43 was on a column between the cabinet doors for channels 42 and 43 making the label/component relationship ambiguous. The labels are now on the appropriate cabinet doors themselves as well, and "Think" signs have been installed under the keyhole in the cabinets (see Exhibits E1-1 and E1-2). However, there are still no labels inside the cabinets to identify which unit or channel the instrumentation within is associated with. That is, once the doors are open the unit and channel identity of the equipment is not labeled.

Exhibit E1-1. McGuire. Current Nuclear Instrumentation Cabinet Labeling.

- The procedure has been changed to require a dual verification of channel identity, and there is a separate procedure for each channel.
- The IAE technician who made the error was interviewed. He stated that there had been problems with turbine runback at that time. He was worried because he knew that if it happened when he was running the test the plant would trip. He felt that those concerns and his familiarity with the system may have caused him to be less vigilant. That person thought that the current panel labeling is an improvement.

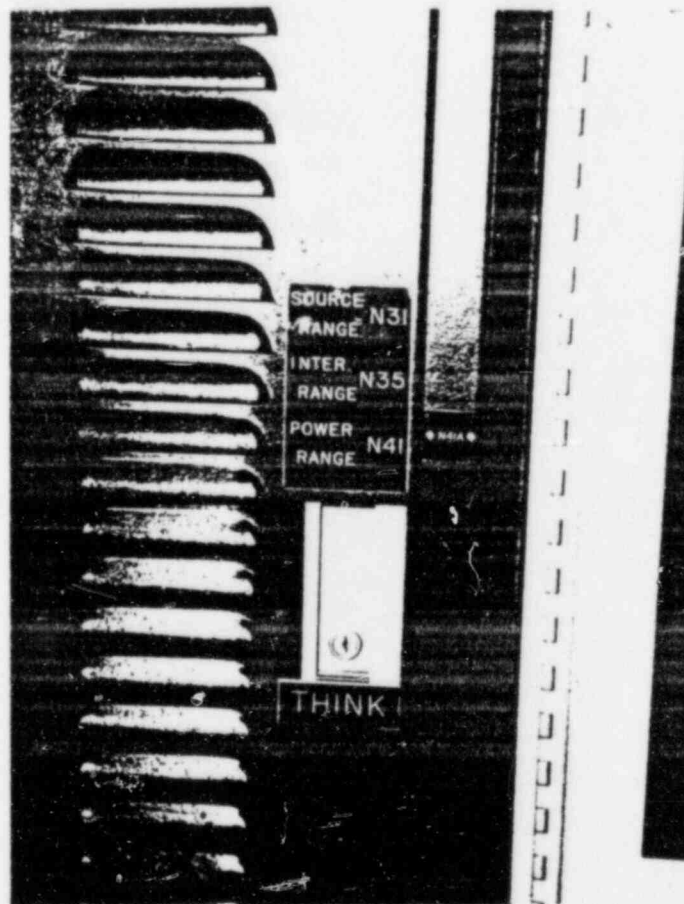
Exhibit E1-2. McGuire. Current Nuclear Instrumentation Cabinet (Front)
