U.S. NUCLEAR REGULATORY COMMISSION

Report No. 50-265/88024(DRP)

Facility Name: Quad Cities Nuclear Power Station, Unit 2

MOTOR CONTROL CENTER TRANSFER CAPABILITY

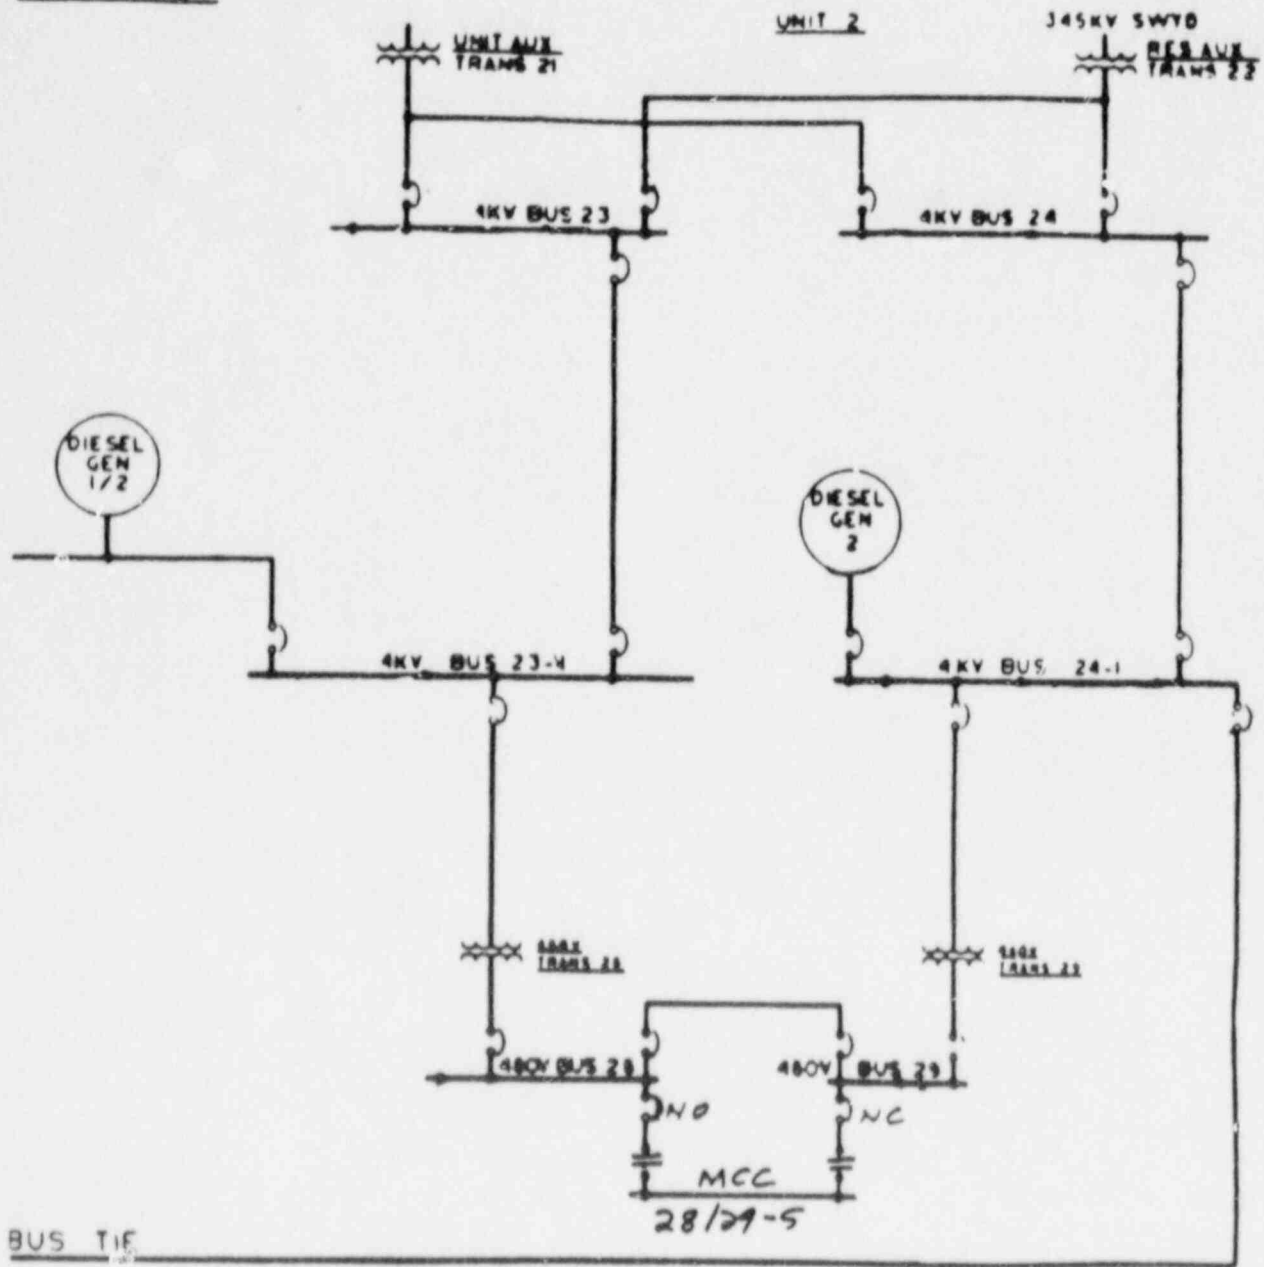
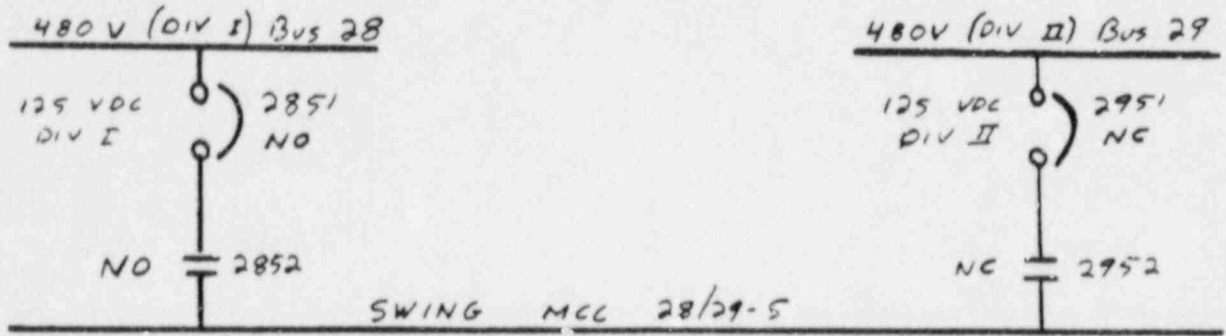
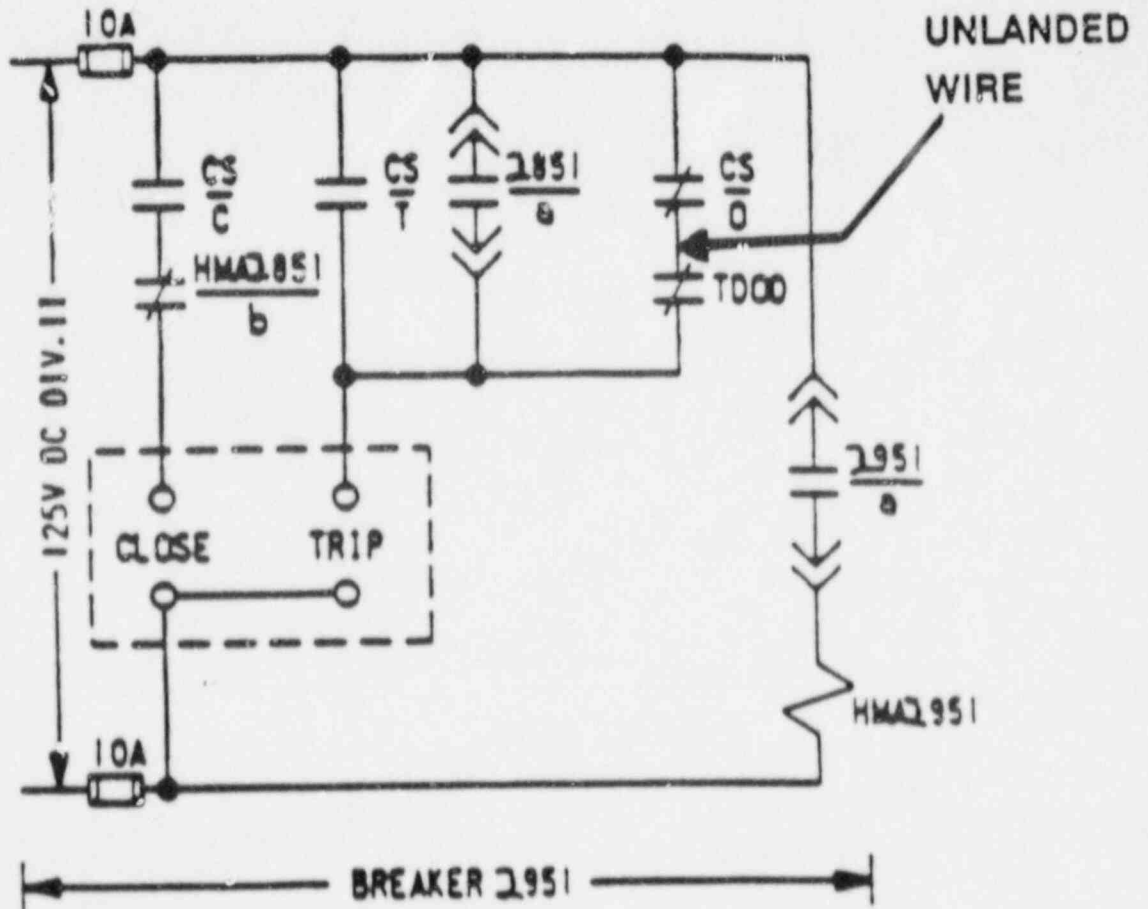
QUAD-CITIES

- RHR SWING MCC FAILED TO TRANSFER DURING INITIAL MOD TEST. STATION PERSONNEL INVESTIGATED, FOUND UNLANDED WIRE.

- ENGINEERING REVIEW SHOWED THAT THE MISSING WIRE WOULD INHIBIT AUTOMATIC TRANSFER. MANUAL ACTION BY THE OPERATOR WOULD STILL BE EFFECTIVE.

(Simplified for clarity)

- IMMEDIATE CORRECTIVE ACTIONS
  - RELANDED THE CONDUCTOR
  - REPEATED MOD TEST; NO FURTHER DISCREPANCIES NOTED
