Appendix A contains discussions of the following items: the original thermal sleeve design and installation; thermal sleeve visual and dye penetrant inspections conducted on the sleeves; laboratory examinations and analysis of removed parts; postulated cause(s) of sleeve failure; and a description of the replacement sleeve (new) design.

Replacement Thermal Sleeve Design

ATTACHMENT 1 - NON-DESTRUCTIVE EXAMINATIONS

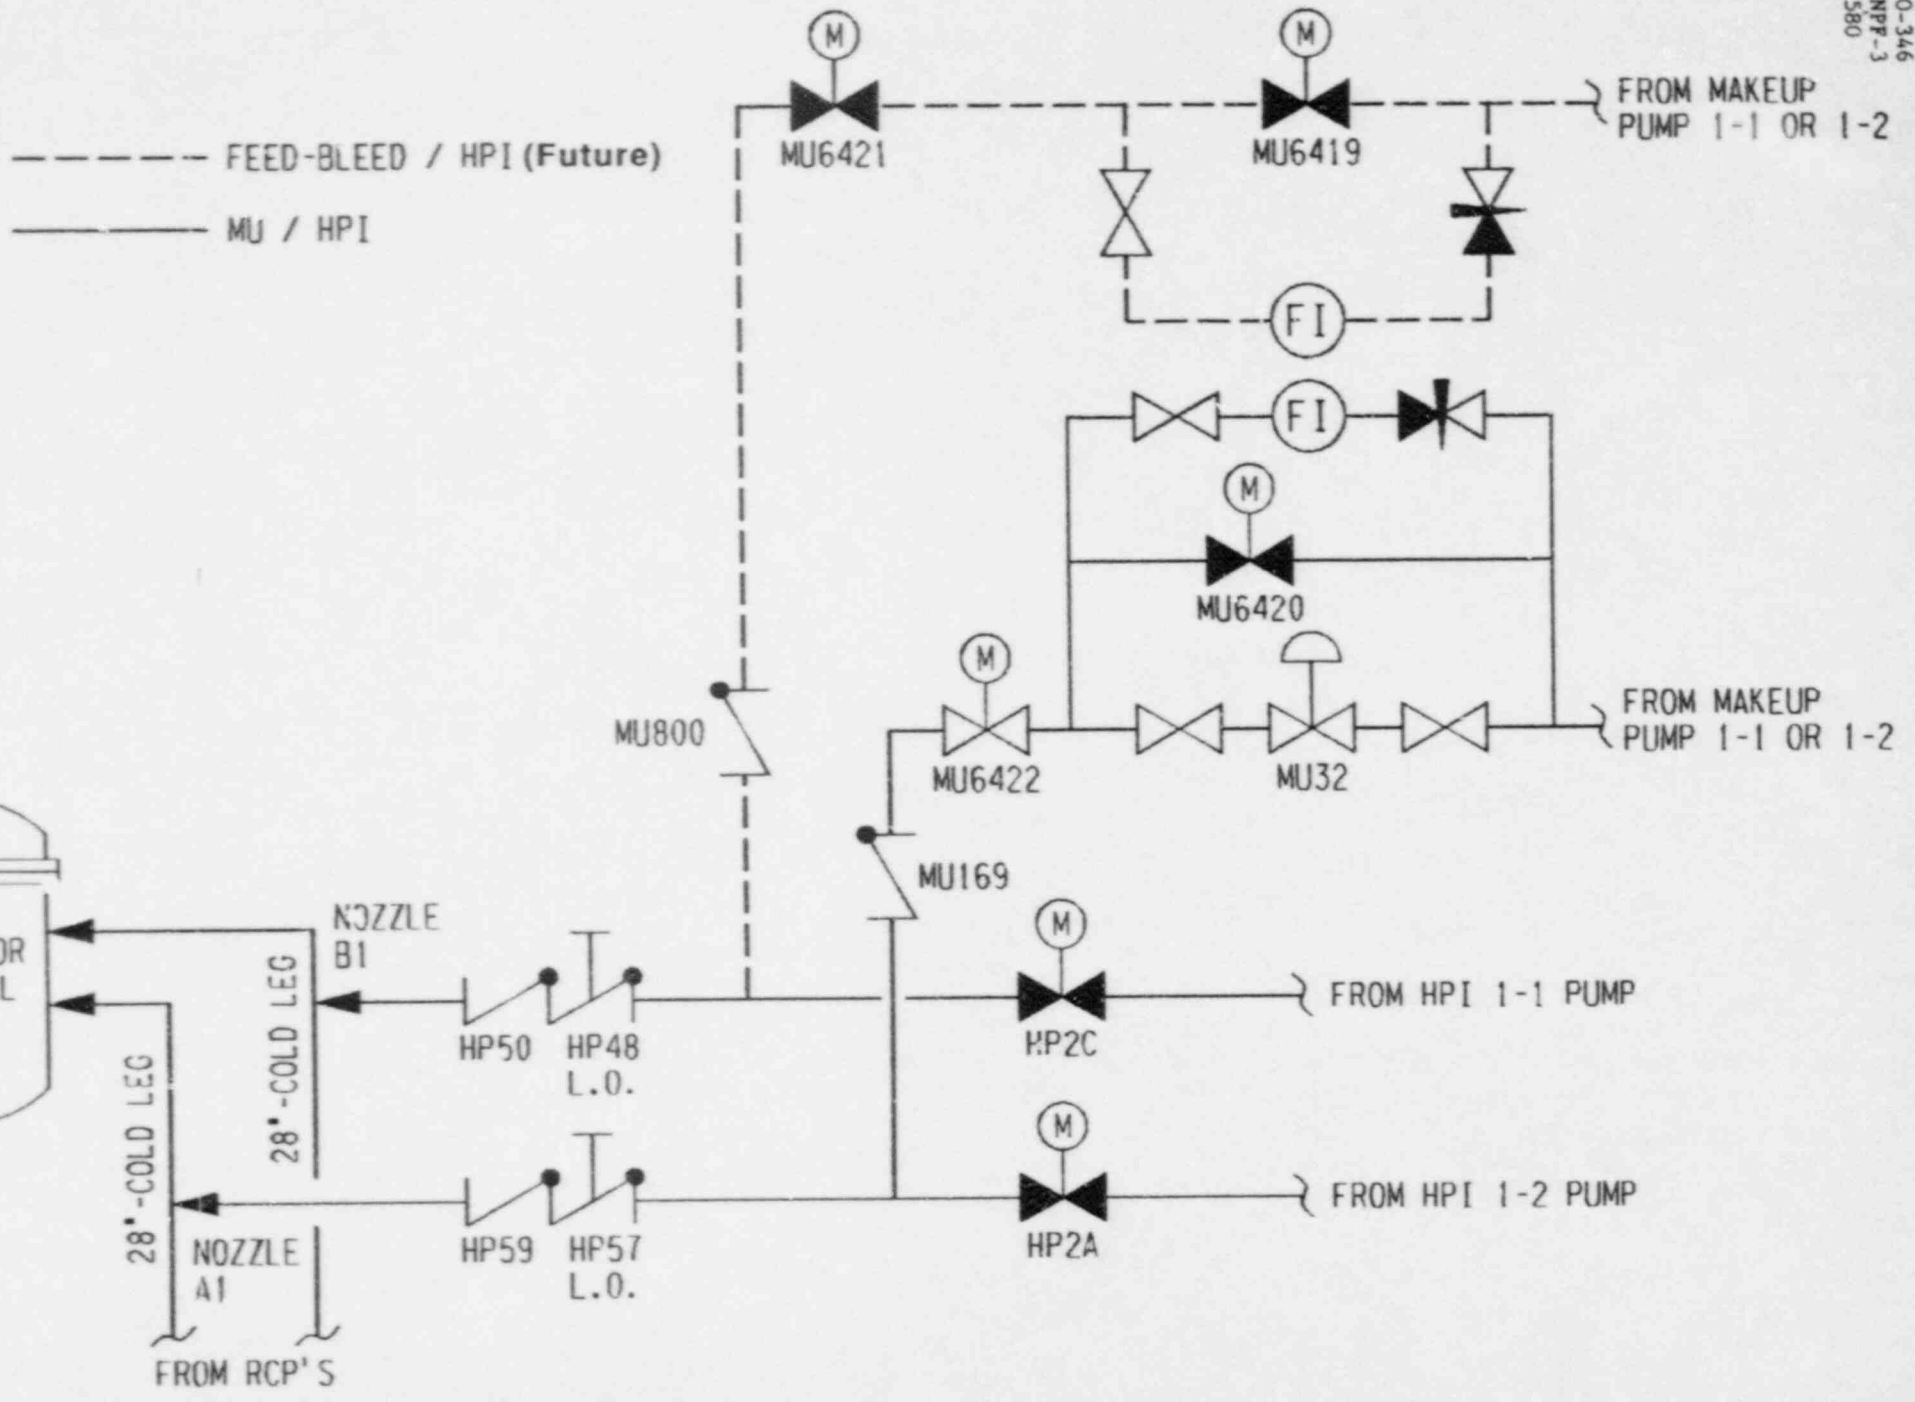
FIGURE B-1

An additional path for makeup to the RCS has been added during the fifth refueling outage. Figure B-1 shows the flow paths for both the normal makeup and that associated with the enhanced feed and bleed capability. One path for feed and bleed flow to the RCS is through HPI nozzle B1 which contains a thermal sleeve of the original design. The inspection of the installed sleeve showed no evidence of any cracking. While it is not intended that this flow path be used for normal makeup duty, minimum flow bypass capability has been designed into the system.

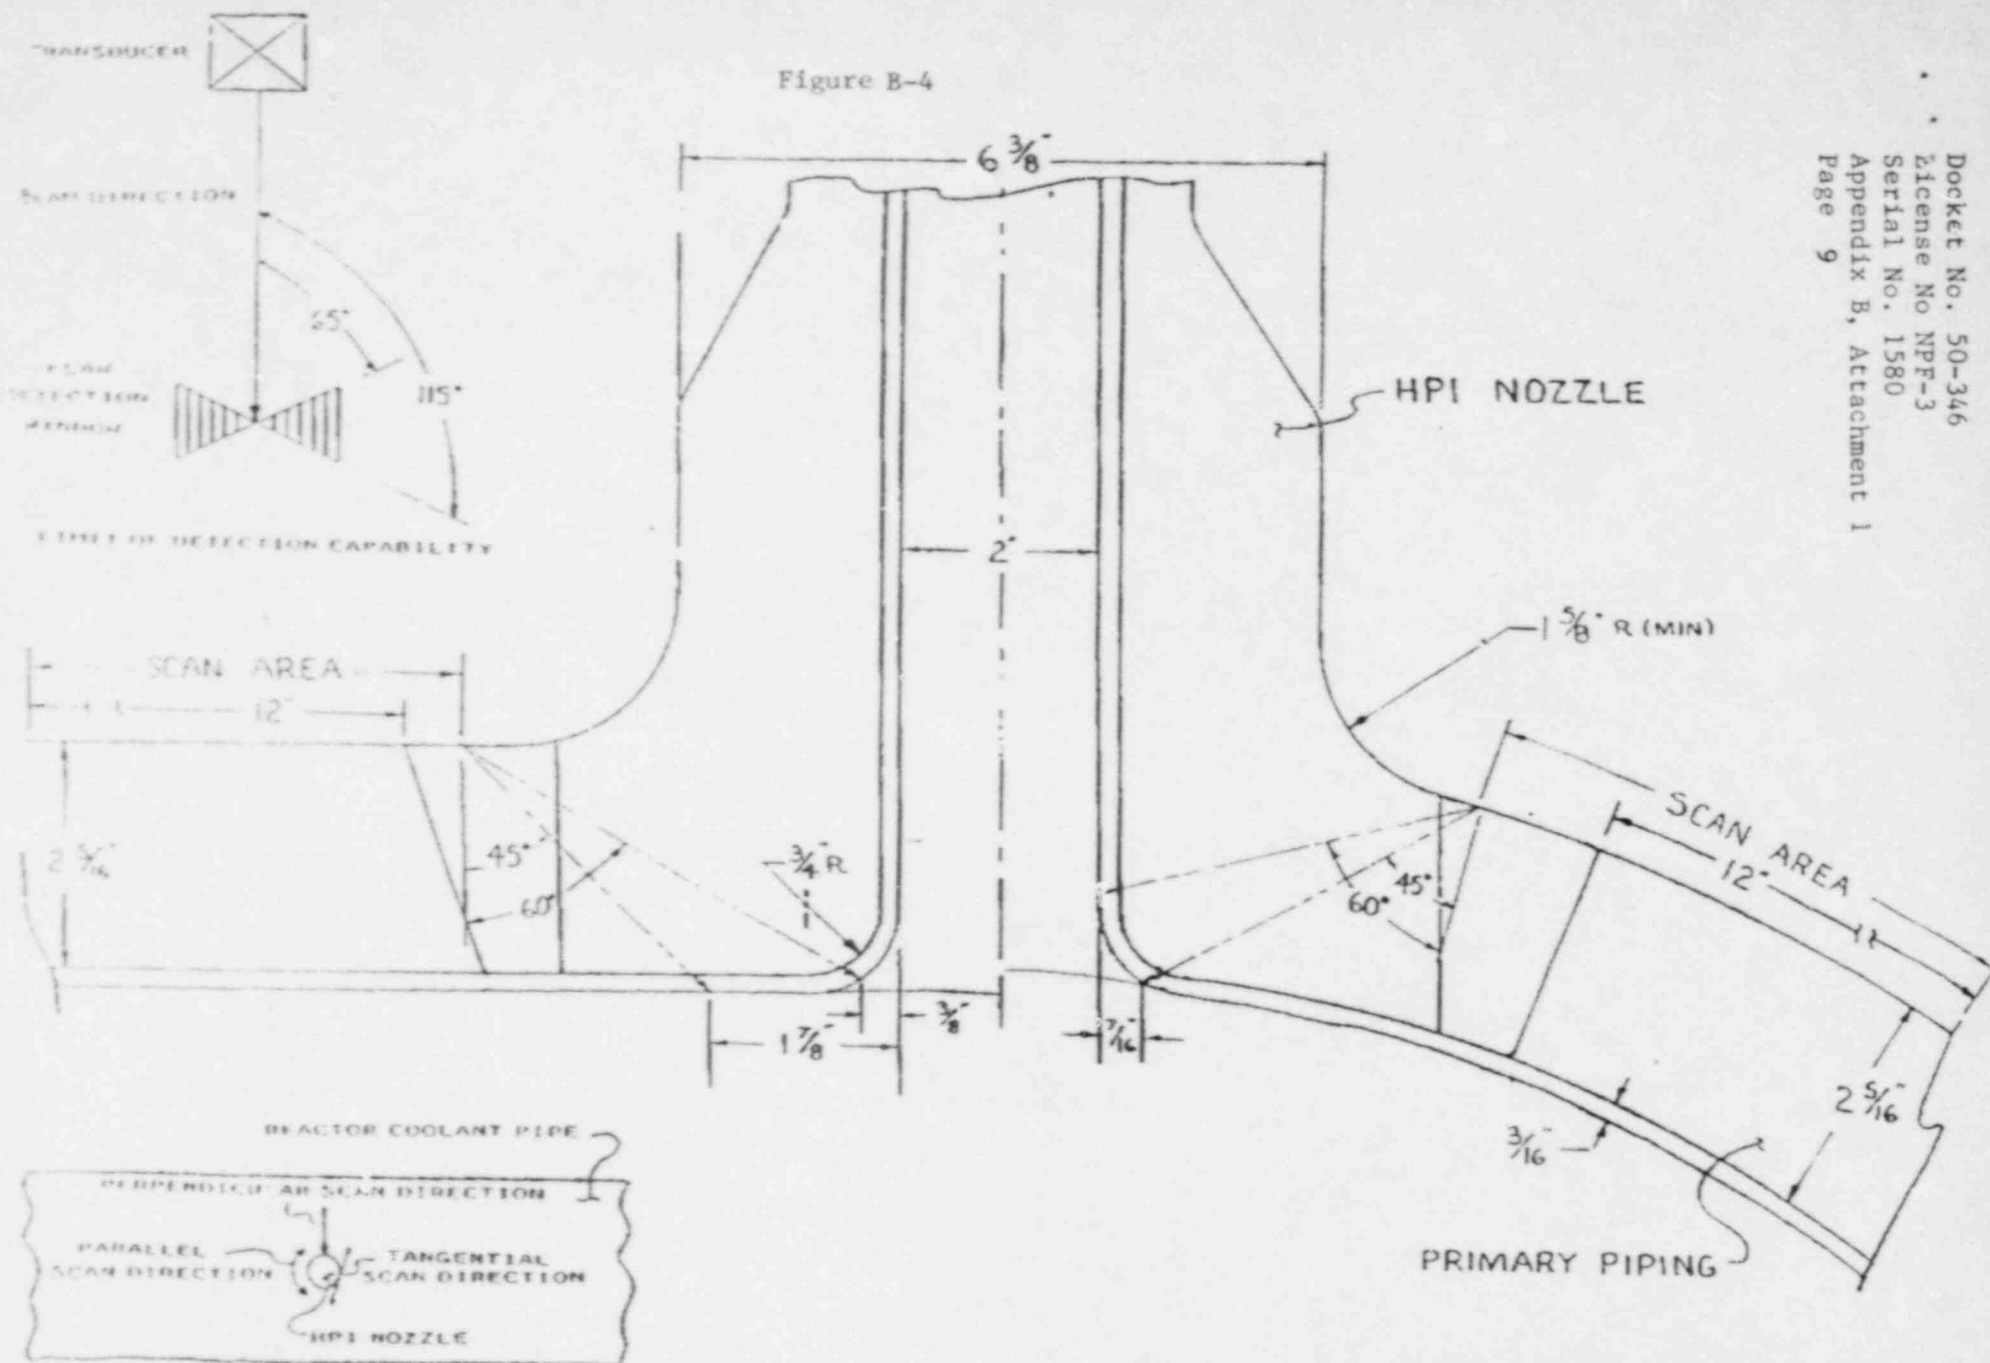
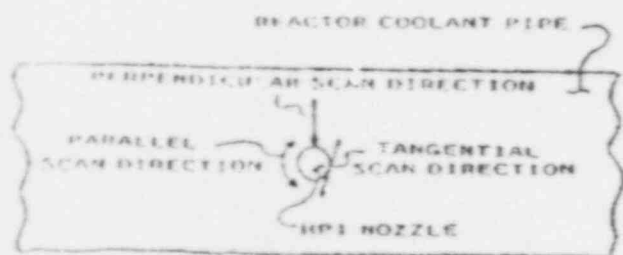
Figure B-4

On July 15, 1988, an ultrasonic (UT) examination was performed on the A1 High Pressure Injection nozzle in order to further characterize the liquid penetrant detected indications. The area of interest included both the accessible portions of the nozzle bore to the maximum extent practical limited by geometry and the surrounding base material of the reactor coolant system piping within a 12 inch radius. The extent of RCS examination was based on judgement derived from experience at Indian Point I. The examination was performed over 360 degrees to ensure full coverage (Figure B-4).

Based on the demonstrated detection levels for the 45 degree and 60 degree examinations and the fact that there were no recordable indications, there is a high confidence level that there are no flaws which penetrate through the clad and into the base material in the areas examined or which exceed the initial flaw sizes utilized in the B&W fracture mechanics analysis.

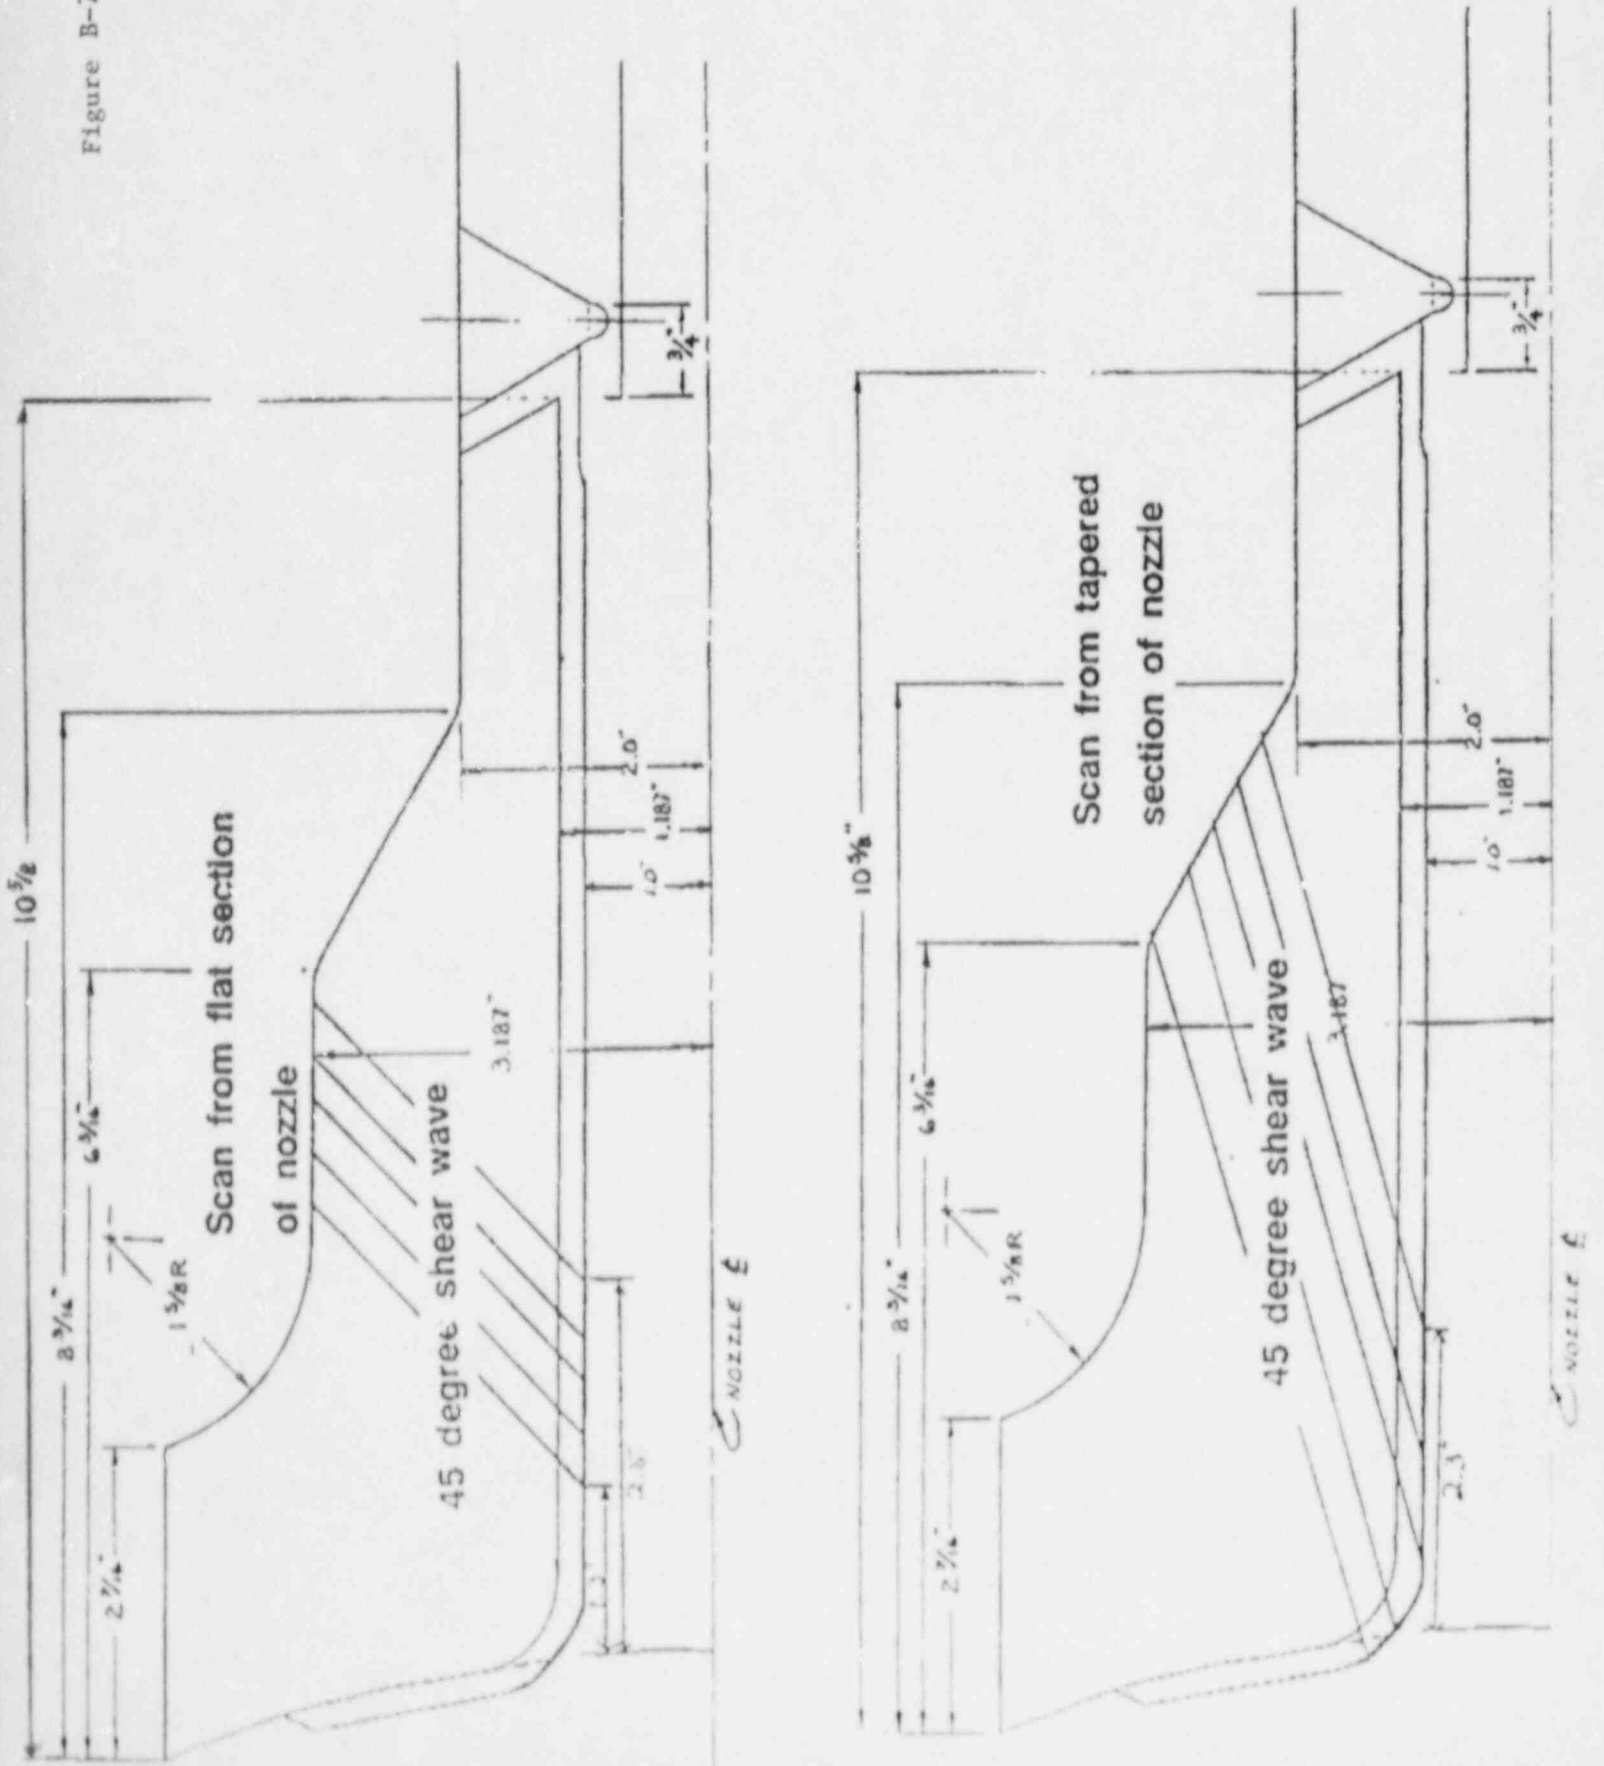
Figure B-7

A second ultrasonic examination was performed on the HPI nozzle to evaluate the condition of the HPI nozzle bore and inside radius in the region where the PT indications were observed. Scans were performed along the nozzle axis to detect circumferentially oriented flaws using 45 degree and 60 degree shear wave angle beams from the flat section of the nozzle (Figures B-7 and B-8).

Based on the demonstrated detection levels for the 35 degree, 45 degree and 60 degree examinations and the fact that there were no recordable indications, there is a high confidence level that there are no flaws which penetrate through the clad and into the base material in the areas examined or which exceed the initial flaw sizes utilized in the B&W fracture mechanics analysis.
