FAILURE ANALYSIS OF
SHAFT SLEEVES IN AN AUXILIARY FEEDWATER PUMP

Report for
South Texas Project

Tech. Report No. 8804-03 FA
BLN No. 8804-05

April 1988

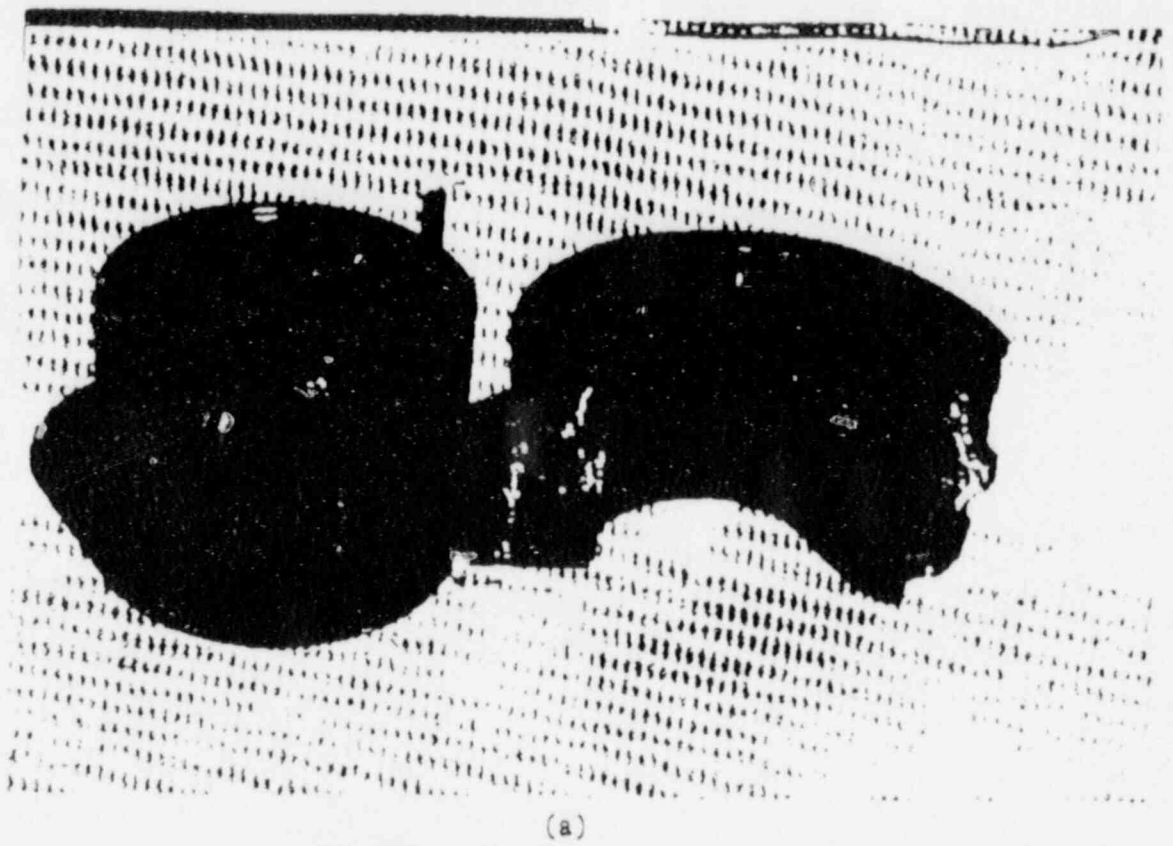
The shaft center sleeve with a key and one-half the throttle bushing and its sleeve are shown in the as-received condition in Figure 1. These samples show cracks, discoloration, and friction marks. The throttle bushing and its sleeve were stuck together except for a segment that separated as shown in Figure 1(b).

Figure 1 (a) The shaft center sleeve (left) and the throttle bushing/sleeve (right) in the as-received condition.
(b) The galled sliding surface between the throttle bushing and its sleeve.

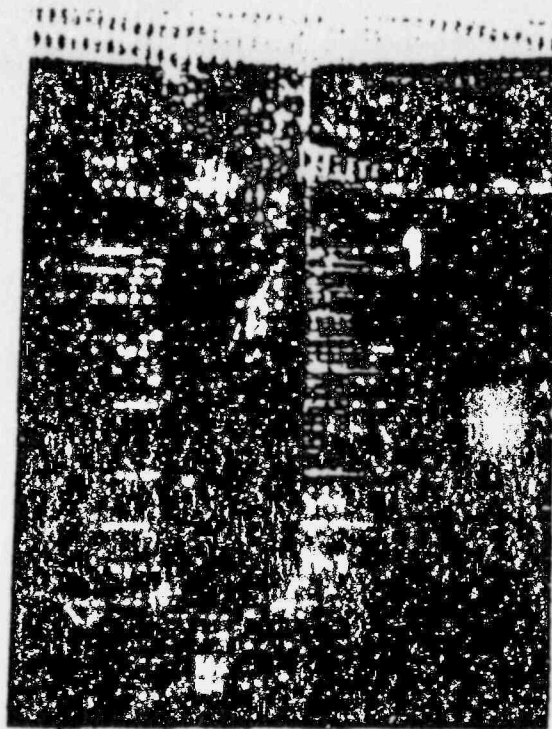
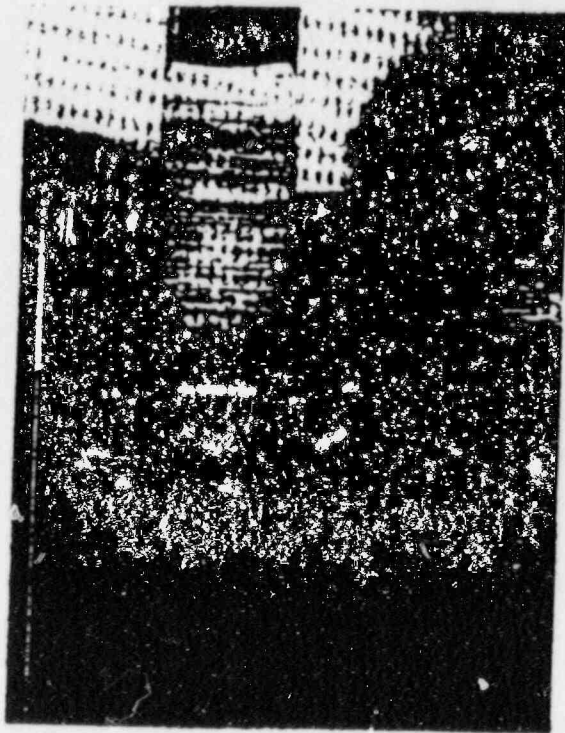
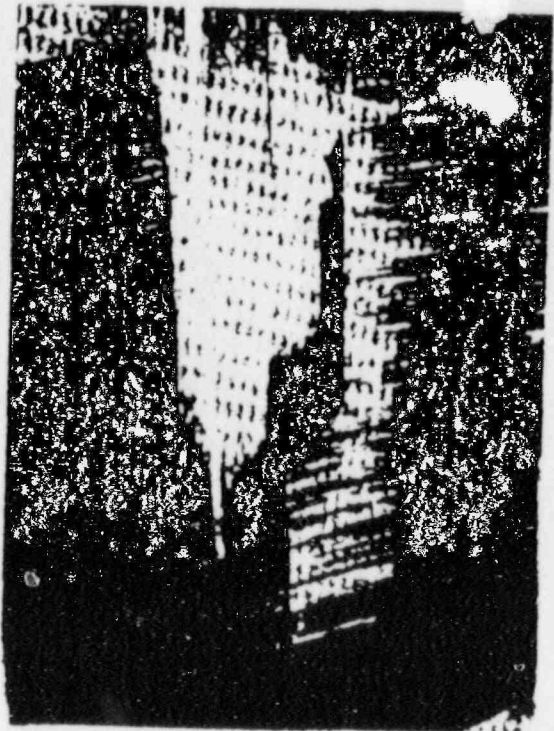
The oblong area at the end of the key in Figure 4(b) revealed a characteristic shear fracture.

Figure 4 (a) The keyway in the shaft center sleeve viewed on the inside surface.
 (b) & (c) The inside surface around the keyway with the key placed in and along the keyway.

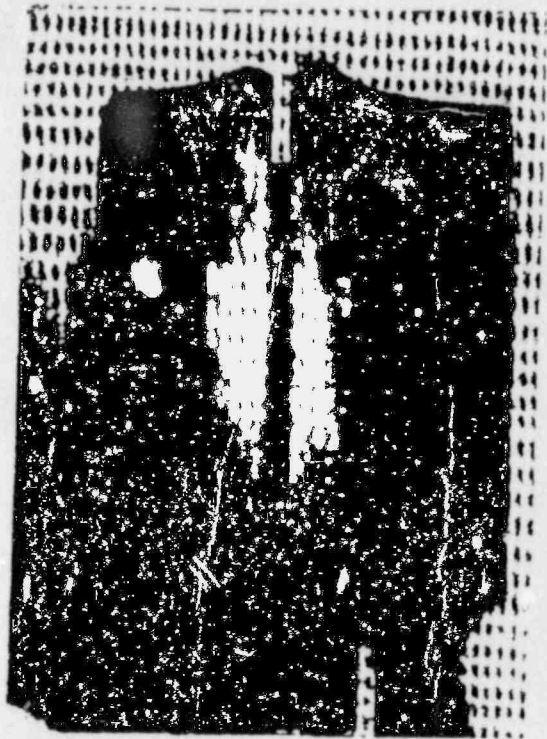
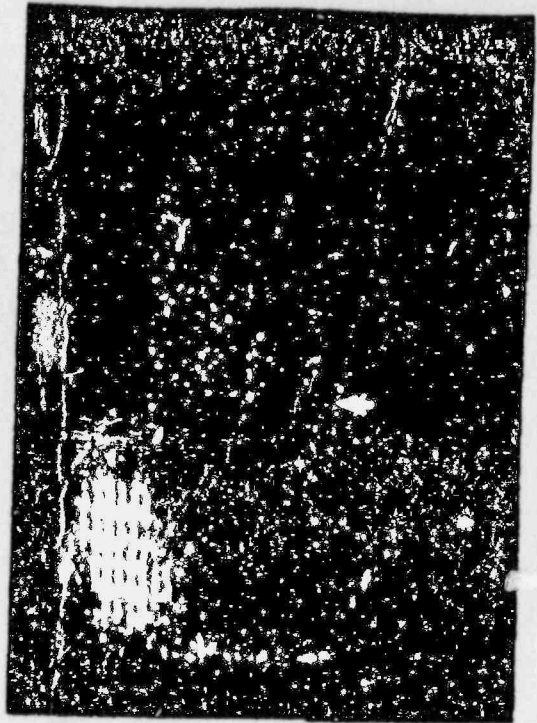
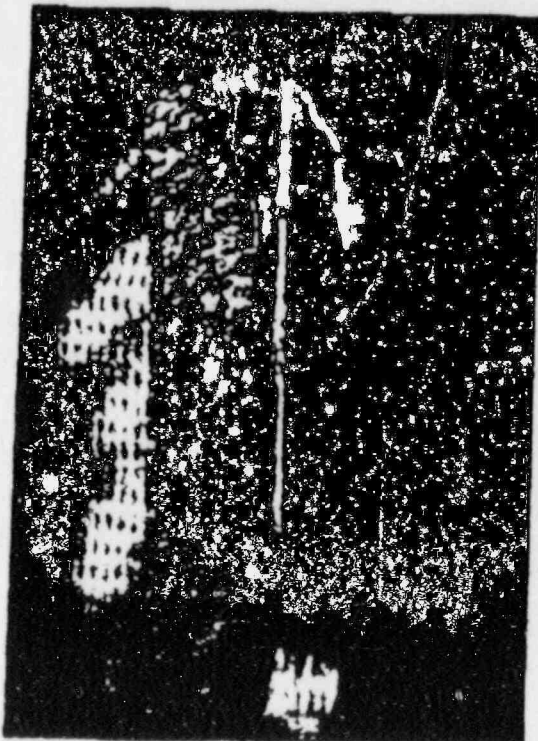
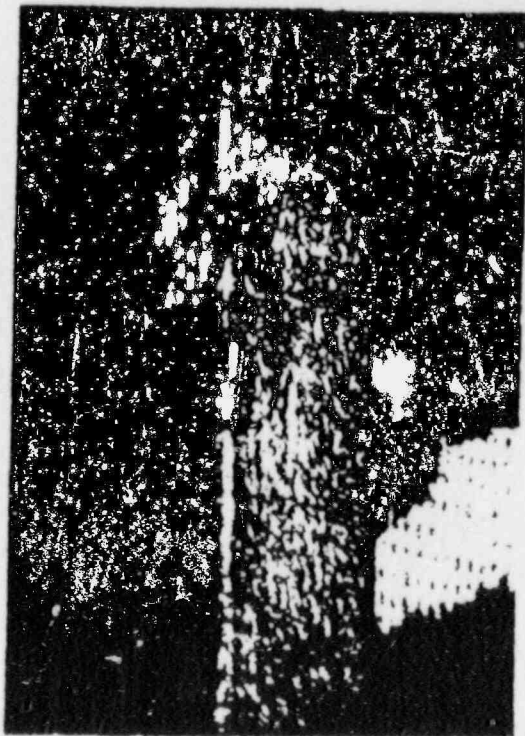
The fracture faces of the two mating pieces of the shaft center sleeve are shown in Figure 5(a). A change in fracture appearance occurred toward the end opposite the keyway. This is marked by an arrow in Figure 5(b). Small areas of rust were found on the fracture faces near the corner of the keyway [Figures 5(a), (b), and (d)]. The fracture appearance of the shaft center sleeve is comparable to that of the throttle sleeve shown in Figure 6.

Figure 5 (a) The mating fracture faces of the shaft center sleeve.
(b) The bottom portion of the fracture showing a transition zone (arrow).
(c) & (d) The mating fracture faces at the keyway. The arrows point to an area with rust on the fracture face.

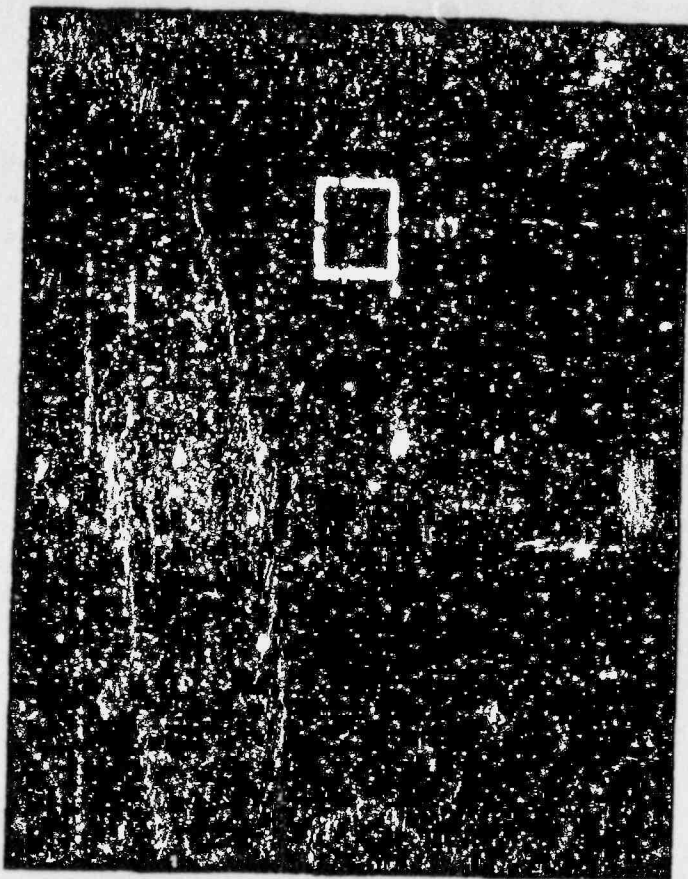
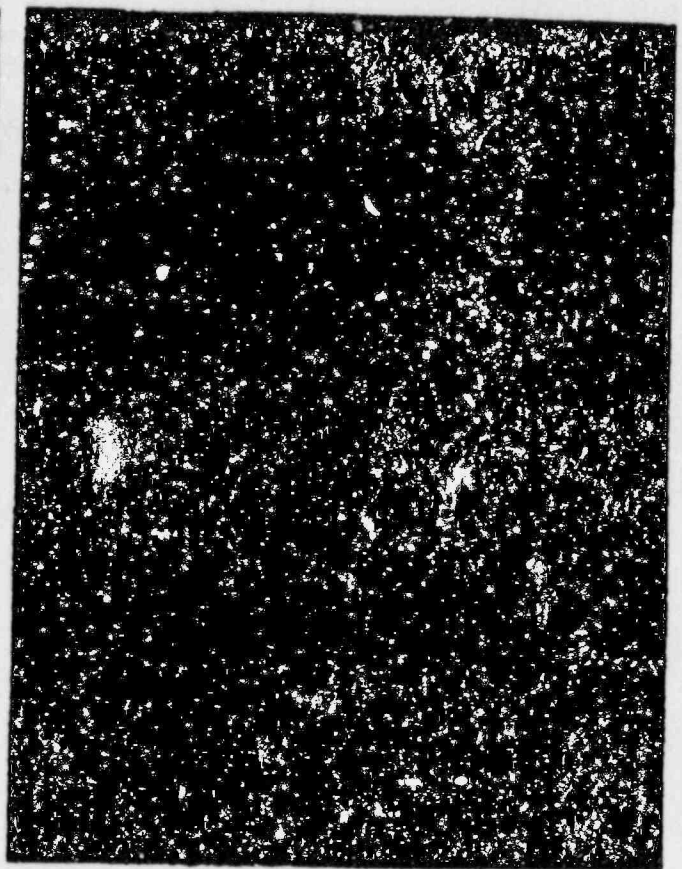
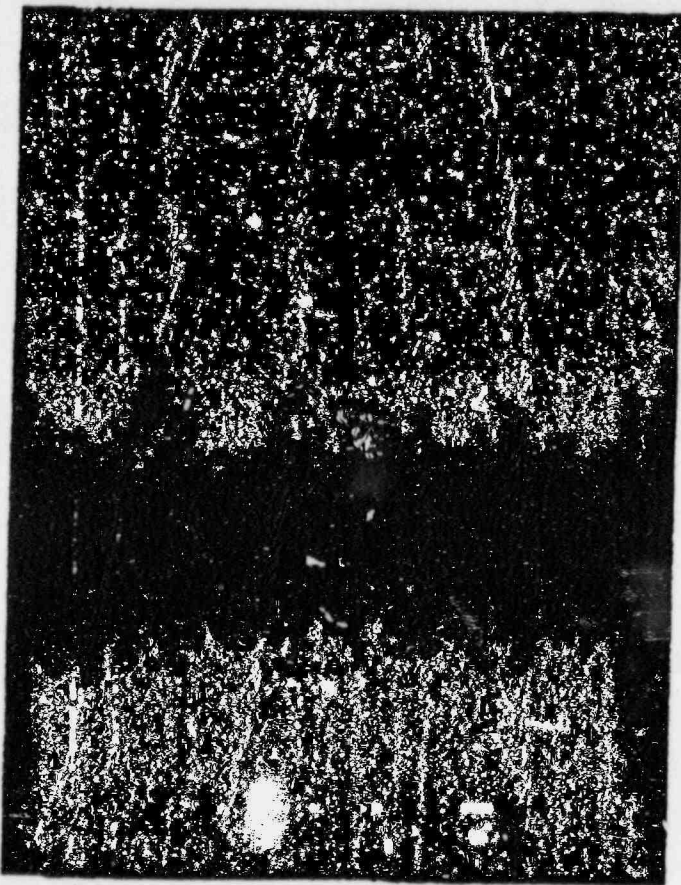
Figure 7(a) shows the area with rust on the fracture face of the shaft center sleeve. The area bounded by a white rectangle is shown at a higher magnification in Figure 7(b). The granular appearance is typical of intergranular cracking. Figure 7(c) is typical for the fracture face near the rounded end of the keyway. It shows no corrosion products on the fracture face. This intergranular mode of fracture persisted until the transition line indicated in Figure 5(b). The finer fracture appearance below the transition line resulted from a change in the fracture mode to a dimple fracture. This change in the fracture mode in a microscopic scale is shown in Figure 8. (A specimen cut from the shaft center sleeve and broken fresh at room temperature in the laboratory showed a dimple fracture mode.)

Figure 7 Scanning electron micrographs of the fracture face of the shaft center sleeve

- (a) The area marked by the arrow in Figure 5(d)
- (b) The area bounded by the white rectangle in (a).
- (c) An area near the end of the keyway.

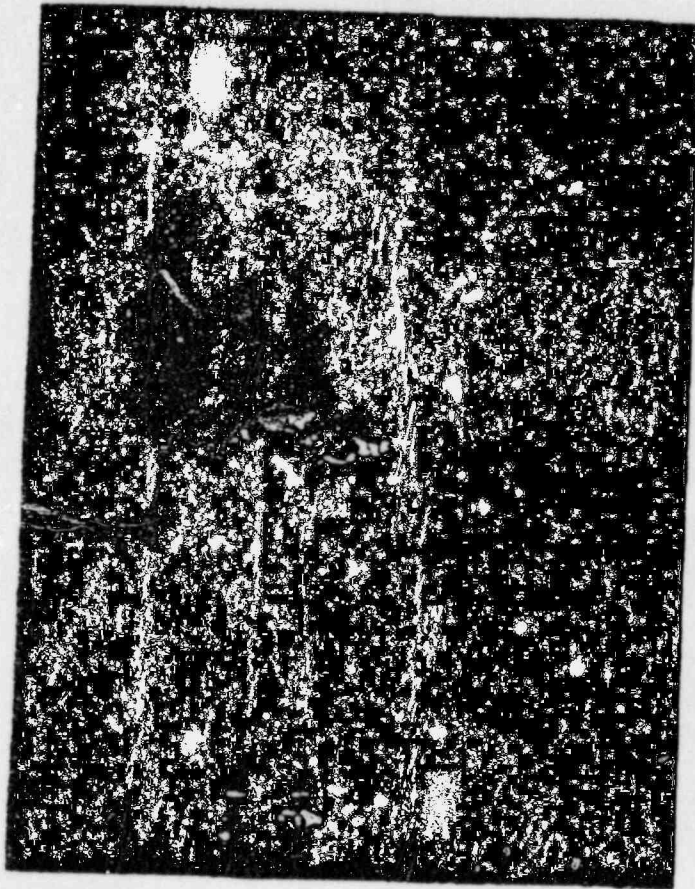
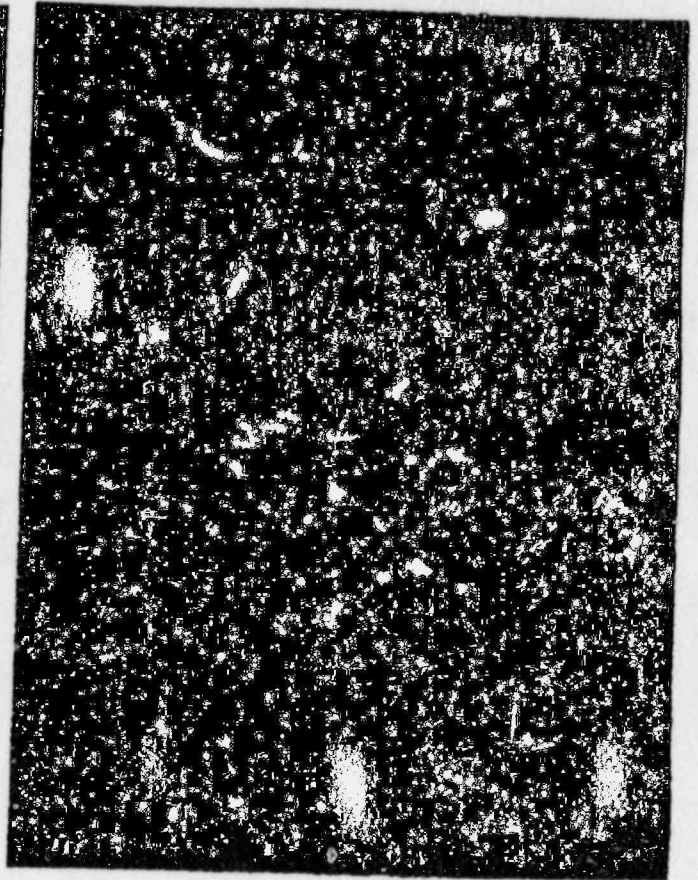
Figure 8 (a) Scanning electron micrograph of an area just above the transition line marked by the white arrow in Figure 5(b).

(b) An area below the transition line in Figure 5(b).

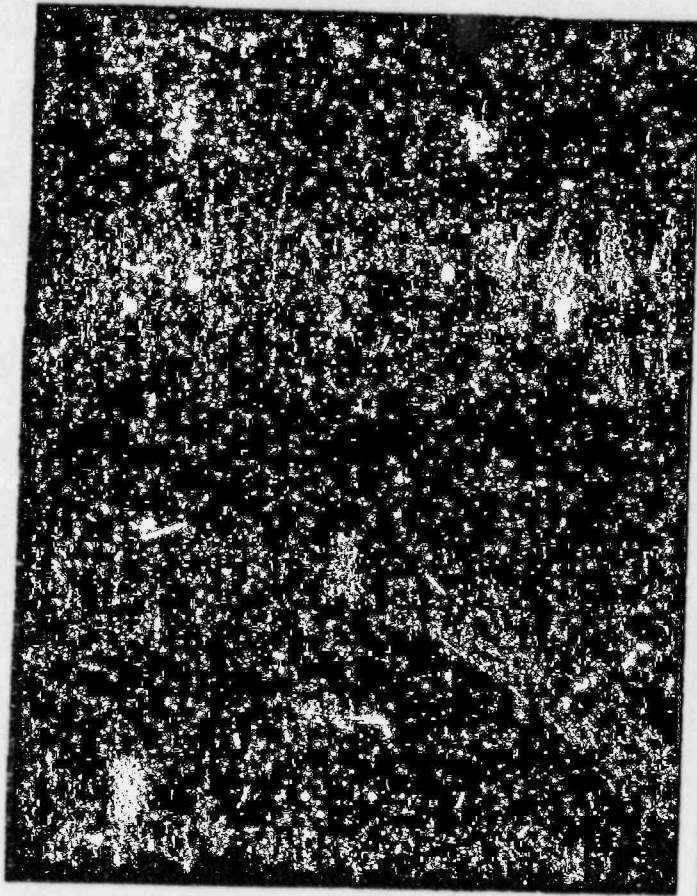
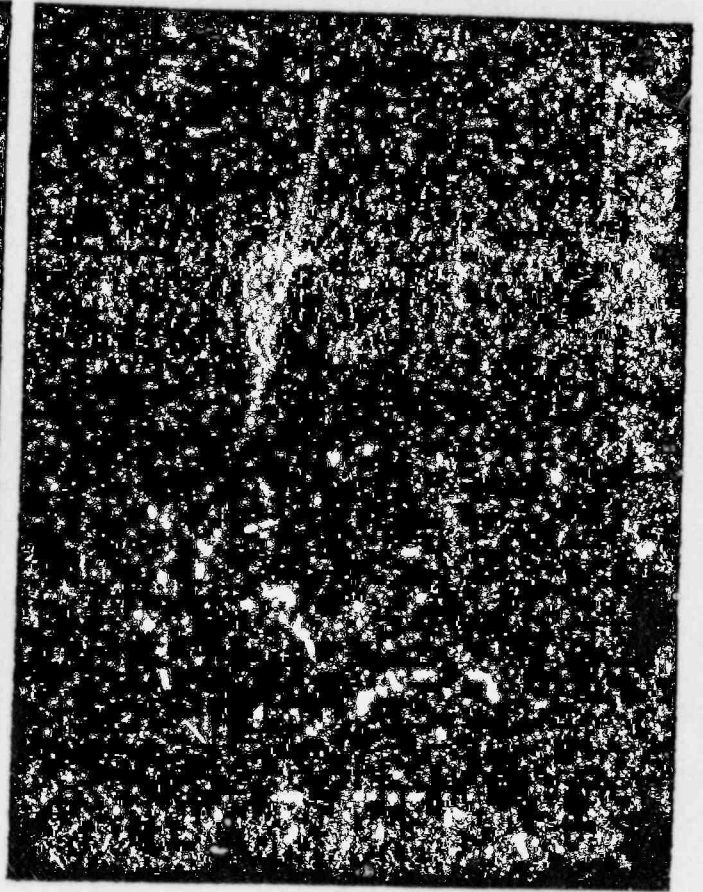
Typical SEM photographs of the intergranular mode of the fracture face in the keyway of the throttle sleeve are shown in Figure 9. The keyway land, adjoining the fracture face (in the area marked by the arrow in Figure 6) was corroded and cracked as evidenced by intergranular attack (Figure 10). The lower halves of the SEM photographs of Figures 10(a) and (b) are a 5X magnification of the areas bounded by the white rectangles. The white arrows

Figure 9 Scanning electron micrographs of the fracture face of the throttle sleeve.

(a) An area near the outside surface. See the area marked by the arrow in Figure 6.

(b) The area bounded by the white rectangle in (a).

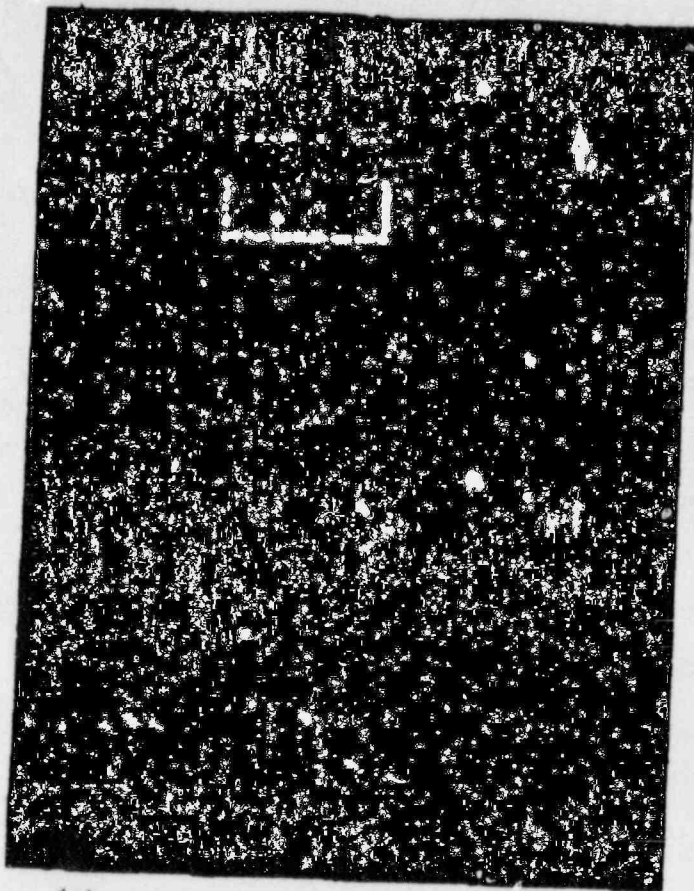
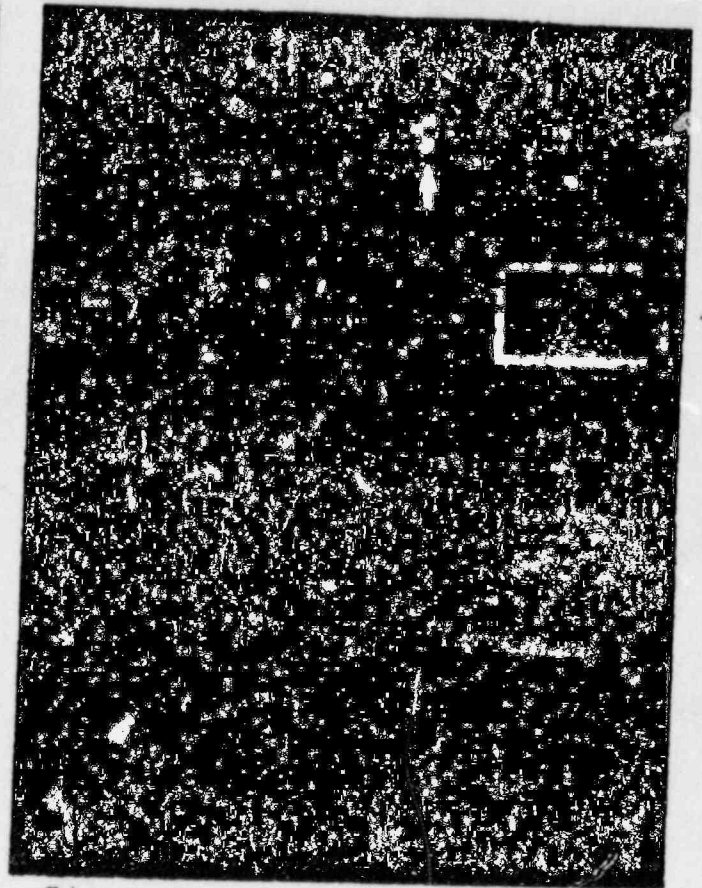
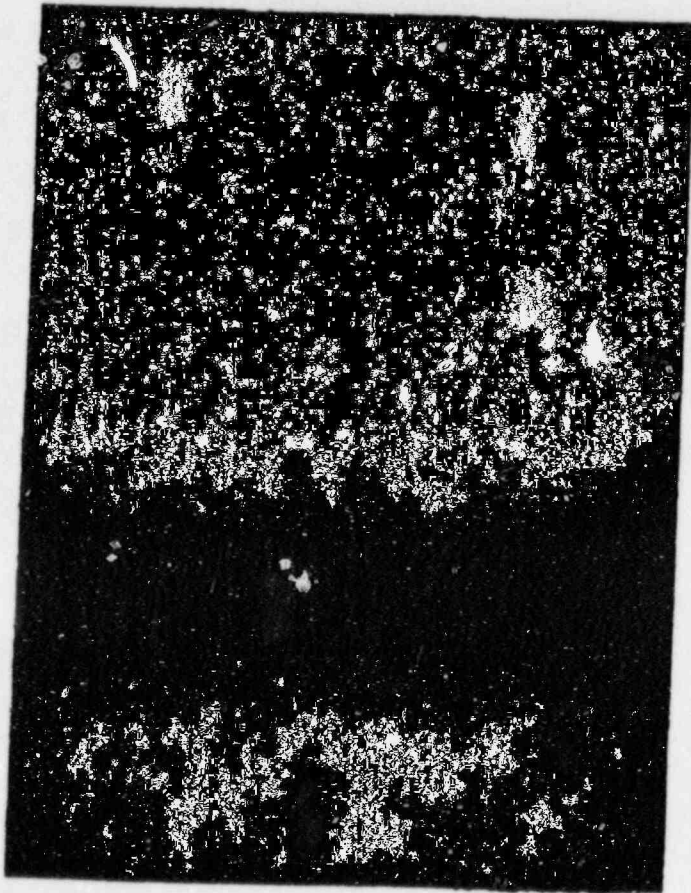
in Figure 10 point to the edges of the fracture face. So, the areas below the arrows are the keyway land. The corrosion in these areas delineated the grain boundaries.

Figure 10 Scanning electron micrographs of the keyway adjoining the fracture face of the throttle sleeve. The arrows mark the edge of the fracture face on the keyway.

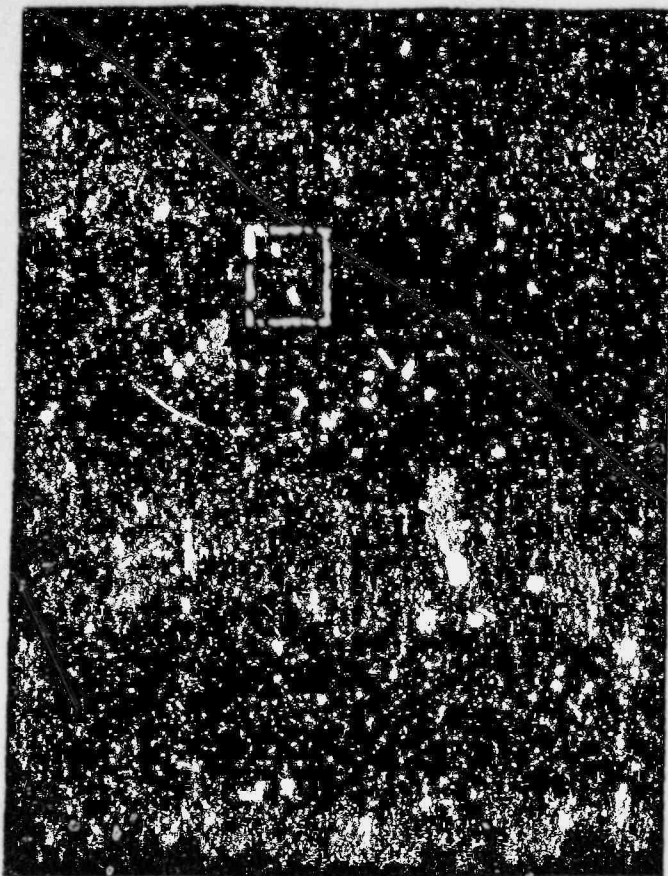
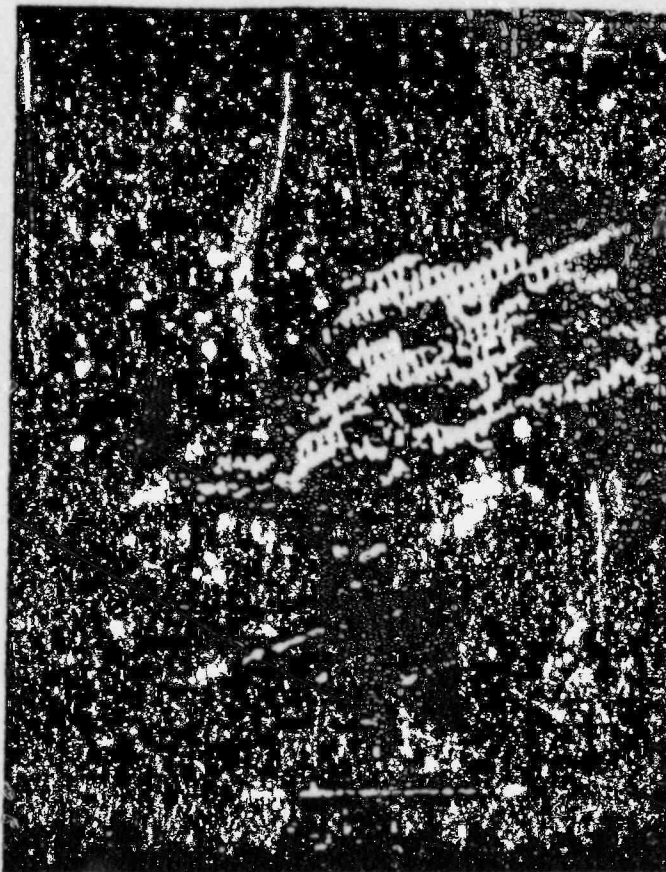
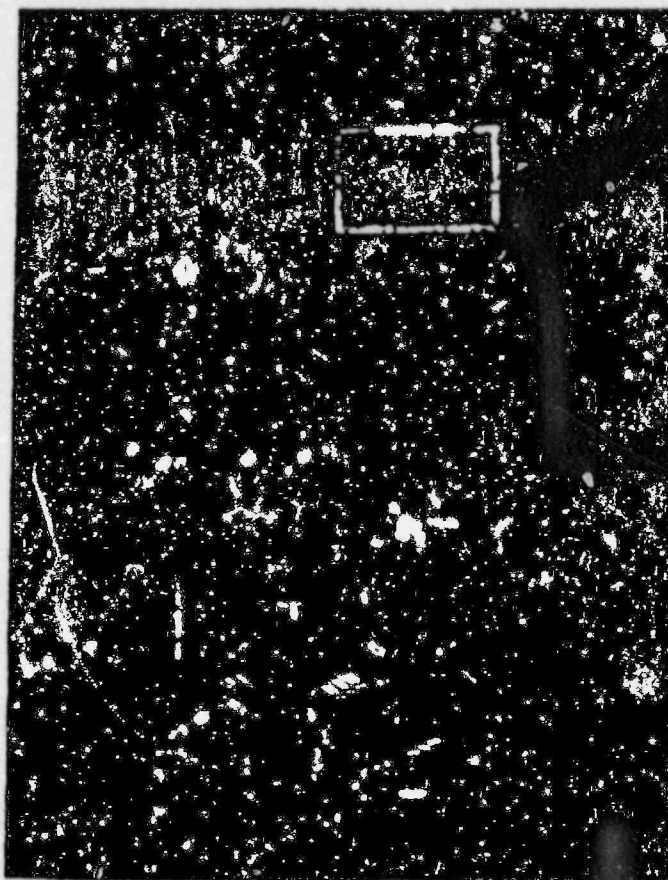
Figure 11 shows SEM photographs of the smeared or abraded surfaces of the sleeves. Energy dispersive X-ray spectra of the areas shown will be presented later.

A small amount of nickel and some silicon were found on the chamfered end of the shaft center sleeve which cut into the 5th-stage impeller hub. Figure 18 shows EDXA spectra of the areas indicated in Figure 11(c). The metal particles found in the smear metal at the edge of the keyway [Figures 13(b) and 14(d)] showed strong chromium peaks and weak iron peaks only and the smear metal surrounding these particles nickel and molybdenum peaks. Therefore, the smear metal may have come from CA6NM and the metal particles from chromium plating probably on the shaft.

- (a) Scanning electron micrograph of an area on the outside surface of the throttle sleeve.
- (b) The area bounded by the white rectangle in (a).
- (c) Scanning electron micrograph of an area at the chamfered end of the shaft center sleeve. See figures 16, 17, and 18 for EDXA spectra.

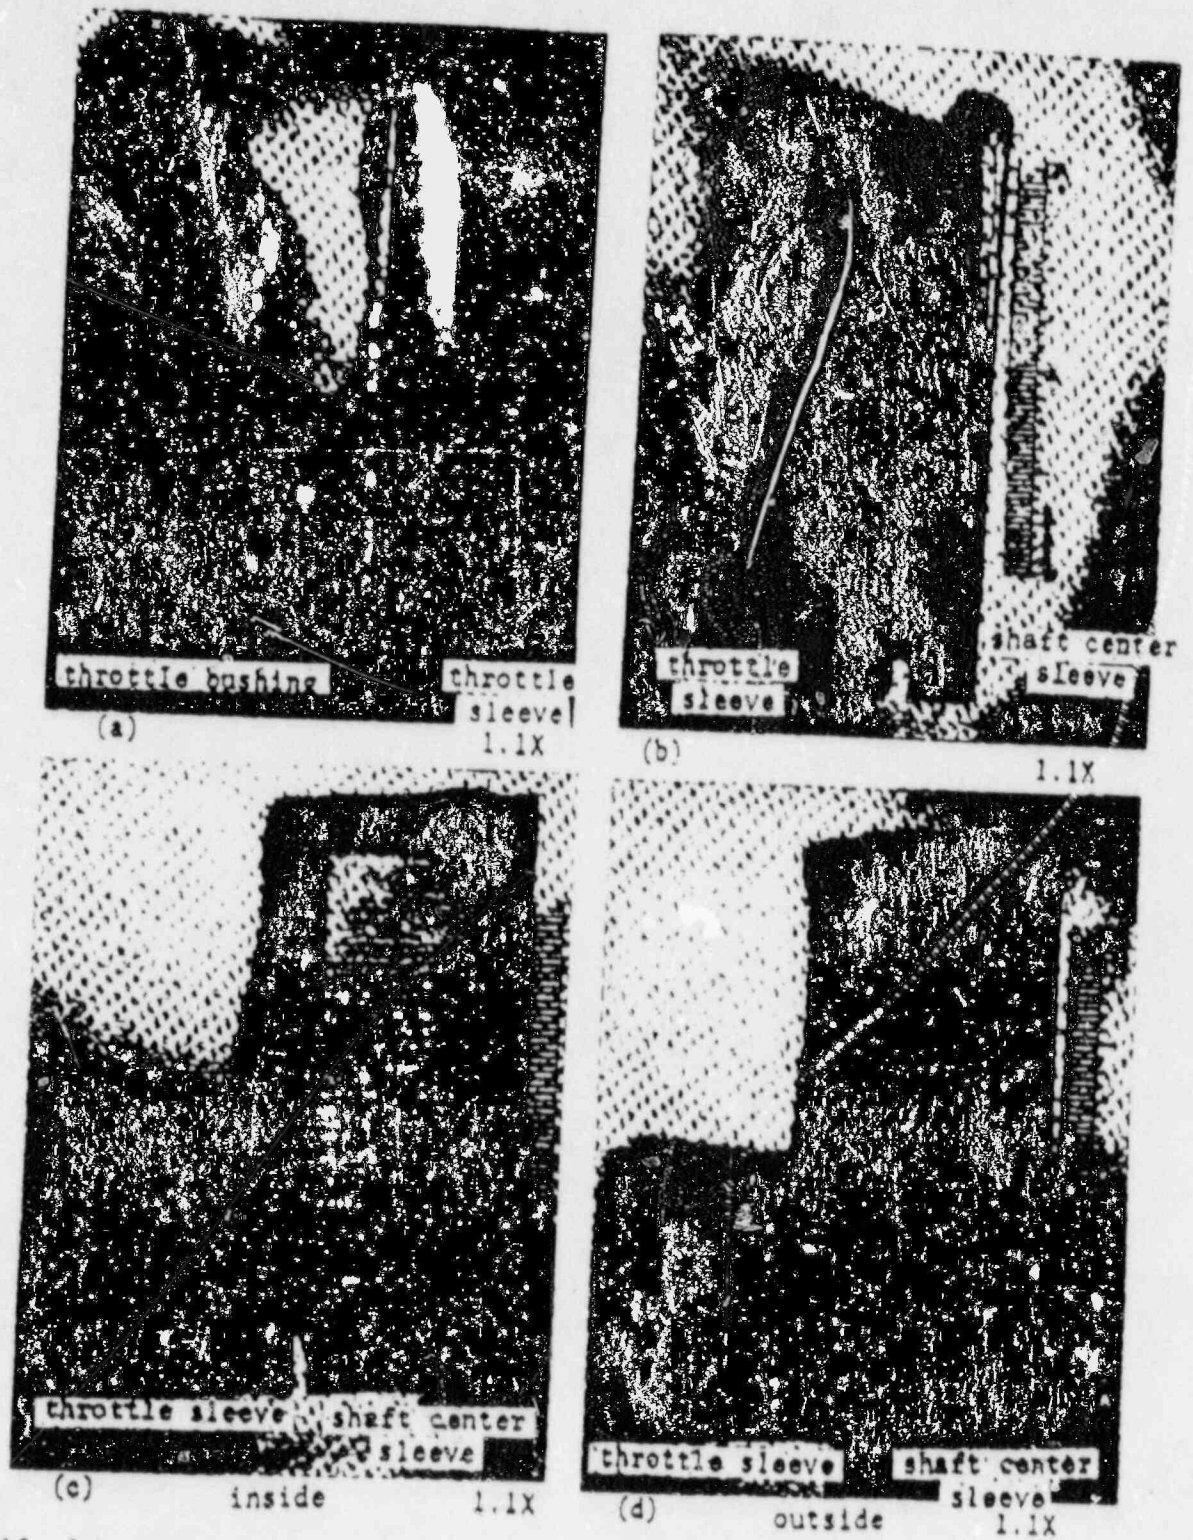
Several specimens from the bushing and the sleeves were etched in dilute hydrochloric acid around 140°F. The results are shown in Figure 12. The heat affected zones from frictional heat are clearly outlined in Figures 12(a) and (b). The heat affected zone in the throttle sleeve extends through the wall thickness, except for a short distance at the end with the keyway (toward the 6th-stage impeller). This end stuck out of the bushing in the final seized condition. A thin layer at the inside surface of the bushing appeared to have melted and squeezed out to the ends. Grain growth occurred in the outside layers of the throttle bushing and the throttle sleeve. As compared with the heavy frictional heat in the throttle bushing and its sleeve, the heat affected zones in the shaft center sleeve are relatively shallow [Figure 12(b)]. The hot acid etching brought out numerous fine cracks on the inside surface and a few relatively large cracks on the outside surface of the shaft center sleeve [Figures 12(c) and (d)].

Hardened steels are susceptible to cracking when heated rapidly in localized areas. Thus, the heat generated by friction or grinding cause what is commonly called heat checks. The higher the hardness, the more susceptible the metal is to heat checks. As shown in Figures 12(c) and (d), the numerous small cracks on the inside surface and a few large cracks on the outside surface of the shaft center sleeve are believed to have been caused by the heat generated by friction between two sliding surfaces. The abrasion marks and the heat affected zones on both the inside and the outside surfaces of the shaft center sleeve attest to the frictional heating. The frictional heating in the throttle sleeve, on the other hand, was so high that the entire cross section within the bushing was quenched and tempered. Therefore, no heat checks formed. In this case, the heat was so high that even the metals melted and grain growth occurred at the faying surfaces.

the shaft center sleeve is equivalent to an increase in diameter by 0.017 inch, which is more than the design clearance between the sleeve and the shaft center stage piece. It is reasonable, therefore, to believe that the initial friction between them was sufficiently high enough to shear the key off. Subsequently, the shaft center sleeve rotated around the shaft inside the center stage piece, cutting into the 5th-stage impeller hub. The keyway length in the throttle sleeve is much longer than that in the shaft center sleeve [See Figures 2(b) and 3(a)] Therefore, the key in the throttle sleeve remained in place, overcoming the friction force that developed as a result of the split. Instead, the friction between the throttle sleeve and the throttle bushing caused such an intense heat that the metals melted, squeezing some molten metal out, and friction welded themselves together for the most part. Since the key was stronger than the 3/8-inch diameter anti-rotation pin for the throttle bushing, the latter sheared off, causing the bushing to rotate inside the casing. This would explain the large heat affected zone and deformation around the bushing collar [Figure 12(a)].

Figure 12 (a) Macrograph of the throttle bushing and its sleeve.
 (b) Axial sections of the throttle sleeve and the shaft center sleeve
 (c) & (d) Same as (b) showing the inside and outside surfaces
 All specimens etched in dilute hydrochloric acid.

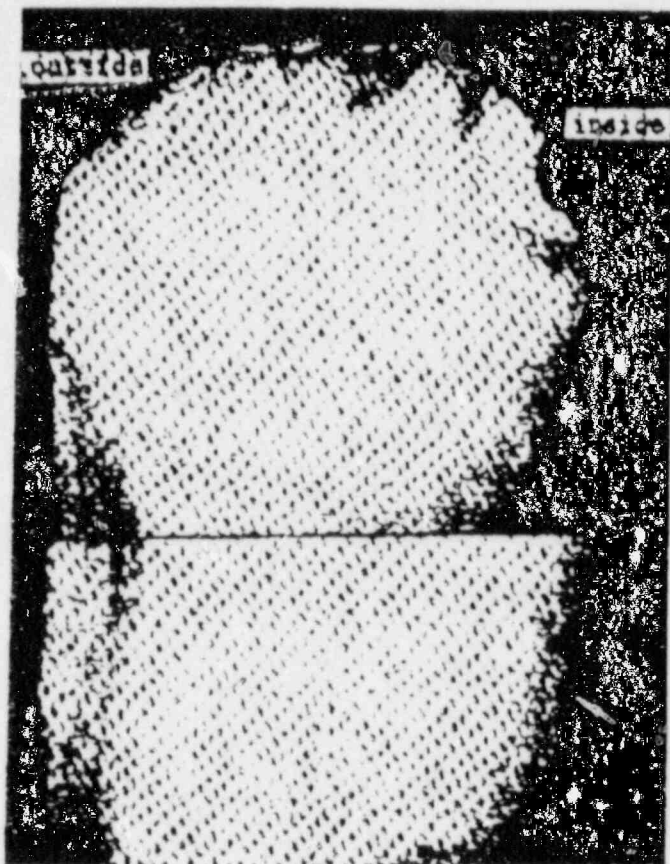
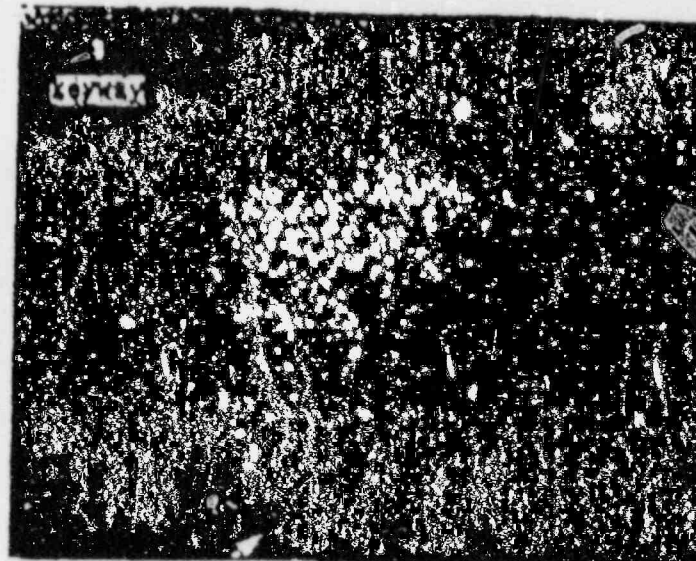
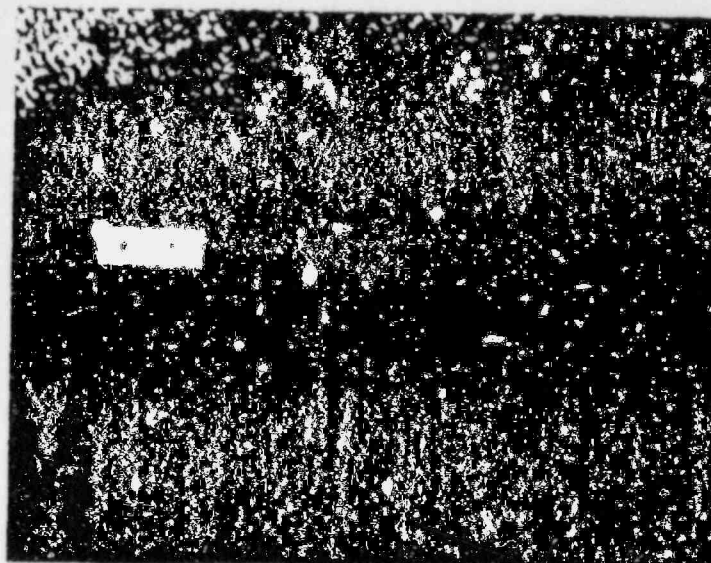
Figure 13(a) shows a profile of an axial-radial section of the chamfered end of the shaft center sleeve. The heat affected zones have been delineated by etching in the Vilella's reagent. A straight portion on the outside surface profile near the top is without a heat affected zone as it retained the original ground surface. Figures 13(b) and (c) show profiles of the keyway corner that did not split in the shaft center sleeve. A 0.01-inch radius

circle can be inscribed at the corner touching the two adjacent sides. Only a small area at the extreme end of the keyway land would be outside this circle. Thus, the keyway corner has an overall radius of 0.01 inch with a smaller radius (about 0.002 inch) at the end of the keyway land.

Smear metal at the edge of the keyway on the inside surface of the shaft center sleeve [Figure 13(c)] contained metal particles. These particles are shown in Figure 14(d).

Figure 13 (a) A profile of an axial section of the shaft center sleeve showing the friction heat affected zones at the chamfered end.

(b) & (c) The corner of the keyway of the shaft center sleeve at the location marked by the arrow in Figure 5(c).

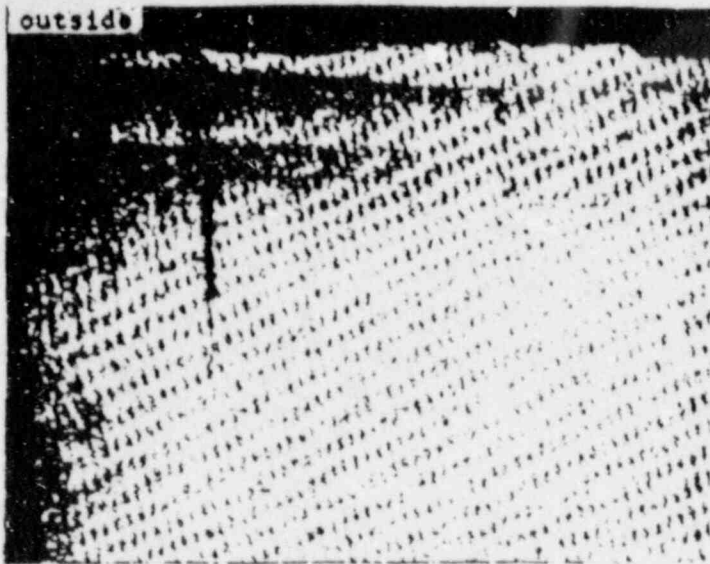
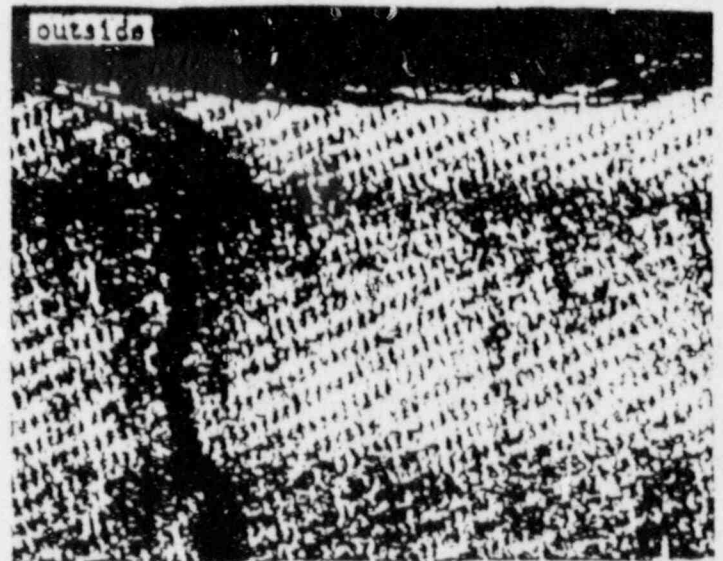
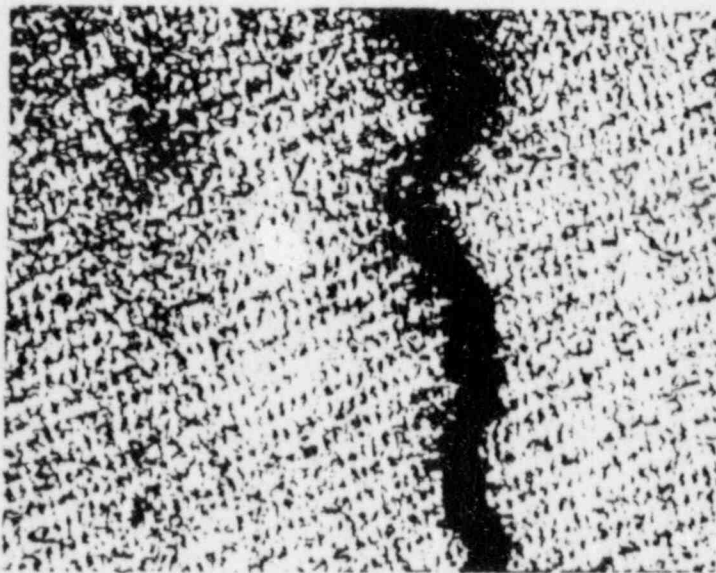
Figures 14(a), (b), and (c) show the heat affected zone and a typical heat crack on the outside surface layer of the shaft center sleeve. These cracks were also intergranular except for the beginning.

Figure 14 (a) A heat crack on the outside surface layer of the shaft center sleeve.
(b) & (c) Same as (a) except at higher magnifications
(d) Near the edge of the keyway of the shaft center sleeve showing foreign metal particles (arrows).

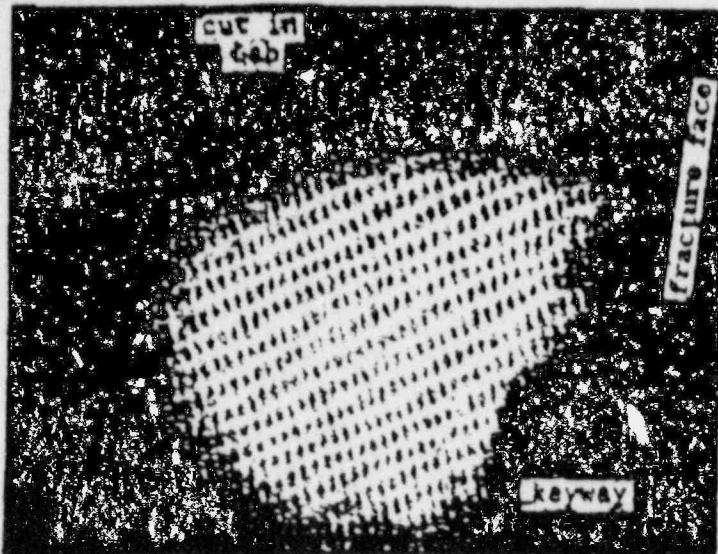
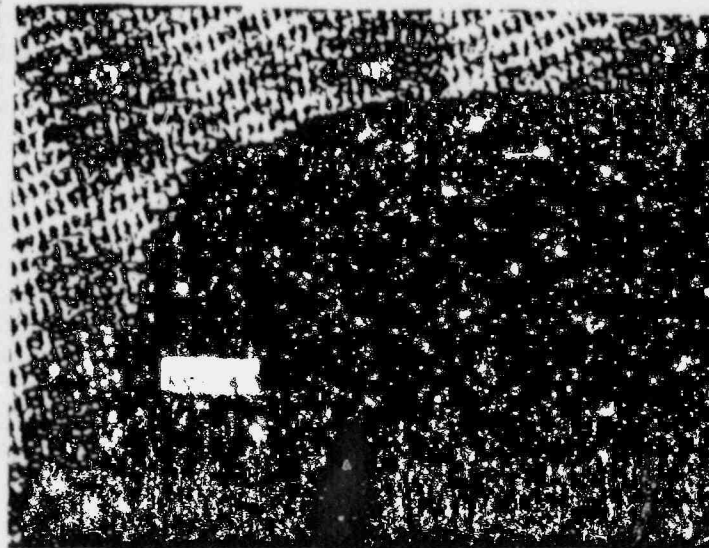
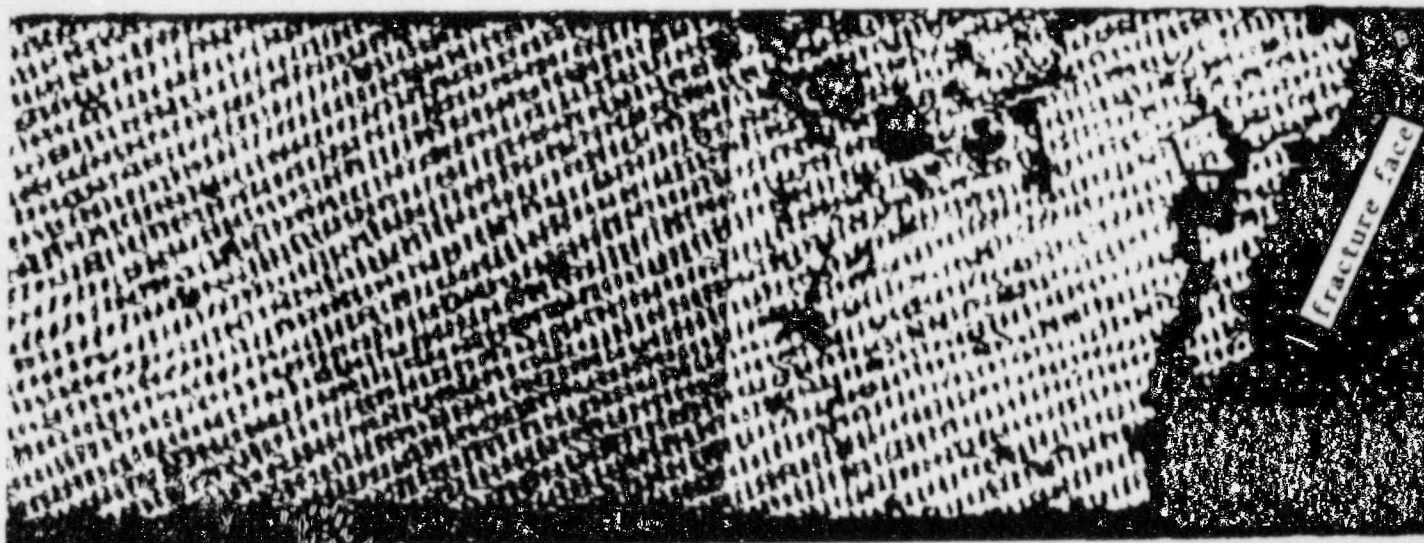
Figure 15(a) shows a cross section of the throttle sleeve at the location marked by the arrow in Figure 6. It can be seen that the split did not occur at the very corner of the keyway; it occurred a short distance away from it, about 1/16 inch. The corner of the keyway can be inscribed with a 0.015 inch radius circle except for a local protrusion [Figure 15(b)]. The cross section shown in Figure 15 is at the area which showed evidence of corrosion (Figure 10) in the keyway land during SEM examination. Figure 15(c) shows secondary intergranular cracks parallel to the fracture face, intergranular attack along the keyway land, and "sponge" metal (due to corrosion) near the beginning of the fracture. The two circular blobs in Figure 15(c) were produced as the etching reagent which had been absorbed by the sponge metal during etching came out later on a dried specimen surface.

The evidence of corrosion and the secondary intergranular cracking (Figure 15) in the throttle sleeve keyway lends support to stress corrosion cracking. Evidence of corrosion was found also on the shaft center sleeve fracture faces, although not as strongly as in the throttle sleeve. Corrosion, resulting in acidification of localized regions, causes the hydrogen to be absorbed by the metal. Cracking caused by stress corrosion or hydrogen embrittlement in high strength steels can be either intergranular or transgranular. A mechanical overload fracture would not be intergranular, as proved by a laboratory fracture of a specimen from the shaft center sleeve. Therefore, in our opinion, the splits in the two sleeves were caused by stress corrosion cracking/hydrogen embrittlement. Both sleeves show evidence of corrosion; both sleeves were under high residual tensile stress (150 ksi) in the circumferential direction. The sleeves are in a highly hardened condition. These three conditions have been known to be conducive to stress corrosion cracking/hydrogen embrittlement.

Figure 15 A cross section of the throttle sleeve at the location marked by the arrow in Figure 6. The arrow in (a) points to the fracture initiation with evidence of corrosion. (c) shows the area marked by the arrow in (a).
