NUREG/CR-4494
PNL-5742

Radiological Assessment of BWR Recirculatory Pipe Replacement

Pacific Northwest Laboratory
Operated by
Battelle Memorial Institute

Prepared for
U.S. Nuclear Regulatory
Commission

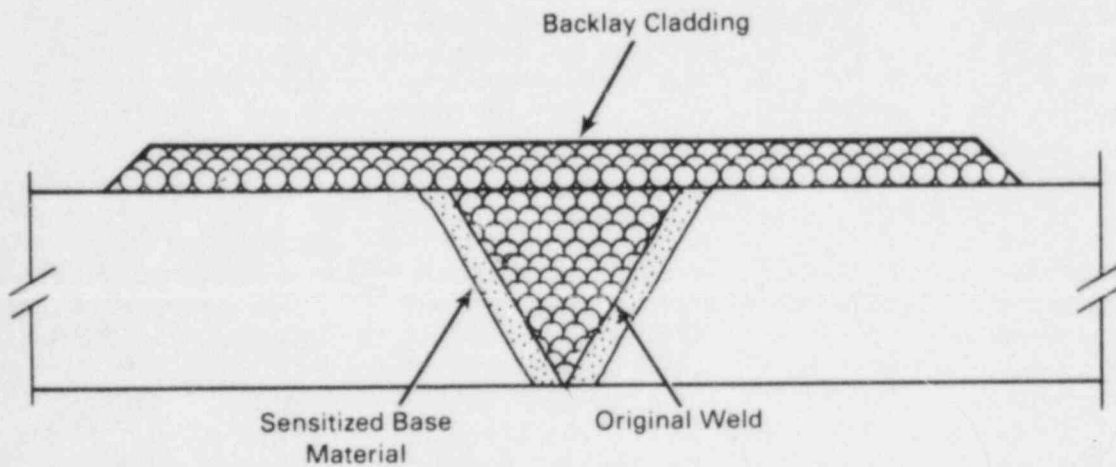
FIGURE 4.2. Weld Overlay Repair

The application of a weld overlay on the outer diameter of a pipe weld is used to mitigate the effects of IGSCC (Newell 1984, Smith 1984). Weld overlay repair is used as an interim repair method to extend the life of welds exhibiting IGSCC. Duplex weld deposits are used to cover the existing weld and the HAZ (Figure 4.2). This provides a barrier to through-wall crack propagation and restores the structural integrity of the pipe to comparable uncracked levels. It also introduces a strong compressive residual stress field to the inner diameter of the pipe. Before mid-1983, WOR was considered as a viable permanent fix. Recent UT sizing difficulties with IGSCC indications cast doubt on the acceptability of WOR applications. It is, however, a temporary

repair method, and advances in UT sizing of IGSCC may make WORs an acceptable long-term repair in the future (Newell 1984). The NRC views weld overlays as an alternative to pipe replacement on a cycle-by-cycle basis only but will consider requests in certain cases for extended operation of BWRs with weld overlays.

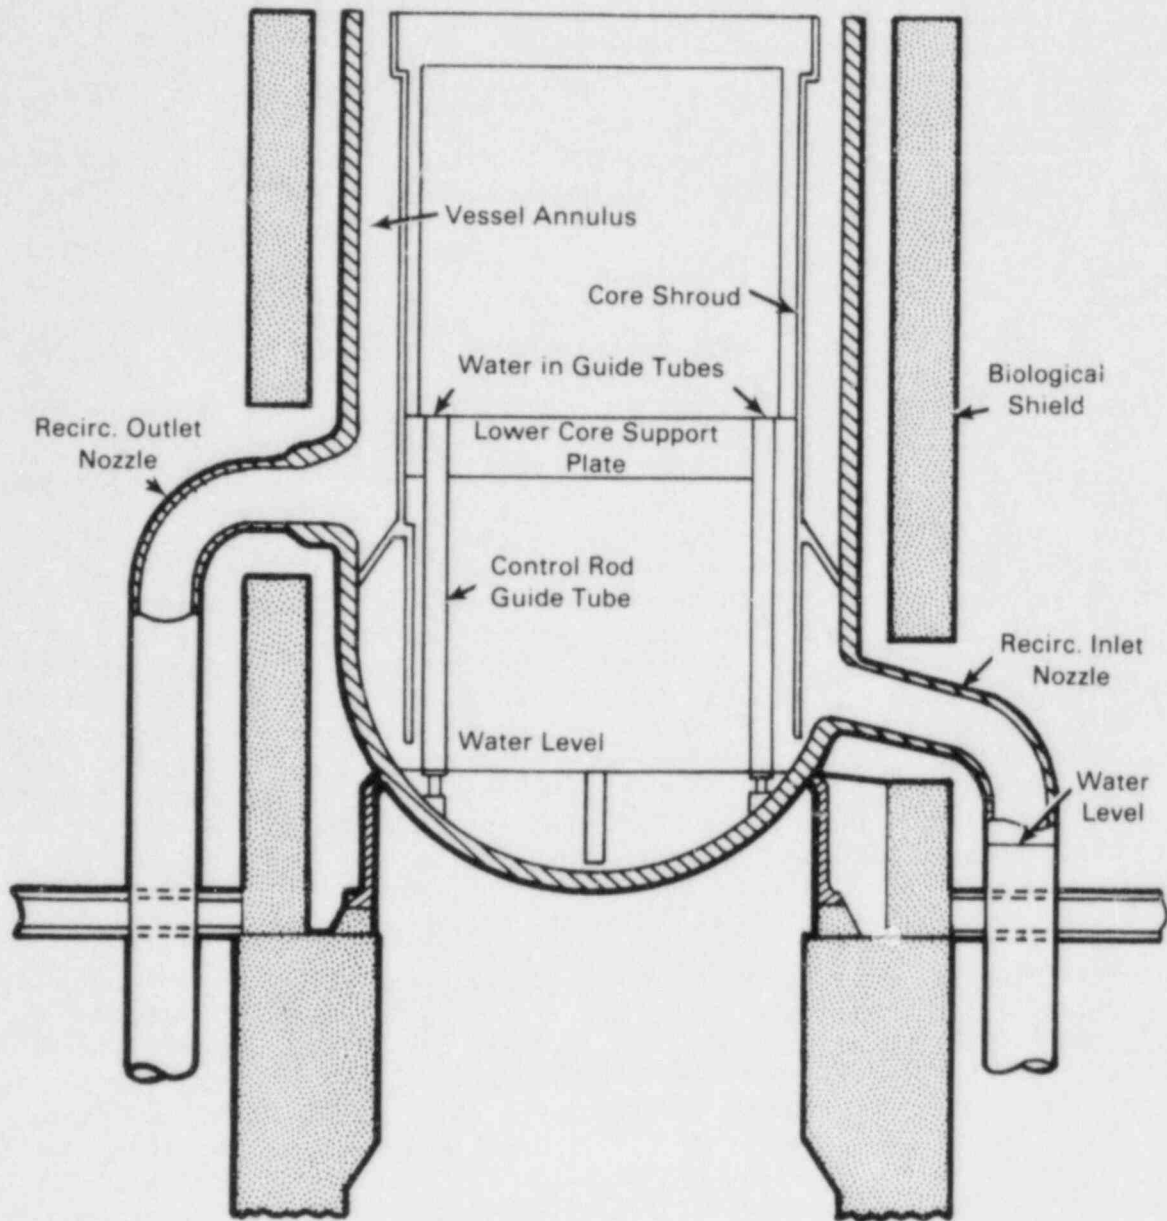
FIGURE 5.3. NMP-1 Reactor Pressure Vessel Configuration During the Recirculation System Repair/Replacement

Nozzle shield plugs, nicknamed the silver bullets, were inserted in the recirculation outlet and inlet nozzles after the adjacent elbows had been cut out. Shield plugs were necessary because the natural shielding provided by reactor water was removed when the water was drained below the lower core support plate to the level shown in Figure 5.3. The plugs reduced the beam of radiation emanating from the lower core support plate, the activated core structure, and the crud traps. Work crews were trained on mockups, and specialized tools were used to install and remove the plugs. In addition, the positioning of the control rods in conjunction with the filling of control rod guide tubes with water was found to be an easy and effective dose reduction technique at NMP-1.

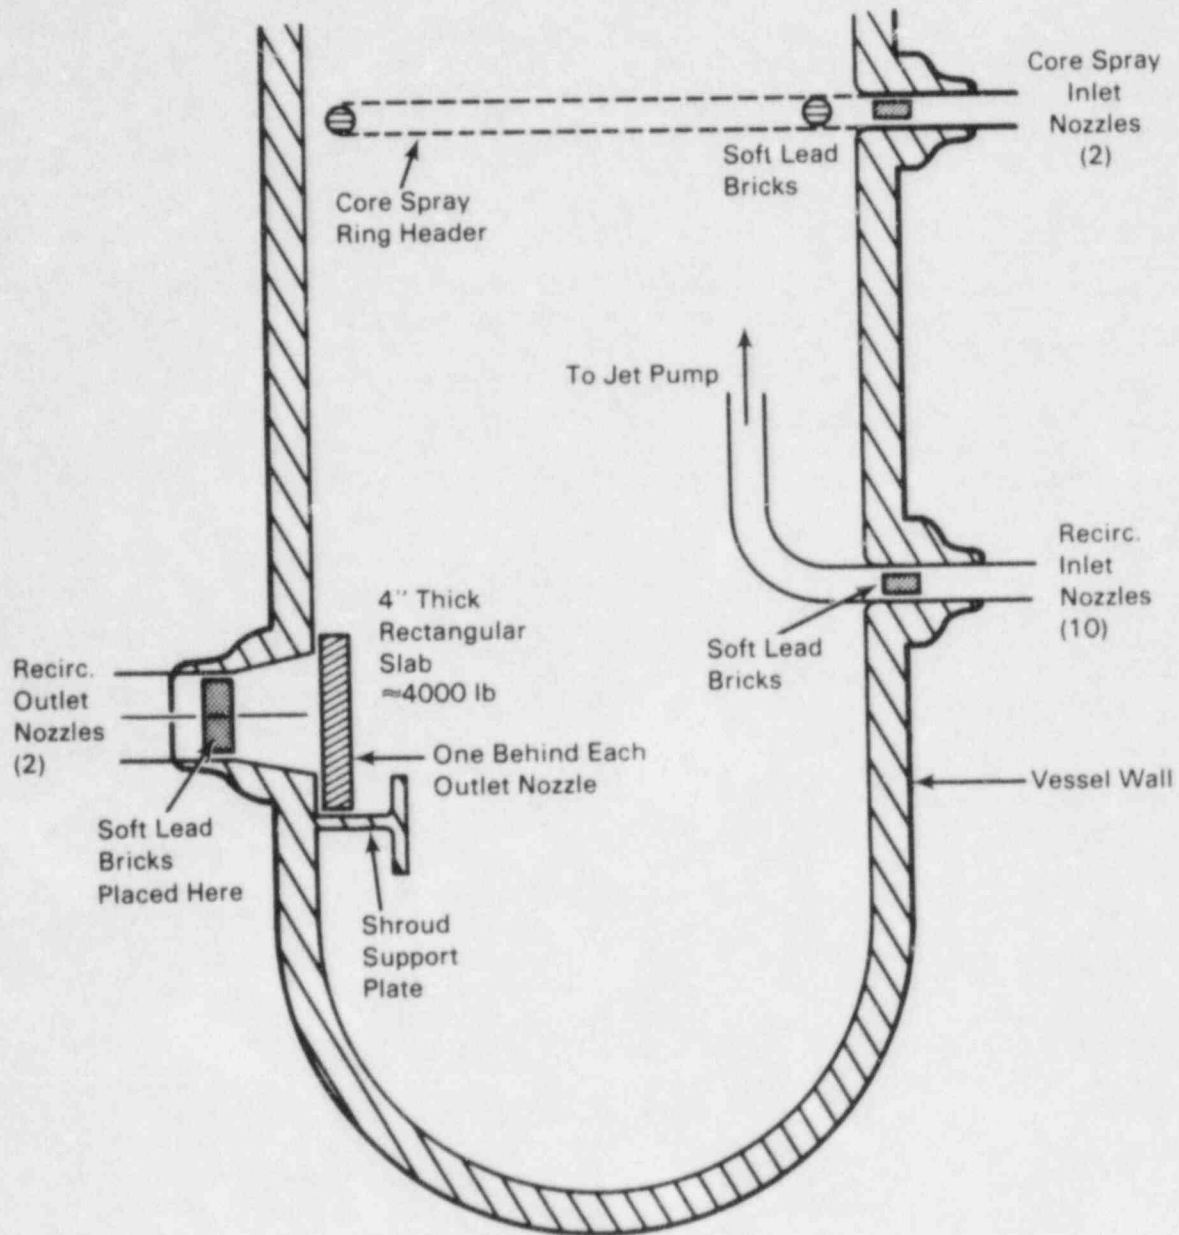
FIGURE 5.5. Proposed Shielding of Reactor Nozzles at Browns Ferry

Water was to be removed from the annulus, and water in the core barrel was to be drained to a level below the jet pump slip joints. All control blades were to be inserted into the core before the water level was lowered. Because of the amount of work to be done around the nozzles and the negligible water shielding, plans were generated for extensive in-vessel shielding. An assessment was made to determine the probable net benefit of constructing annulus shields for placement behind the two suction nozzles and in-vessel shields for the core spray nozzles. There was considerable concern that the annulus shield would be very difficult to set into place, and there was a risk that such positioning might damage the RPV internals. To assist in determining whether to use the annulus and core spray nozzle shields, measurements of radiation levels around the nozzles in Unit 2 during the "draindown" were planned. The placement of these shields is shown in Figure 5.5.

Shielding in the biological shield in and around the recirculation and core spray piping penetrations was to be provided using soft lead bricks placed in a metal frame. About 7500 soft lead bricks were to be used for the 12 recirculation openings and the two core spray openings. Soft lead bricks would also be used to plug the ends of valves and the discharge on the recirculation pumps. A special pump inlet shield was being designed to rest evenly on the two flow splitters without damaging the pump.
