Subject: Byron Station Units 1 and 2
Braidwood Station Units 1 and 2
Inspection of Cast Stainless Steel
Component Welds
NRC Docket Nos. 50-454/455 and 50-456/457

ULTRASONIC EXAMINATION OF CAST STAINLESS STEEL WELDS
AT BYRON AND BRAIDWOOD STATIONS

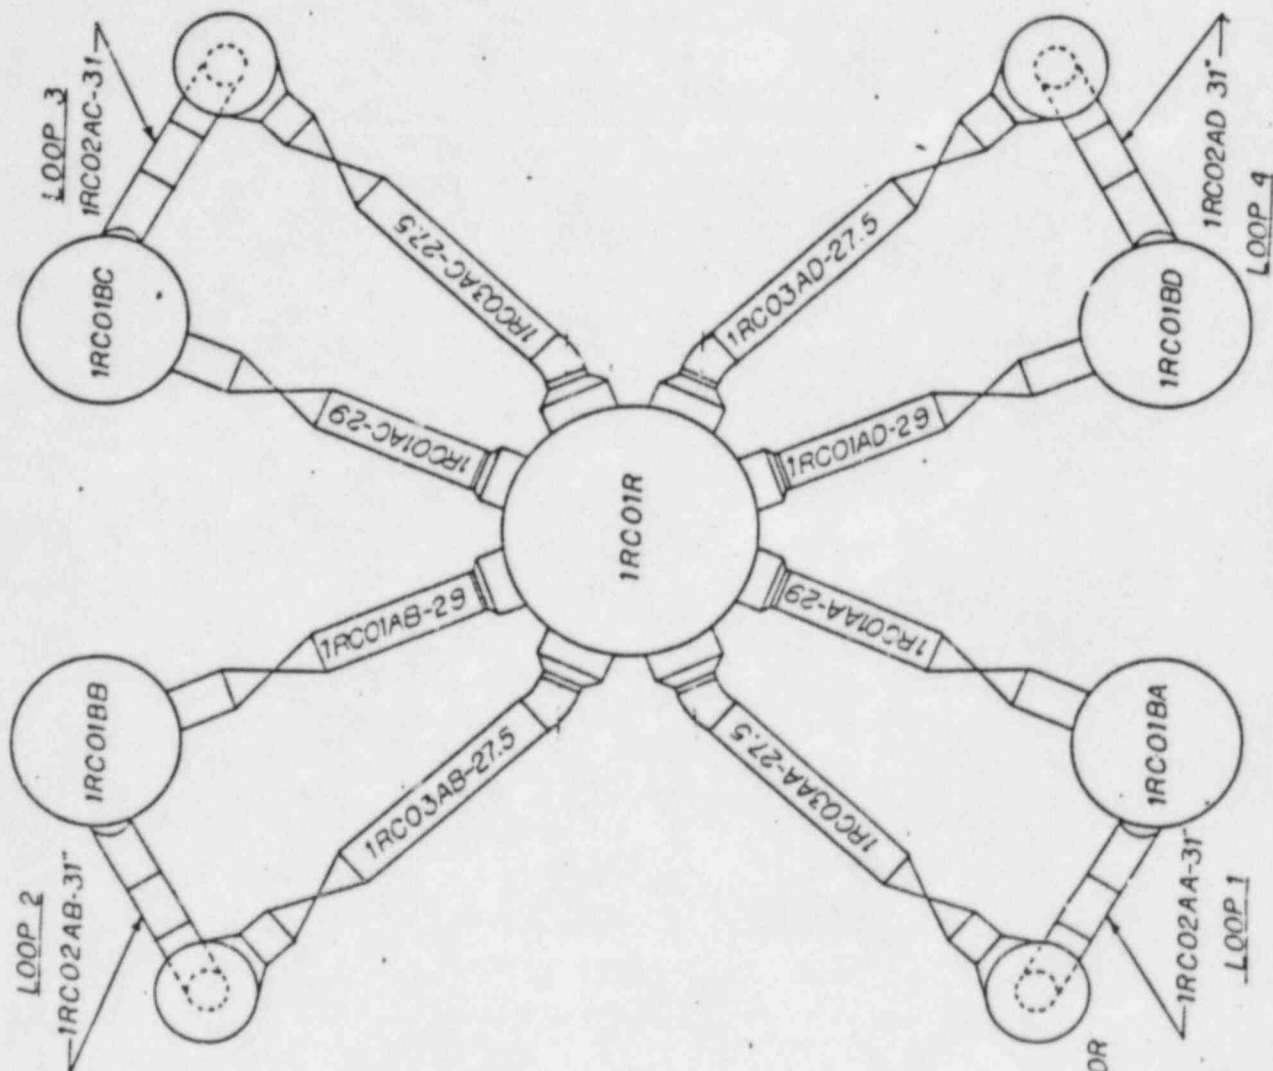
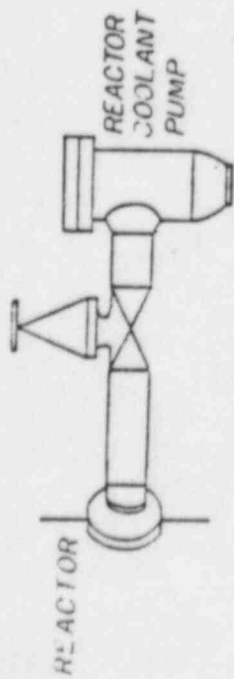
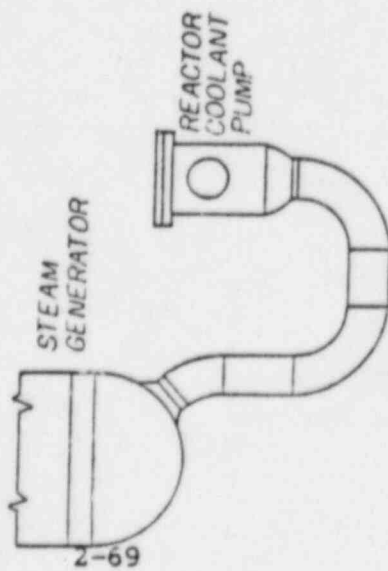
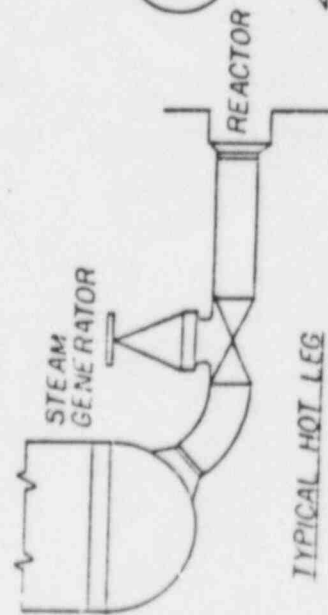
FIGURE 1

Byron and Braidwood Units 1 and 2 are Westinghouse four loop pressurized water reactors of essentially identical designs. The reactor coolant system design is shown in Figure 1. Each plant utilizes statically cast stainless steel elbows, pump casings and valve bodies in the reactor coolant system. The material specifications for these stainless steel components are as follows:

The Byron and Braidwood reactor coolant piping was forged from SA376 (Grade 304N) stainless steel. Reactor vessel and steam generator primary nozzles were fabricated from carbon steel and then clad with stainless steel on the inner diameter (I.D.) surfaces. Forged stainless steel safe-ends (SA182, Grade F316) are welded to the reactor vessel nozzles. The reactor cold leg nozzle safe-ends are welded to cast stainless steel elbows. The hot leg nozzle safe-ends are welded to pipe. The clad steam generator nozzles are welded directly to cast stainless steel elbows.

The cast stainless steel welds in the reactor coolant system can be categorized as follows:

1. Forged safe-end - to - cast elbow welds
2. Steam generator nozzle - to - cast elbow welds
3. Forged pipe - to - cast elbow, pump or valve welds
4. Cast elbow - to - cast pump or valve welds

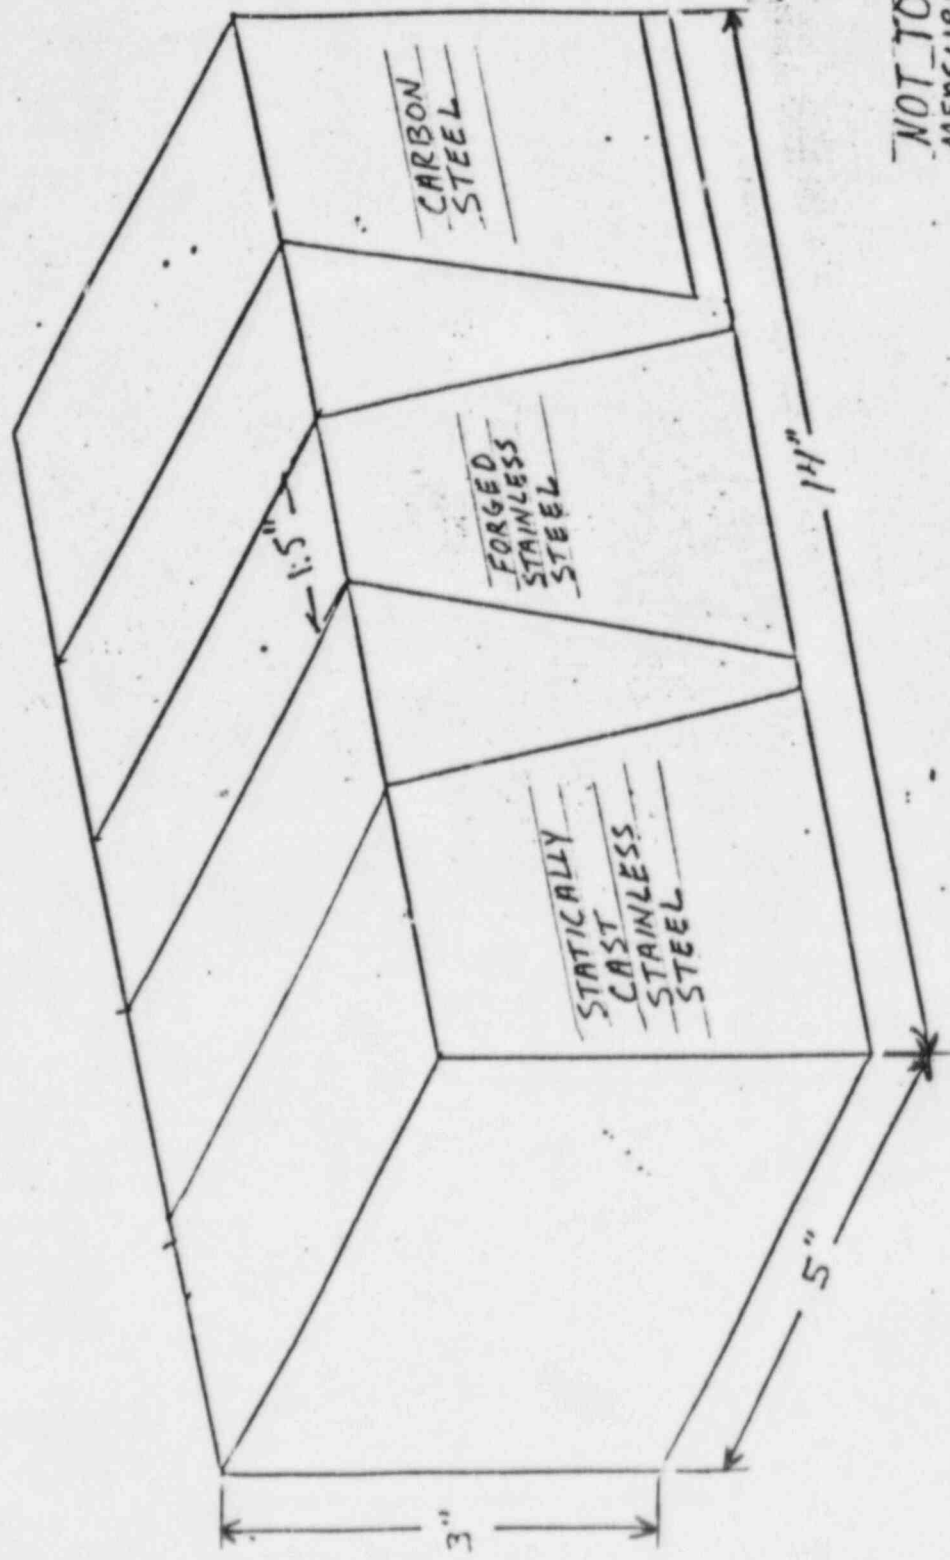
Figure 2: Sketch of Byron Safe End to Elbow Calibration Block BY50

Cast stainless steel material was obtained from the manufacturer of the cast stainless steel elbows at Byron and Braidwood Stations. This material was welded to other steel blocks to represent a calibration standard for the reactor nozzle - safe-end - cast elbow configuration. Two calibration holes were drilled into the cast stainless steel material. One hole was at the weld fusion line, $1/4$ of the wall thickness (T) from the inner diameter (I.D.) of the cast stainless material. The other hole was in the corner of the required inspection volume, $1/3$ T from the inner diameter and approximately $1/2$ inch from the fusion line into the cast material. The mockup is shown in Figure 2.

An examination procedure was developed with state of the art ultrasonic techniques. Forty-five (45) degree (2.25 megahertz) refracted longitudinal wave transducers were utilized to maximize penetration of the cast material. However, the procedure yielded very limited results. During calibration on the mockup, the hole at the weld fusion line, $1/4$ T from the I.D., could not be seen from the cast side. Refracted longitudinal wave ultrasonics were ineffective in examining the mockup material.

The acoustic properties of cast stainless steel at Byron and Braidwood vary from component to component. For this reason, a comparison of the attenuation characteristics of the mockup and the Byron and Braidwood elbows was made. Using a 1 MHz longitudinal wave transducer on the cast side of the mockup, gain settings of 24 to 26 decibels (dB) were needed to obtain an 80 percent back wall reflection. With a

2.25 MHz transducer, 32 to 34 dB gain was needed to see the back reflection. Performing the same test on a Byron cast elbow, 28 to 32 dB gain was needed for 1 MHz and 40 dB gain was required for 2.25 MHz. Similar results were obtained from measurements made on Braidwood elbows. It was concluded from these tests that the cast elbows installed at Byron and Braidwood are more attenuative than the cast material in the mockup.

1. Reliable angle beam measurements could not be made on the Byron mockup with the EPRI transducer (those used at Vogtle) due to the flat, rectangular shape of the mockup. The EPRI transducers were relatively large, with curved shoes which prevented proper coupling to the flat mockup. A change in thickness in the scanning surface of the mockup also prevented good examination results. However, the ultrasonic transparency was measured on the cast portion of the mockup with 2.25 MHz and 1 MHz straight beam transducers and was determined to be very poor.
