LICENSEE EVENT REPORT (LER)

FACILITY NAME (1) CRYSTAL RIVER UNIT 3						DOCKET NUMBER (2) 0 5 0 0 0 3 0 2				PAGE (3) 1 OF 0 6	
---	--	--	--	--	--	--------------------------------------	--	--	--	----------------------	--

TITLE (4) Design Error Leads to Inadequate Isolation Between Instruments in the Control Room and Remote Shutdown Panel

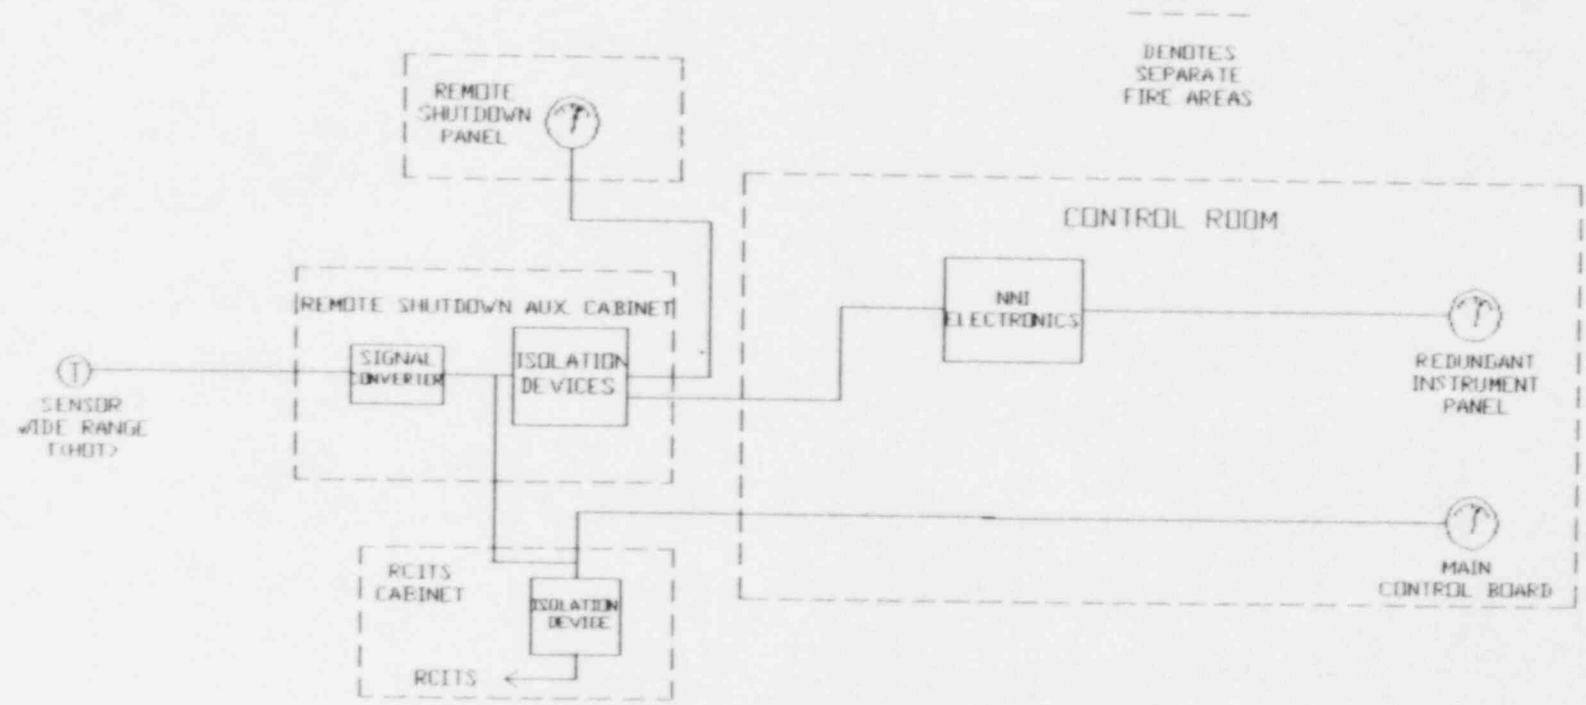
FIGURE 1  
CHANNEL 'A'

Isolation between the Control Room and Remote Shutdown Panel was compromised when the Control Room  $T_{HOT}$  instrument inputs were selected from points between the Remote Shutdown Auxiliary Cabinets and the RCITS isolation devices (See Figures 1 and 2). It should be noted that cable routing between the Remote Shutdown Auxiliary Cabinets and the RCITS cabinets meets 10 CFR 50, Appendix R separation requirements.

A design modification which provided the required isolation between the Control Room and Remote Shutdown Panel  $T_{HOT}$  instrumentation has been developed and then installed on May 27, 1988.
