L I C E N S E E E V E N T R E P O R T (L E R)

FACILITY NAME (1) Arkansas Nuclear One, Unit One DOCKET NUMBER (2) / PAGE (3)
01510101 31 1 3110F1017

TITLE (4) Potential Degradation Of Environmental Boundary Seal On Rosemount Instrumentation Transmitters Due To Rotation Of The Electronics Housing After Assembly

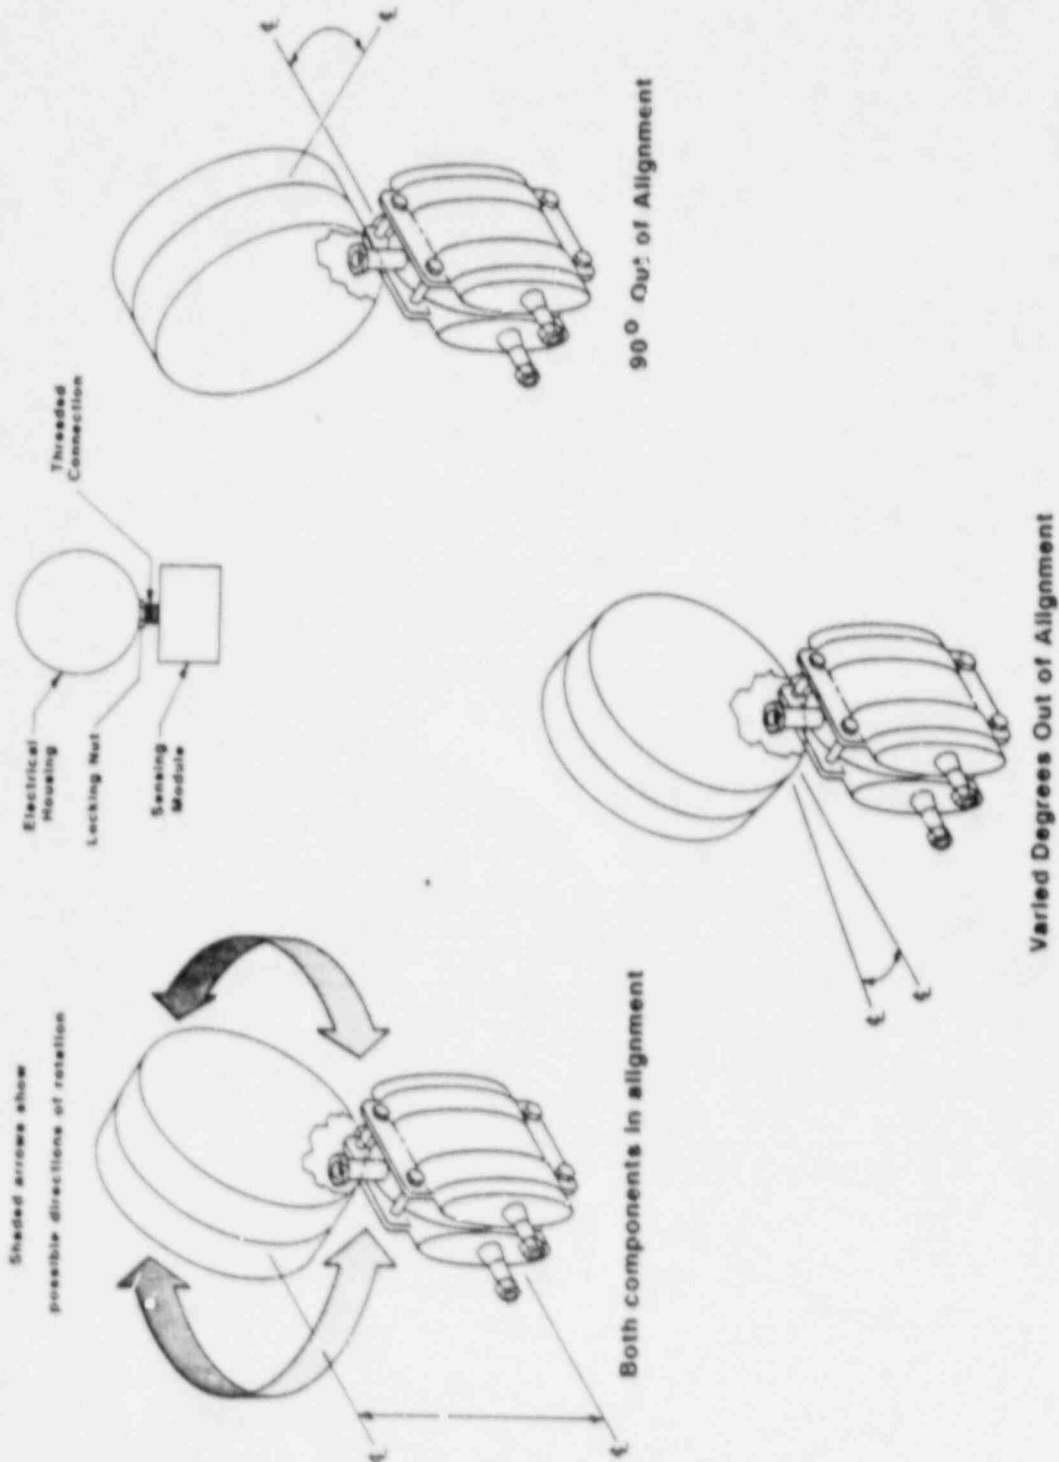
FIGURE 1

On April 6, 1988, while performing repairs on an ANO-2 safety injection tank (SIT) water level transmitter [LT], maintenance personnel reviewed the vendor (Rosemount) reassembly procedure in the instruction manual for the transmitter and questions were raised concerning instructions related to sealing requirements for the threaded interface between the transmitter sensor module and electronics housing, i.e., neck seal. Rosemount was contacted for clarification concerning the instruction manual requirements for baking the thread sealant on the neck seal at an elevated temperature following transmitter assembly. During the discussions with Rosemount personnel it was revealed that the neck seal area is an environmental boundary which must be established and maintained to ensure the environmental qualification (EQ) of the transmitter. Additionally, Rosemount also stated that this EQ boundary might be degraded if the electronics housing were rotated after the transmitter was assembled and the environmental boundary seal had been established (see figure 1).

Additional discussions with Rosemount personnel were held concerning the potential for degradation of the neck seal due to rotation of the electronics housing following assembly and curing of the thread sealant (see figure 1). Rosemount indicated that if rotation were to occur the environmental seal provided by the thread sealant could be broken and the EQ of the device could be affected.

Although not conclusively determined, rotation of the sensor modules for the Rosemount transmitters most likely occurred during initial installation of the instruments. The root cause was that the need to maintain the neck seal was not clearly identified by Rosemount in either the qualification test reports for the instruments or in the instruction manuals providing guidance on installation and maintenance of the transmitters.

Inspections and tests were performed on forty two (42) ANO-2 Rosemount transmitters which are required to be environmentally qualified. The two transmitters discovered to have a small amount of leakage were disassembled, the sensor module threads were cleaned and the transmitter was reassembled with thread sealant applied to the sensor threads. During reassembly the electronics housings were properly oriented with respect to the sensor module. Repairs for the ANO-2 transmitters were completed on April 24.
