KANSAS GAS AND ELECTRIC COMPANY

KMLNRC 86-038
Re: Docket No. STN 50-482
Subj: Special Report 86-01

SPECIAL REPORT 86-01

Inservice Tendon Surveillance Voids In Excess of 5 Percent Of Net Duct Volume

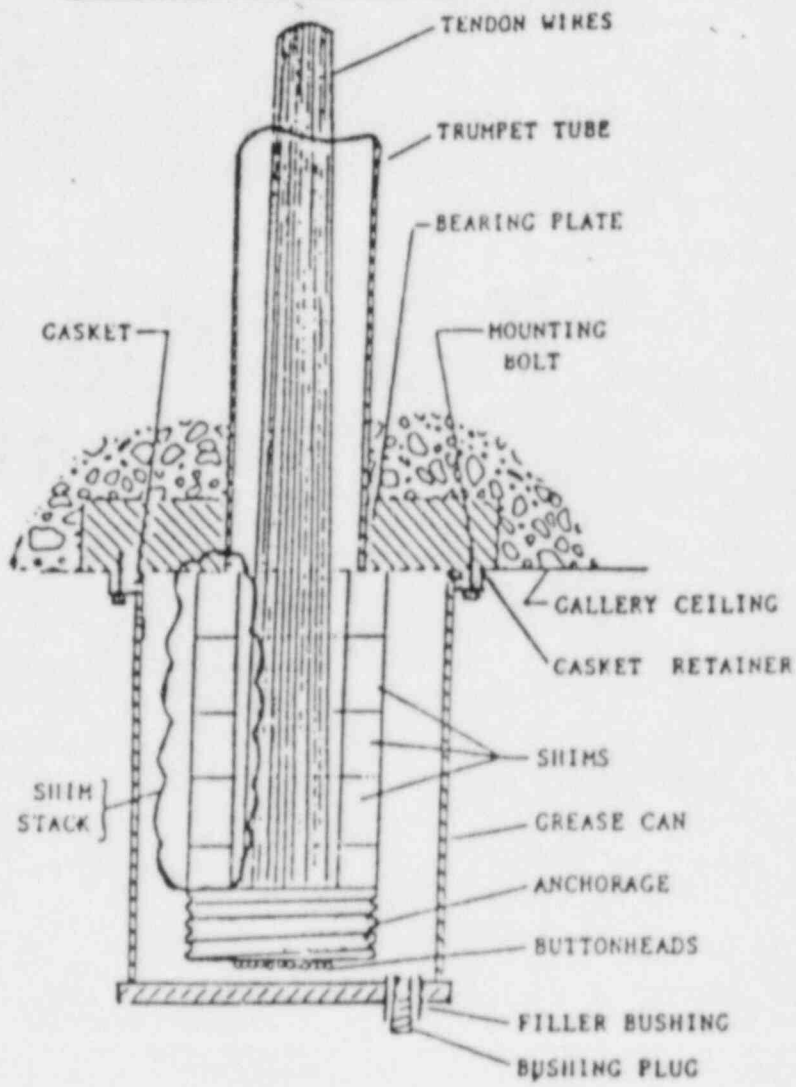
FIGURE 1

The first year tendon surveillance at Wolf Creek Generating Station (WCGS) began January 27, 1986. The surveillance inspection procedures required in part, inspection of tendon wire and anchorage components for evidence of corrosion and/or cracking, inspection of concrete adjacent to the bearing plates for cracks, inspection of the tendon system for signs of water intrusion, verification of tendon lift-off force and elongation, and the measurement of sheathing filler grease voids expressed as a percentage of the net duct volume. Figure 1 illustrates details of a typical vertical tendon anchorage and grease can assembly.
