U. S. NUCLEAR REGULATORY COMMISSION
REGION I

Report No. 86-05
Docket No. 50-271 License No. DPR-28
Licensee: Vermont Yankee Nuclear Power Corporation
RD 5, Box 169, Ferry Road
Brattleboro, Vermont 05301
Facility: Vermont Yankee Nuclear Power Station
Location: Vernon, Vermont
Dates: February 9-27, 1986
Inspectors: William J. Raymond, Senior Resident Inspector
Glenn W. Meyer, Project Engineer

Inspection Summary: Inspection on February 9-27, 1986 (Report No. 50-271/86-05)

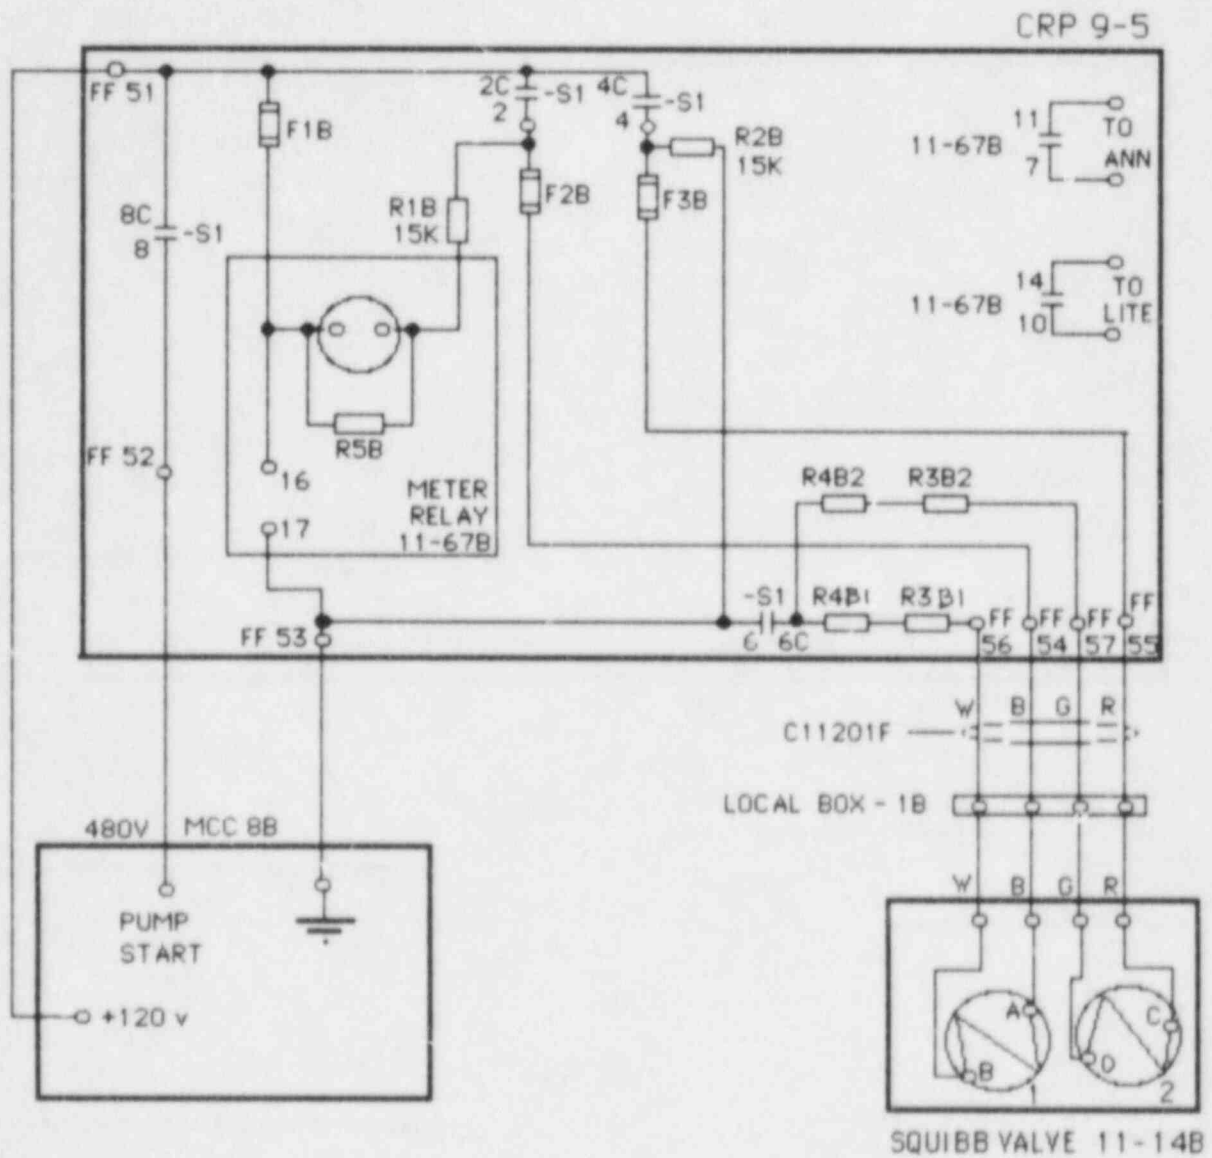
Figure 1

The wiring configuration for the System 2 firing and monitoring circuits, which is typical for System 1, is shown in Figure 1. The mechanical details of the squib valve and explosive chamber are shown in Figure 2. The squib valve is opened by shearing the cap on the inlet fitting mounted in the valve flow path. The cap is sheared off by the trigger assembly that is actuated by two explosive charges in the primer subassembly. Either primer charge is sufficient to shear the inlet fitting plug. The primer charges are ignited by concurrently applying 120 VAC to bridgewires embedded in the charges. Turning the CRP 9-5 control switch to the System 2 position closes contacts 2, 4, 6, and 8, which starts the B pump, applies voltage to the bridgewires in the B valve primer charge, and shunts around control relay 11-67B of the continuity monitoring circuit. Once actuated, the primer, the trigger assembly, and the inlet fitting cannot be reused and must be replaced.

The continuity monitoring circuit, mentioned above, continuously confirms that the fuses, resistors, wires and bridgewires in each firing circuit are intact and lights a panel 9-5 light for each valve to confirm this. It does this by closing a contact in series with the panel light when control relay 11-67B is energized (picked up). The relay is normally energized when 120 VAC is supplied to one side of the coil, and a path to ground exists through the following circuit: 15K resistor R1B, fuse F2B, primer bridgewire AB, resistors R3B1-R4B1-R4B2-R3B2, primer bridgewire CD, fuse F3B, 15K resistor R2B, and neutral (see Figure 1).

The monitoring circuit indicated continuity existed, even though it would not fire because the following closed circuit existed (shown for "B" side - typical for both; see Figure 1): 120 VAC was provided through fuse F1B to one side of the coil for relay 11-67B; a path to ground existed through resistor R1B, F2A, terminal point FF 54, primer coil BA, terminal point FF 55, fuse F3B, resistor R2B, terminal point FF 53, and to neutral. Only one primer bridgewire was included in the monitoring circuit, instead of two for each squib valve, as is normally the case.

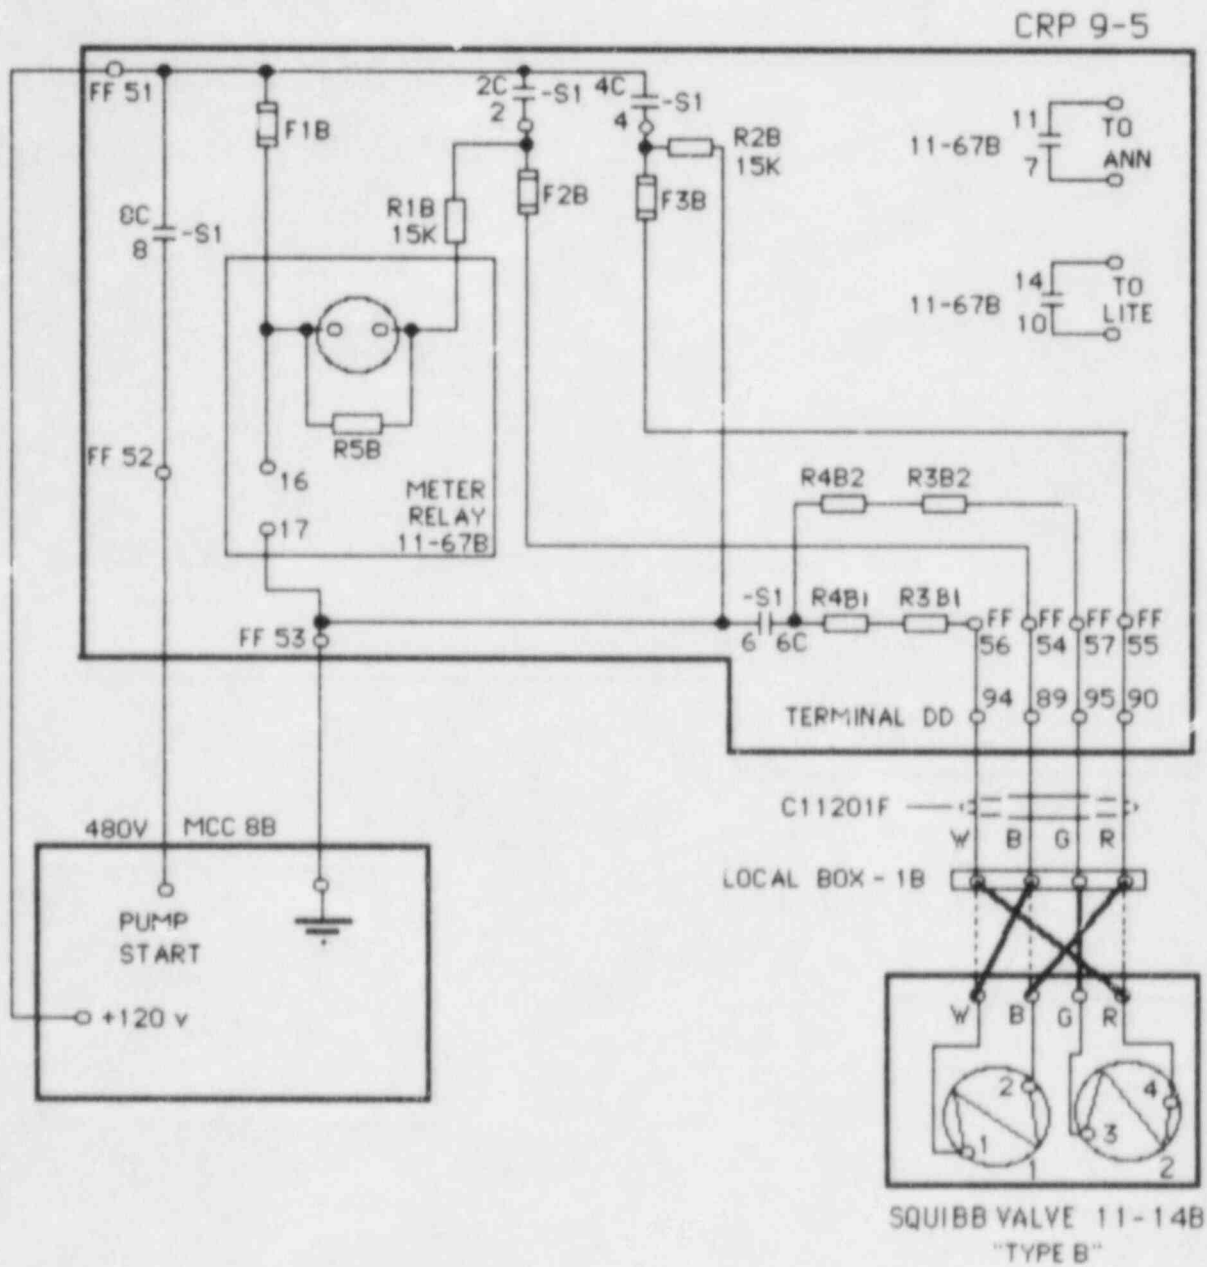
AS - BUILT WIRING V11-14B

Licensee investigation of the System 1 firing circuit determined that the primer charges were miswired (when compared to Control Wiring Diagram (CWD) 191301, Sheet 1200) by having both 120 VAC high side leads wired to the A-B primer bridgewires, and both neutrals wired to the C-D primer bridgewires. The wiring was found rolled (i.e., interchanged) at a local terminal box (TB) mounted immediately above the squib valve. Instead of the white-black-green-red sequence (W-Bk-G-R) required by the CWD, entering and leaving the TB, the sequence into the TB was Bk-G-W-R, and the sequence leaving the TB was W-G-R-Bk. The firing circuit worked properly when tested at 4:19 P.M. after the TB was rewired per Maintenance Request (MR) 86-0278 to agree with the CWD. The TB wiring for the System 2 squib valve was inspected and also found miswired as follows: sequence into the TB was R-W-G-Bk, and the sequence out of the TB was Bk-R-G-W. Although different in appearance, the terminal boxes were electrically the same (e.g., black connected to white, white connected to red, etc.).

The as-found wiring of System 2 is shown in Figure 3.

- Revise testing procedure OP 4203 to include pin to pin continuity tests and a test of new primers using the firing circuit.
- Revise terminal box wiring such that hot leads alternate around the connector and either primer type will fire.
- Revise CWD to as-built configuration.
- Revise procurement program to specify latest drawings are sent with parts.
- Review other surveillance procedures which test performance of components following use to determine whether additional testing and design changes are appropriate.
- Retest SLC system following completion of other recommendations.
