SUBJECT: THE OPERATING REACTORS EVENTS MEETING
 September 6, 1988 - MEETING 88-36

OPERATING REACTORS EVENTS BRIEFING 88-36
EVENTS ASSESSMENT BRANCH
LOCATION: 12-B-11 WHITE FLINT

TUESDAY, SEPTEMBER 6, 1988, 11:00 A.M.

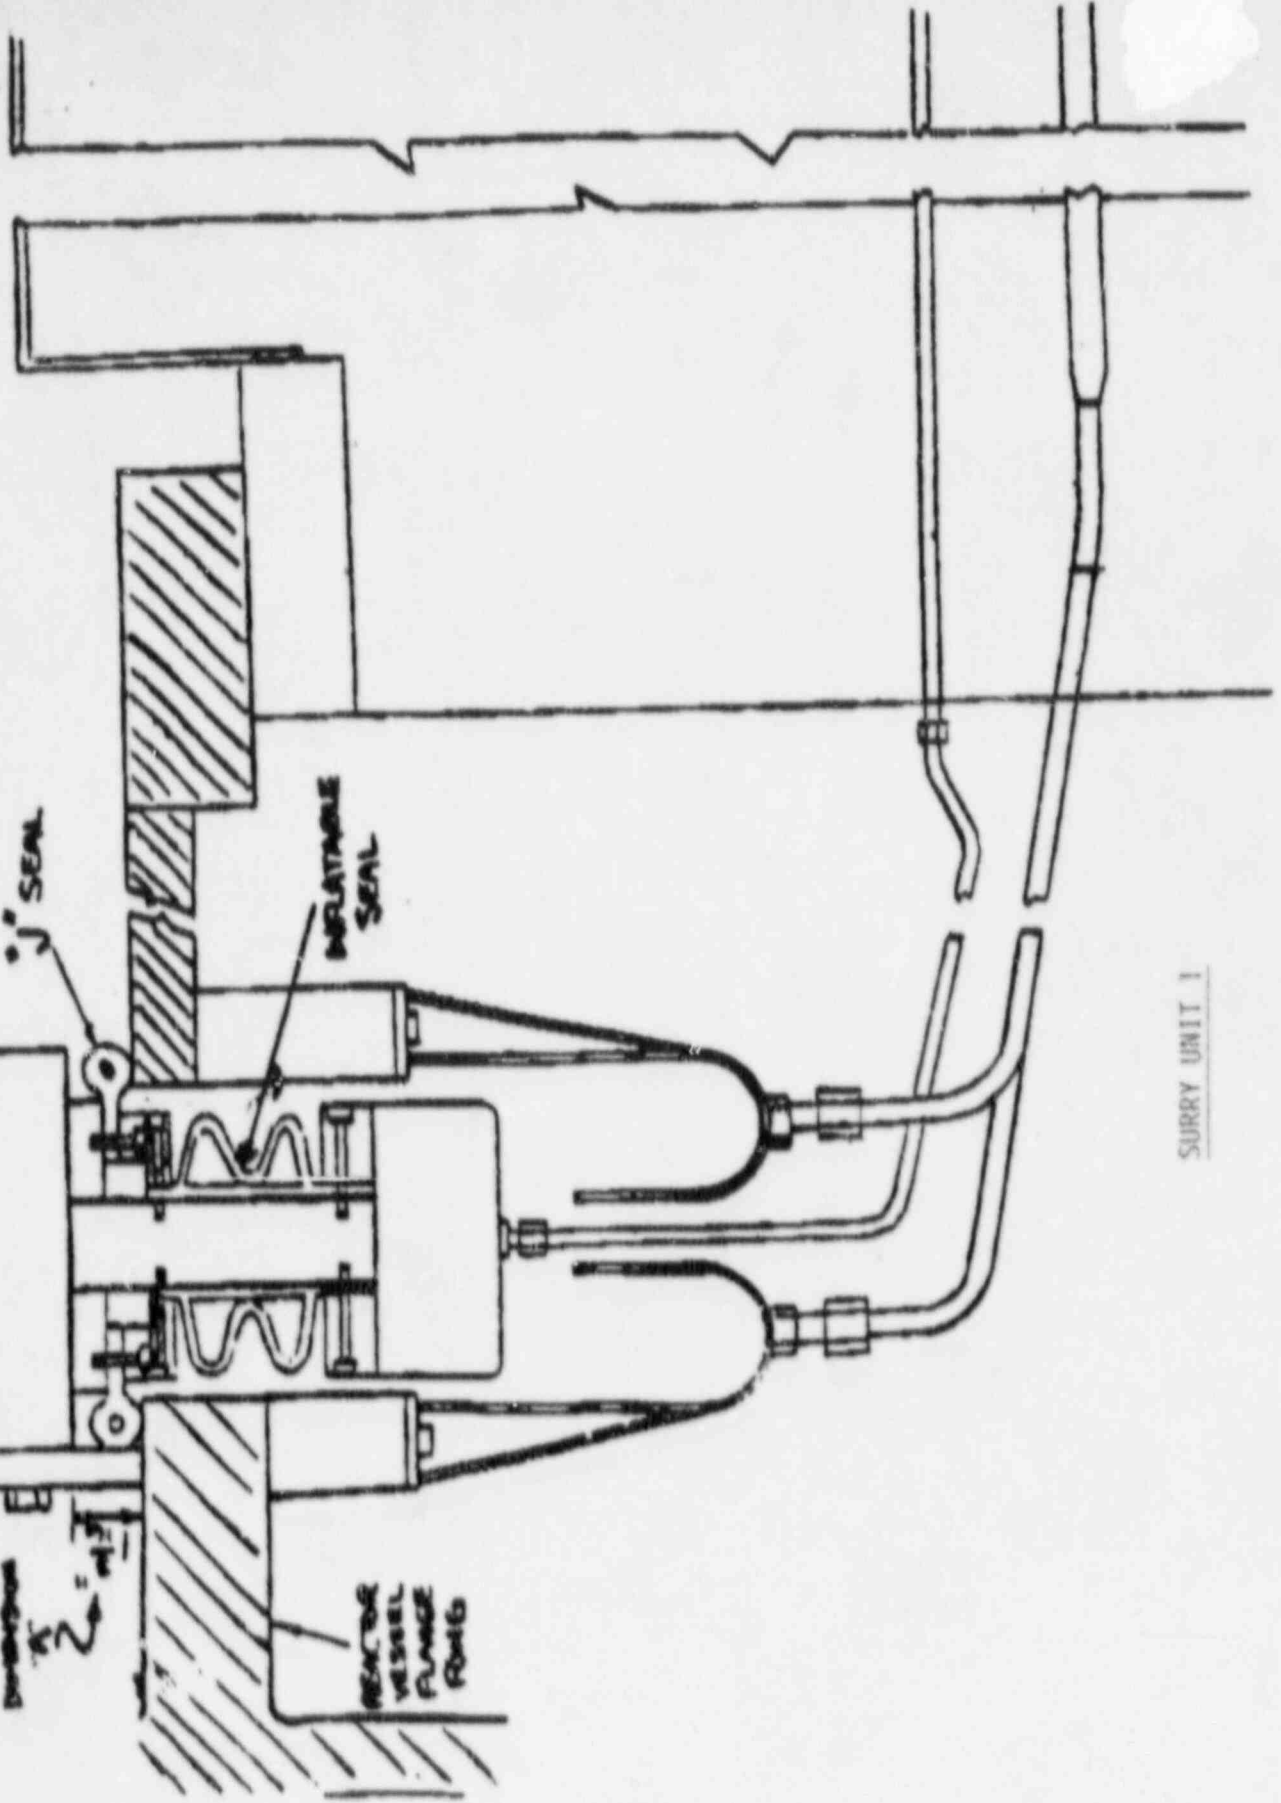
SURRY UNIT 1

- o REFUELING CAVITY FLOOR SEAL FAILURE
 - LOSS OF INSTRUMENT AIR PRESSURE TO THE INFLATABLE SEAL
 - FAILURE OF THE NITROGEN BACKUP SYSTEM TO INITIATE
 - PASSIVE "J" SEAL FAILED
- o EVENT WAS NOT REPORTED TO THE NRC UNTIL SEPTEMBER 1, 1988 AND THE LICENSEE WAS RELUCTANT TO PROVIDE INFORMATION WHEN ASKED.
- o IMPROPER OPERATOR ACTION IN RESTORING LEVEL COULD HAVE SIGNIFICANTLY REDUCED THE SPENT FUEL POOL RESULTING IN HIGH RADIATION IN THAT AREA.

- o UNIT 1 DEFUELED.
- o APPROX 30,000 GAL OF BORATED WATER INTO THE INCORE ROOM.
- o INCREASED RADIATION LEVEL FORCED EVACUATION OF W PERSONNEL ON MANIPULATOR CRANE.
- o USAR INCORRECTLY STATED THAT THE "J" SEAL WOULD PREVENT EXCESSIVE LEAKAGE.
- o IE IN 84-93, NRC I/E BULLETIN 84-03, AND INPO SOER 95-01 HAD BEEN ISSUED TO ALERT LICENSEES TO THE POSSIBILITY OF SEAL PROBLEMS.
- o AT THIS TIME THE LICENSEES PROCEDURES FOR MANY ASPECTS OF THIS EVENT ARE NOT ADEQUATE.
- o CAVITY LEVEL COULD HAVE BEEN MAINTAINED BY USE OF THE LPSI OR RHP PUMPS, BUT THE PUMPS WERE OUT-OF-SERVICE BECAUSE NO FUEL WAS IN THE VESSEL.

- o SURRY 2 IS ALSO SUSCEPTABLE TO THIS TYPE OF SEAL FAILURE AND WILL ENTER REFUELING SOON.
- o EVENT TERMINATED BY OPERATOR ADJUSTING THE NITROGEN REGULATOR AND OPENING A SHUT LOCAL INSTRUMENT AIR ISOLATION VALVE TO THE SEAL.
- o WATER LEVEL IN THE REFUELING CAVITY WAS RESTORED BY IMPROPERLY OPENING THE FUEL TRANSFER CANAL GATE VALVE.
- o MANUFACTURER (PRESRAY) SAYS THAT THE SURRY SEAL ARRANGEMENT ("J" SEAL WITHOUT A BACKING PLATE) IS UNIQUE.

- o DETAILED DESIGN REVIEW OF THE ARRANGEMENT WAS PERFORMED (LACK OF POSITIVE BACKING PLATE ON "J" SEAL, INFLATABLE SEAL SHOULD BE STRONGER MORE RESILIENT, AND HAVE MORE CONTACT SURFACE AREA).

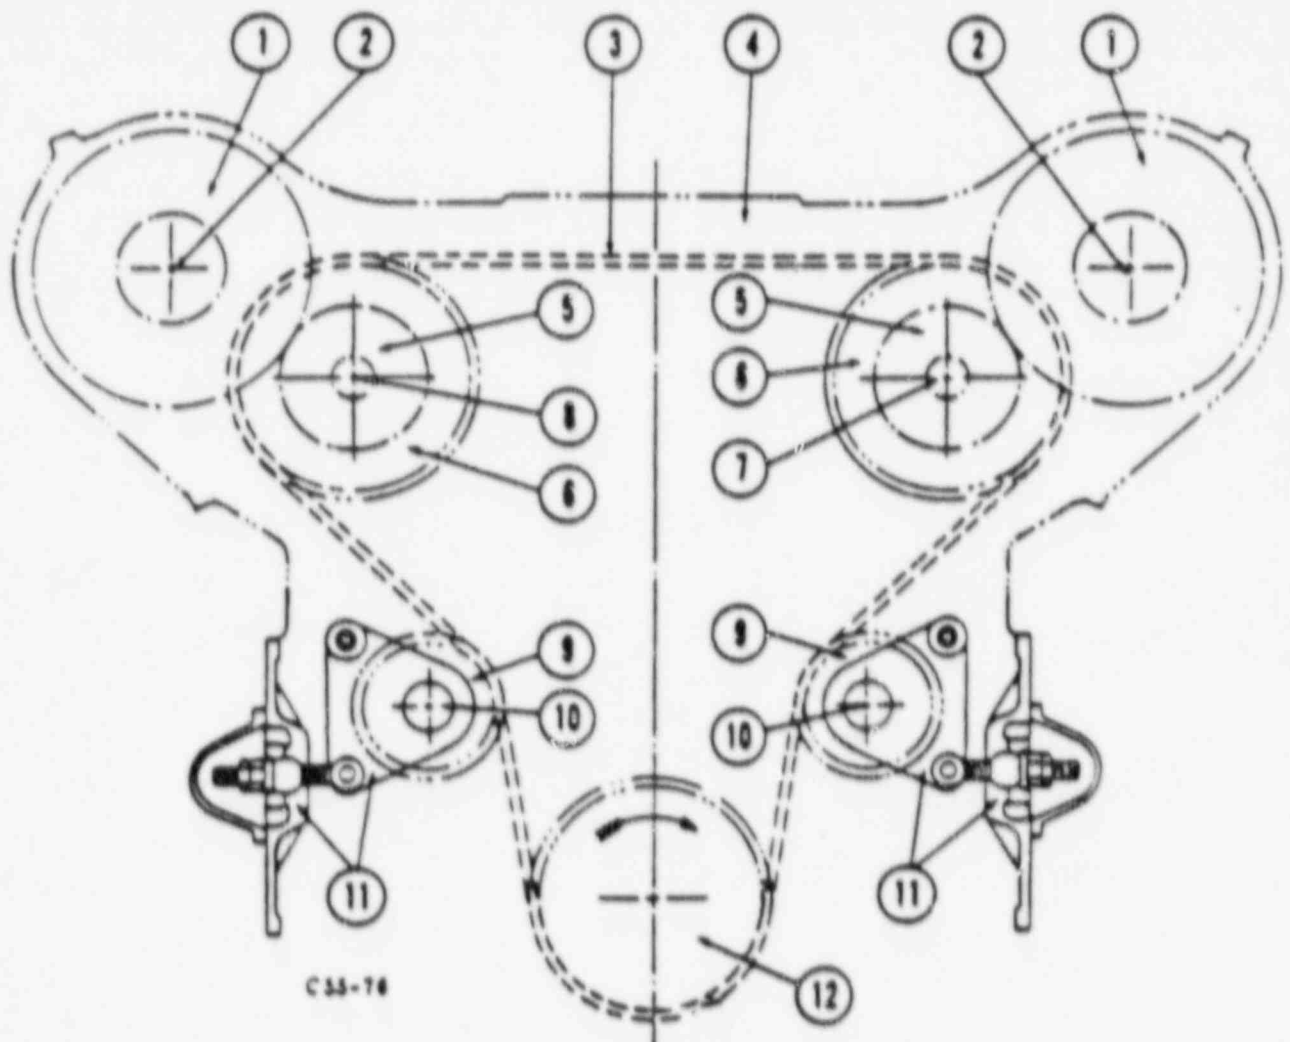
Camshaft and Governor Drive Chain

JACKET WATER FOUND IN COMBUSTION CHAMBERS WHICH LEAD TO THE DISCOVERY OF CRACKED HEADS ON EACH OF THE DIESEL'S 20 CYLINDERS.

THE PROBLEM WAS DETERMINED TO BE CAUSED BY IMPROPER INSTALLATION OF THE TIMING CHAIN.

- o SOME TIME BEFORE JULY 5, 1988 THE LICENSEE REPAIRED THE UNIT-2 "C" DIESEL GENERATOR LUBE OIL LINE TO THE TWO TIMING CHAIN TIGHTENERS.
- o THE CHAIN WAS REINSTALLED AND TENSION TO THE CHAIN WAS APPLIED USING ONLY ONE OF THE TWO TIGHTENERS.
- o THIS PROCEDURE ADVANCED THE TIMING CHAIN ABOUT 20 DEGREES.
- o THE TIMING ADVANCE PROBLEM CAUSED THE FUEL TO BE INJECTED AND CONSEQUENTLY COMBUSTED BEFORE THE PISTON REACHED TOP DEAD CENTER (TDC).
- o PRESSURE STRESSES AND THERMAL STRESSES ON THE DIESEL WERE SEVERE AND RESULTED IN MECHANICAL FAILURES WHICH WERE NOT READILY DETECTABLE.
- o UNDER HIGH PRESSURE AND TEMPERATURES THE POTENTIAL EXISTED FOR THE PISTON PIN LUBE OIL FILM TO DEGRADE AND RESULT IN EXCESSIVE WEAR ON THE BEARINGS.
- o IN THE CASE OF SOUTH TEXAS:
 - ERROSION AND/OR CRACKING OF VALVE RECESS AREAS OCCURRED AT THE TOP OF THE PISTON PROBABLY DUE TO EXCESSIVE HEAT.

- THE HEADS CRACKED, PROBABLY DUE TO THERMAL STRESSES, THIS ENABLED JACKET WATER TO ENTER INTO THE CYLINDER AND ERODE THE PISTON,
- o THE DIESEL DID NOT FAIL, IT TESTED SATISFACTORILY AND WAS RUN FOR ABOUT 20 HOURS BEFORE A ROUTINE MAINTENANCE PROCEDURE IDENTIFIED JACKET WATER IN THE CYLINDERS,

- o PD-IV HAS PERFORMED AN ONSITE INSPECTION OF THE DIESELS IN CONJUNCTION WITH REGION 17,
- o PD-IV RECOMMENDS A FLUSH OF THE DIESEL LUBE OIL SYSTEM TO REMOVE IRON OXIDE CONTAMINANTS IDENTIFIED DURING ITS INSPECTION BUT WHICH IS APPARENTLY UNRELATED TO THE TIMING CHAIN PROBLEMS WITH THE DIESEL,
- o PD-IV IS PLANNING TO REVIEW VENDOR MAINTENANCE PROCEDURES,
- o EAB RECOMMENDS THE VENDOR BRANCH BE INFORMED OF PD-IV ACTIVITIES,

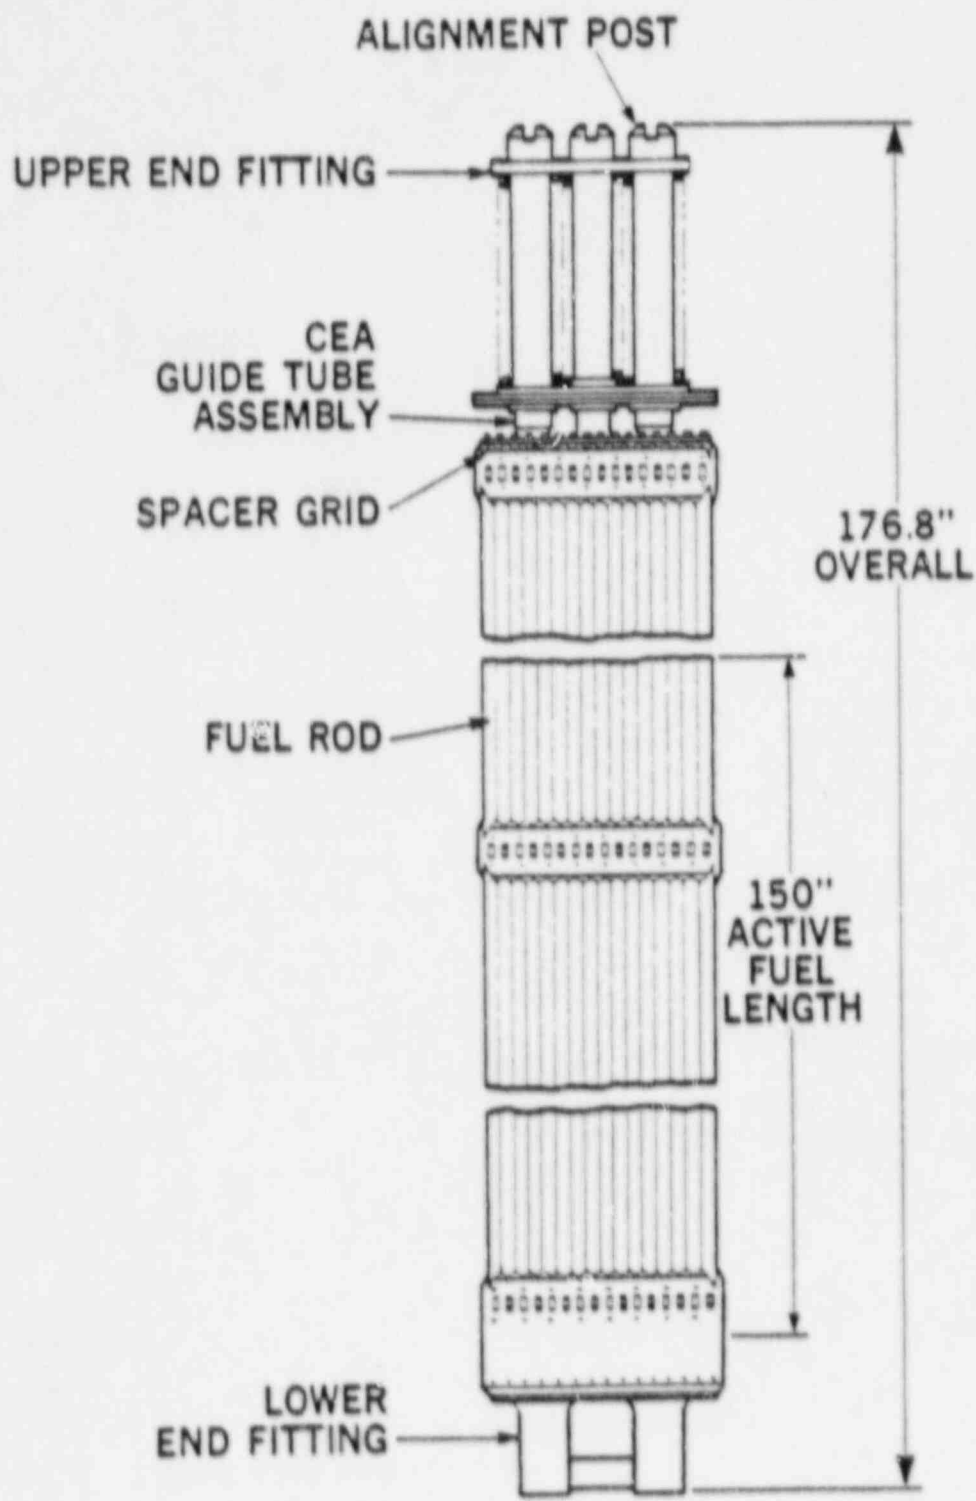
DURING REMOVAL OF THE REACTOR VESSEL UPPER GUIDE STRUCTURE (UGS) IN PREPARATION FOR PLANT REFUELING, ONE FUEL BUNDLE WAS FOUND TO BE STUCK TO, AND HANGING FROM, THE BOTTOM OF THE UGS (BOTTOM OF BUNDLE WAS 19 INCHES ABOVE THE CORE).

- o ON SEPTEMBER 3, 1988 WHILE IN MODE 6 (REFUELING), A FUEL BUNDLE WAS DISCOVERED HANGING FROM THE BOTTOM OF THE UPPER GUIDE STRUCTURE DURING REMOVAL OF THE STRUCTURE. NO APPARENT FUEL DAMAGE; AREA RADIATION MONITOR READINGS BELOW ALARM SETPOINTS.
- o CONTAINMENT ACCESS PENETRATIONS AND LINES IN DIRECT CONTACT WITH THE CONTAINMENT ATMOSPHERE WERE MANUALLY ISOLATED AS A PRECAUTIONARY MEASURE. NON-ESSENTIAL PERSONNEL WERE EVACUATED FROM CONTAINMENT.
- o WIRES WERE PLACED SEVERAL INCHES FROM SIDES OF BUNDLE (NOT TOUCHING) FIVE FEET BELOW TOP OF BUNDLE TO PREVENT BUNDLE FROM FALLING OVER IN CASE IT DISLODGED FROM UGS.
- o LICENSEE PREPARED PROCEDURE FOR FREEING BUNDLE FROM UGS WITH WORKER IN BASKET SUPPORTED BY JIB CRANE USING SPECIAL TOOLS. LICENSEE FABRICATED TOOLS AND PERFORMED MOCKUP TRAINING.

- o USING PROCEDURE, LICENSEE SUCCESSFULLY GAINED CONTROL OF STUCK FUEL BUNDLE, FREED BUNDLE FROM UGS, AND LOWERED BUNDLE ONTO ADJACENT FUEL ASSEMBLY AND SECURED BUNDLE BY LEANING IT AGAINST THE SIDE OF THE CORE BARREL.
