FACILITY: McGuire Nuclear Station, Units 1 and 2

SUBJECT: SUMMARY OF SITE VISIT AND MEETING ON GROUNDWATER LEVEL MONITORING  
AND CONTROL (TACS 56472 AND 56473)

SUBJECT: SITE VISIT TO MCGUIRE NUCLEAR STATION AND MEETING  
WITH DUKE POWER COMPANY REGARDING THE TECHNICAL  
SPECIFICATION FOR THE PERMANENT DEWATERING SYSTEM

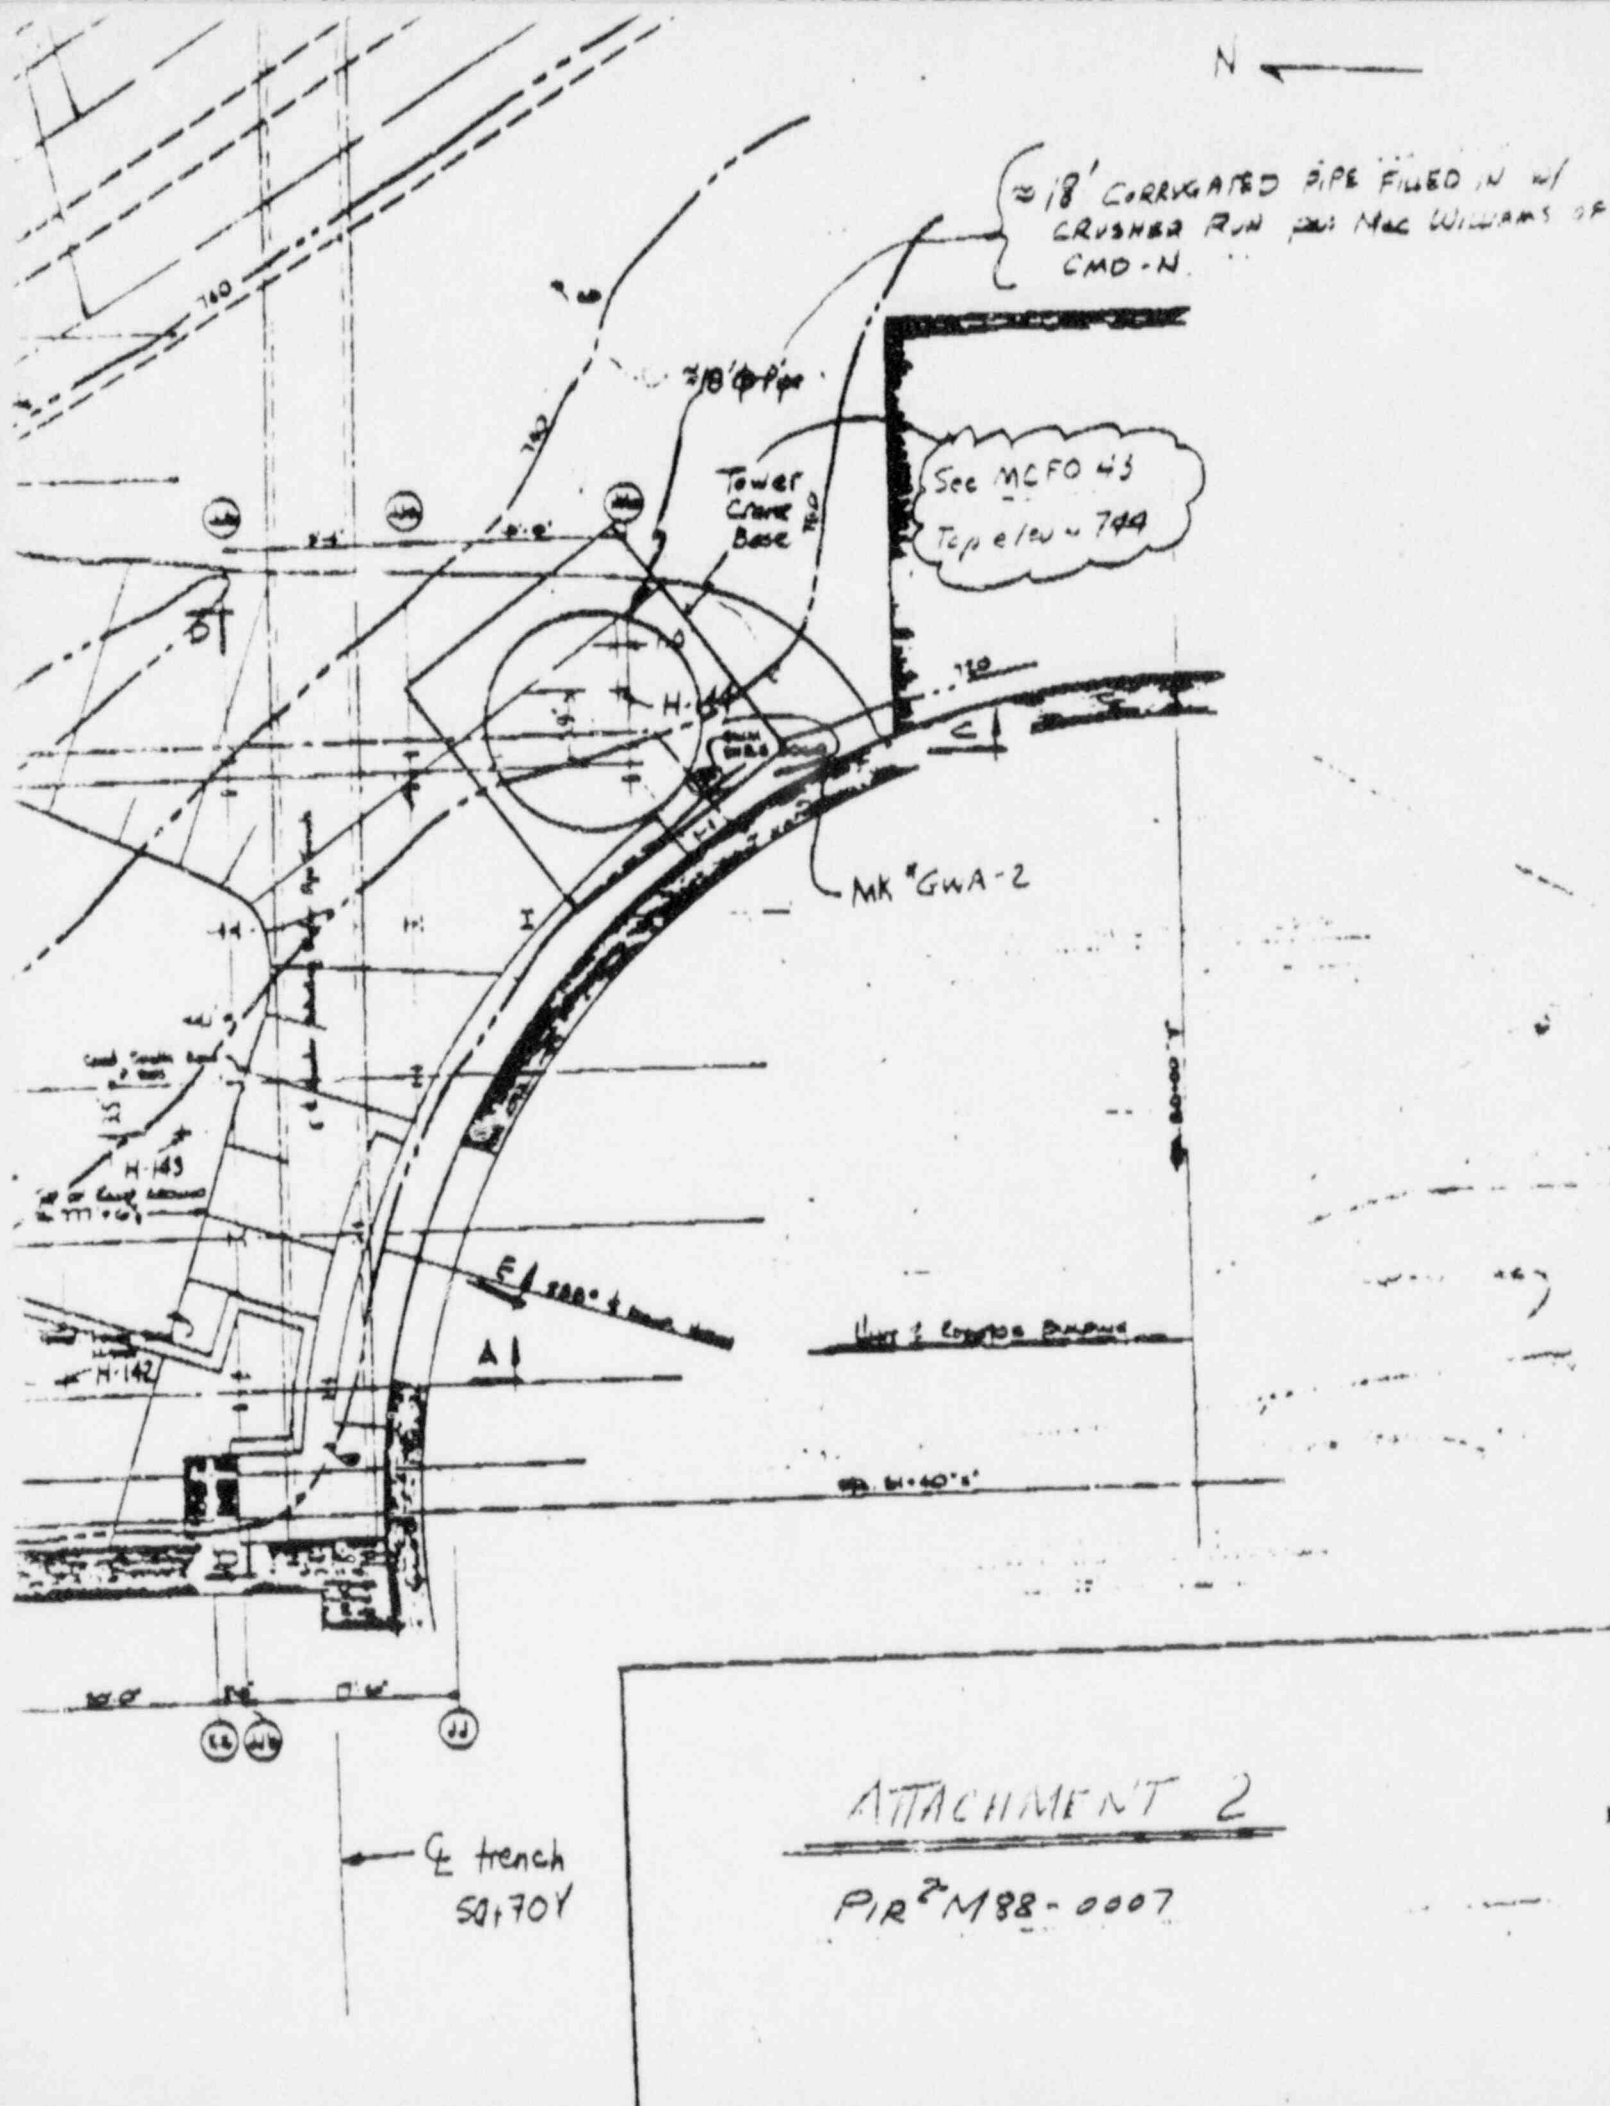
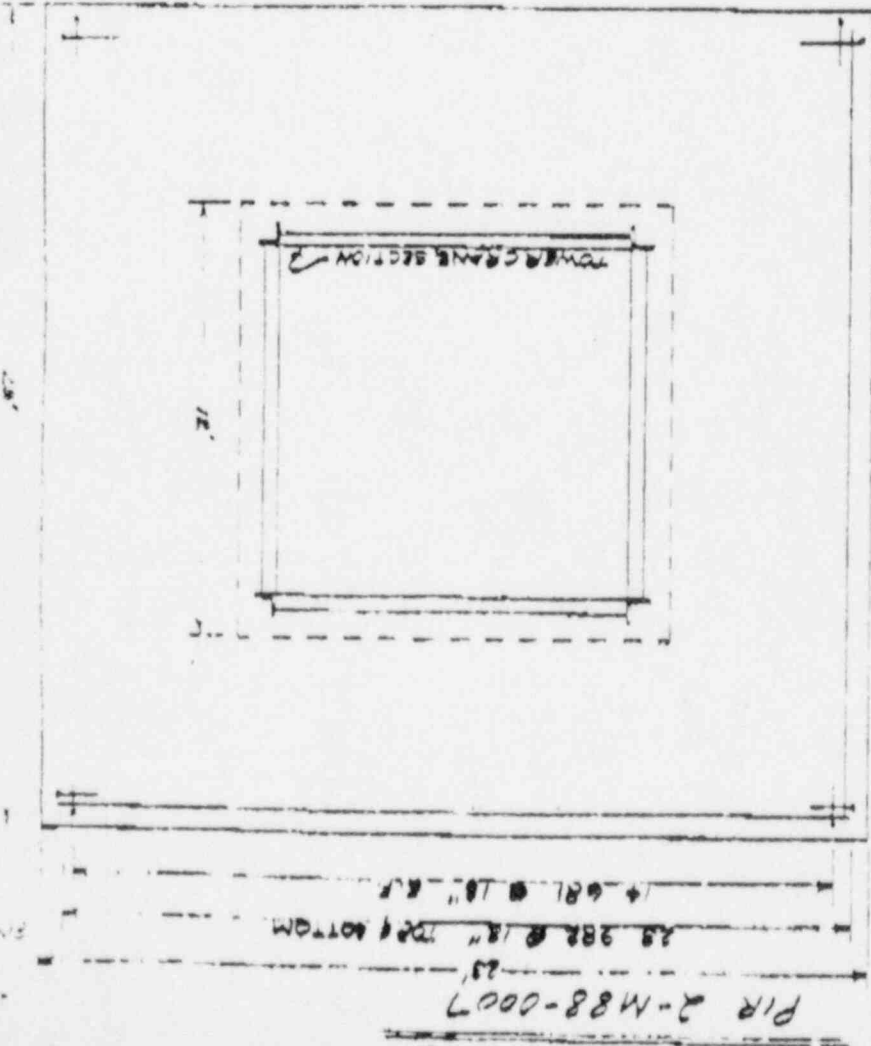
PIR<sup>2</sup>M88-0007

- ② If this groundwater monitor actually reflected the true groundwater conditions, and if we also assumed a worst case scenario of blockage of the underdrain system, the Reactor Bldg. walls are specifically designed for a maximum groundwater level of 750+0. The remaining monitors will still fall under the Tech. Spec. procedures. Since there is a Aux. Bldg. monitor located nearby with an initial alarm level at EL. 718+8, any indication of groundwater in this area will be noted. Also there is a monitor located inside of the Unit 2 Equipment Staging Bldg. (East side of Unit 2 Aux. Bldg.), which has an initial alarm level of 731+0, and two monitors located inside the Unit 2 Diesel Gen. Bldg. with initial alarm levels of 739+2.

- A. RB is designed for a 750' water level.
- B. Other blags. protected by other wells, which are not alarming.
- C. GWA2 has spuriously alarmed in the past.
- D. The Tech spec water levels are unnecessarily restrictive.
- E. GWA2 is currently alarming @ level 725.0.
- F. GWA2 may be influenced by the old RB tower crane foundation, which is within 10' of the well.

Conclusion: GWA2 alarming @ level 725.0 does not affect Unit 2 operability.

In order to avoid an unnecessary Plant Shutdown, the Civil Support Section (CSPH) recommends that the subject monitor be deleted from the current McGuire Technical Specification. The remaining monitors in the McGuire Technical Specification will be sufficient to indicate an increase in groundwater.
