Subject: Catawba Nuclear Station, Unit 1  
Docket No. 50-413  
Special Report

SPECIAL REPORT REGARDING  
DIESEL GENERATOR 1A VALID FAILURES ON  
APRIL 19, 1988, APRIL 25, 1988 AND MAY 5, 1988  
DUE TO PRESSURE SENSOR DESIGN FLAWS

DIESEL GENERATOR 1A VALID FAILURES DUE  
TO PRESSURE SENSOR DESIGN FLAWS

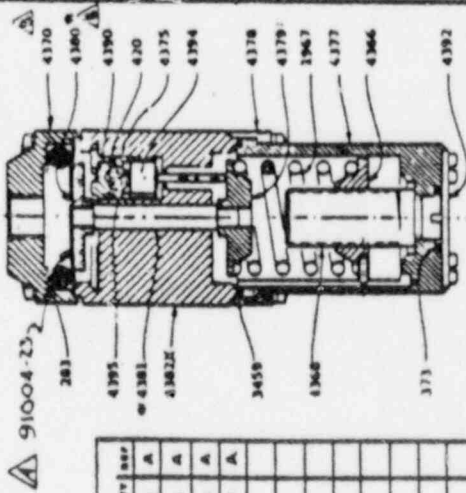
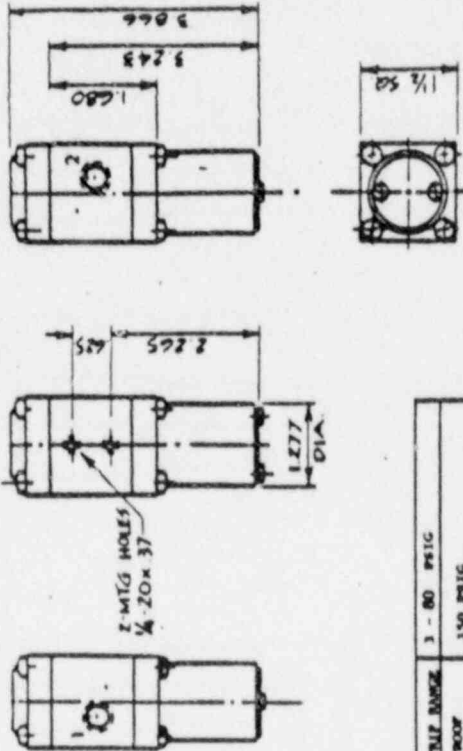
B4400 PRESSURE SENSOR SUB-ASSEMBLIES

An IMO Delaval and Calcon representative arrived on site at IAE's request on May 7th, 1988, with 12 new Calcon Model B4400 pressure sensors that had been closely inspected. They observed first hand the problems that were being encountered. It was determined that a batch of sensors received on April 15, 1988, were of poor quality. The three that had failed (2 P3s and 1 Lo Lo Lube Oil) were of this lot. The Calcon rep pointed out that friction binding between the large spring and spring

housing internal to the sensor (see Enclosure 3) could lead to the high reset values that were seen. Work Requests 9277 IAE, 9278 IAE, and 9279 IAE were written to replace sensors from the suspect batch on D/Gs 2A, 2B, and 1B respectively. In addition, W/Rs 9282 IAE, 9283 IAE, and 9281 IAE were written to verify that the reset pressures for the P3 on D/Gs 2A, 2B, and 1B respectively, were not abnormally high. The P3 in 1DECPA was replaced with one delivered by the vendors per W/R 27726 OPS. The other sensors of this type on D/G 1A were not from the suspect batch, and therefore were not replaced.

Based on the discoveries made by Calcon, it is concluded that the 7th, 8th, and 9th valid failures within the last 100 valid starts on Unit 1 D/Gs are attributed to the same root cause: inadequate design and manufacture of the Calcon Model B4400 pressure sensor. Upon returning to his plant on May 9, 1988, the Calcon Rep discovered that by stacking up the tolerances allowed in the manufacture of the sensor, it was possible to have negative .022" or no gap between the diaphragm (P/N 283) and the pressure head (P/N 4370). (See Enclosure 3.) If all parts were in the middle of these tolerances, there would be a .010" gap. And, if the parts were at the other extreme of the tolerances, then a .030" gap would be present. The effect of the negative gap would cause the diaphragm to fuse to the

pressure head from spring pressure on the pressure plate (p/n 4380). This in turn reduced the normal pressure area of approximately 1 1/8" diameter down to 3/8" diameter, thus requiring more pressure to overcome the spring pressure and reset the sensor. On newly calibrated sensors, this is not seen because the diaphragm has not had time to stretch and seat itself against the pressure head. This explains the time factor involved in the failure of these sensors. The failed sensors, including the P3 removed after the 7th valid failure, were measured and verified to have a negative difference between the diaphragm and pressure head, indicating the diaphragm was actually being compressed. This was also evident from inspecting the diaphragm and noting the compression ring on the diaphragm. Calcon's modification to this type of sensor ensured that a positive gap will always be present between the diaphragm and the pressure head. With all of these type sensors being replaced, no further failures of this type should exist. Further verification of the effectiveness of this modification was demonstrated by calibrating 2 of the failed sensors and checking reset pressure. After a period of time, reset pressure was seen to raise significantly. The modification of taking .030" from the inside of the pressure head was then performed on these 2 sensors. They were again recalibrated and allowed to sit overnight. The next day they were checked and reset pressure had not changed.

This design flaw had a significant effect on D/G operation. All of these sensors are set on a decreasing pressure to trip the engine. However, the reset pressure is critical also. If the sensor is not reset on an engine start, then it will vent continuously and not allow pressure to build up in any of the pneumatic lines. This explains why all annunciators for Group II trips were received during these 2 failures. The reason the defect was so pronounced with a sensor used in the P3 application was because the setpoint of 40 psid is higher than the other sensor applications: 10 lube oil, 30 psid; 10 turbo oil, 15 psid; 10 lube oil, 35 psid. This means that a higher spring pressure must be overcome to reset the sensor. Also, lube oil pressure, which the other sensors are seeing, actually increases higher than 60 psi which is the maximum P3 would ever sense.

Per Calcon, this design flaw has existed since 1980, as none of the parts involved have had changes affecting these tolerances. From inspections performed by the Calcon Rep on site it was noted that approximately 40% of the sensors checked actually had a negative clearance between the diaphragm and the pressure head. It so happened that the ones with this discrepancy were used in the P3 application on D/G 1A during the 7th and 8th, and 9th valid failures.

On May 9, 1988, at approximately 1430 hours, a call was received from the IMO Delaval Rep. He stated that the Calcon Rep, after leaving Catawba, made more discoveries about the suspect model of sensors. It was requested that the IMO Delaval and Calcon Rep visit the site once more with some newly modified sensors and assist IAE with replacing all sensors of this type on each engine. The IMO Delaval Rep stated that the engines were not inoperable with the sensors that were currently installed, however, the additional measure of replacing the sensors was needed. The Calcon and IMO Delaval Rep. arrived on site on May 11, 1988, with more new sensors. They explained in detail the discoveries about the sensors that had been determined to be the main reason they had failed. Because of a tolerance stack-up in the manufacture of the sensor, the pressure sensing diaphragm can be held solid against the pressure head, thus creating a smaller surface area (see Enclosure 3). This smaller surface area would require a much higher pressure to reset the sensor. Calcon had remanufactured the pressure head on the new sensors brought with them to add an additional 1 1/8" diameter circular bore .030" deep, to provide a positive gap between the head and the diaphragm. The new sensors will be stamped P/N B4400B to distinguish them from the questionable sensors. All Calcon B4400 sensors were replaced on D/Gs 1A, 1B, 2A, and 2B per W/Rs 9295 IAE, 9296 IAE, 9297 IAE, and 9298 IAE with Calcon B4400B sensors.
