CONFIRMATORY ACTION LETTER

CAL-RIII-86-01

LETTER TO MR. HAROLD R. DENTON

NRR TRIP REPORT FROM

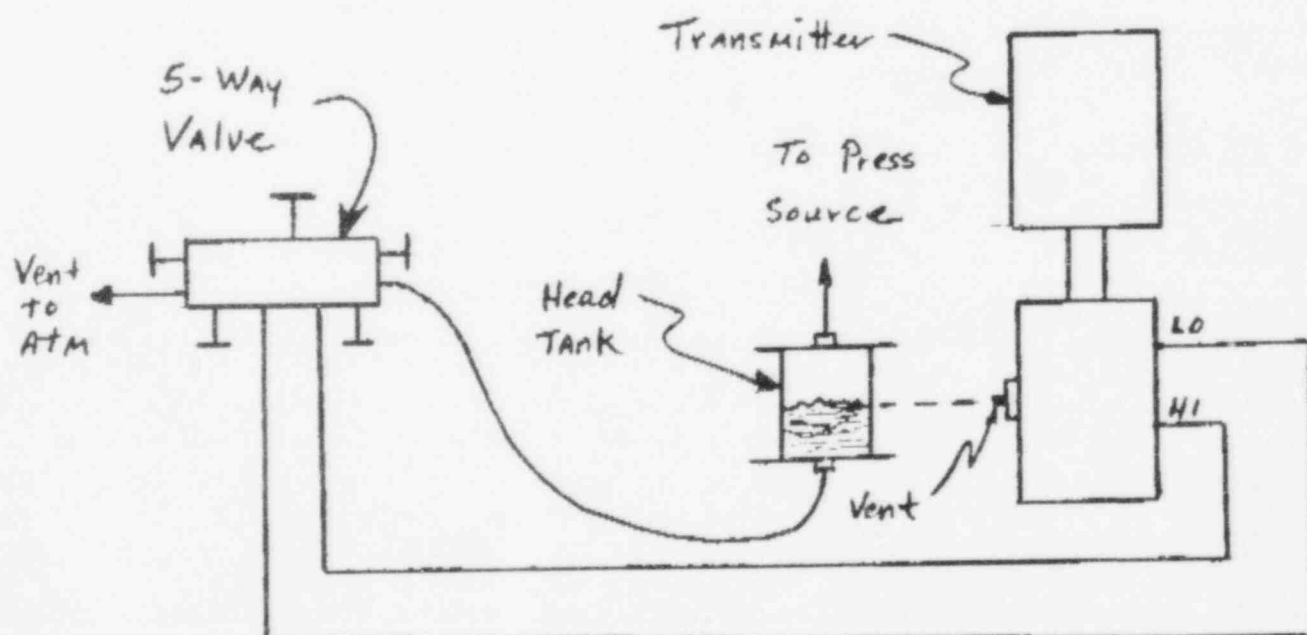
Calibration Technique - The suppression pool level instruments are designed such that they have a "dry" reference leg, vented to containment atmosphere, and a wet variable leg sensing pool level. This configuration requires the use of a "head tank" on only the variable side. A head tank is used to allow the instrument to be calibrated with water. It is crucial that the head tank be at the same elevation each time the calibration is performed. The methods to accomplish this are for the most part left up to the technician with the probable result being that the reproducibility of the calibration is questionable. Dry calibration techniques cannot be used because not all water can be removed from the instrument, and as a result, an offset would be experienced. An additional problem occurs in that if the instrument bypass valve is opened, water would be admitted to the reference leg. Water in the reference leg would result in a positive offset. During the taking of as found data, no water was observed in the reference leg. Additionally, it is relatively impossible to cause water to enter both reference legs at the same time, unless the containment is flooded to above the 674.0 foot elevation.

When calibrating with one head tank, extreme care must be observed when adjusting the elevation of the tank. The current procedure is to match the elevation of the head tank with the center of the vent screw on the transmitter. If the tank is above the center line, a negative offset will occur, and below the center will result in a positive offset. It should be noted that there is no mounting mechanism currently provided to align and hold the position of the head tank assembly during calibration.

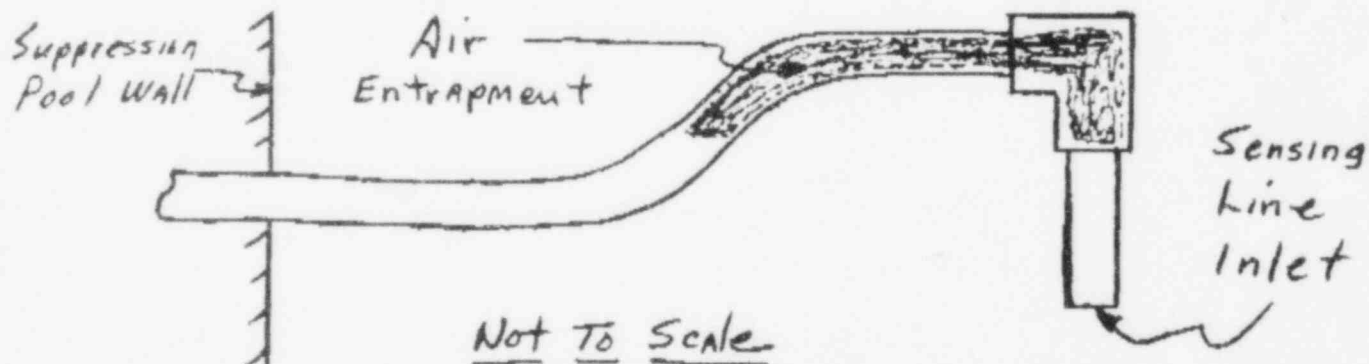
As mentioned earlier, there currently exists three points in the sensing line, between the sensing tap and the tee where the narrow range instrument line taps off, where the high points cannot be vented. Two of these points are in the three quarter inch line, where a high mass flow rate would be required in order to completely remove any entrapped air. Most important to note is that the sensing line inside the suppression pool has an elevated offset just prior to the elbow which directs the sensing line down towards the pool floor (see sketch below). The opening is directed towards the floor to minimize the turbulent effects when RHR is running, as both the RHR suction line and the level sensing line share the same penetration.

This offset can, and is expected to still contain some entrapped air. Entrapped air in this location will have equal effect on both the wide and narrow range level channels. Both the A and B instrument loops are installed on a similar manner.

Assuming that the sensing line contained air in the location described, prior to the event all of the suppression pool level instruments may have been indicating about two and one half inches ( $2 1/2"$ ) lower than actual pool level. At the time of the earthquake, the pool was upset, causing a "wave" effect. This upset can be clearly seen on the suppression pool level recorder charts. When the level went momentarily low at the sensing tap, there was a momentary vacuum sensed at the end of the pipe tap. This low pressure caused some of the entrapped air to be pulled out the end of the pipe, resulting in a restoration of about  $1 1/2$

At this time, the spontaneous venting of some entrapped air in both of the suppression pool level instrument sensing lines is the only suspected cause for the observed pool level change at the time of the seismic event. Several corrective actions are therefore recommended.

Sensing Line Filling and Venting - The facilities currently installed are inadequate to provide complete filling and venting of the sensing lines. Additionally, due to the complex nature of the process being measured and the difficulty in assuring the proper and repeatable venting and filling, the following actions will be taken:

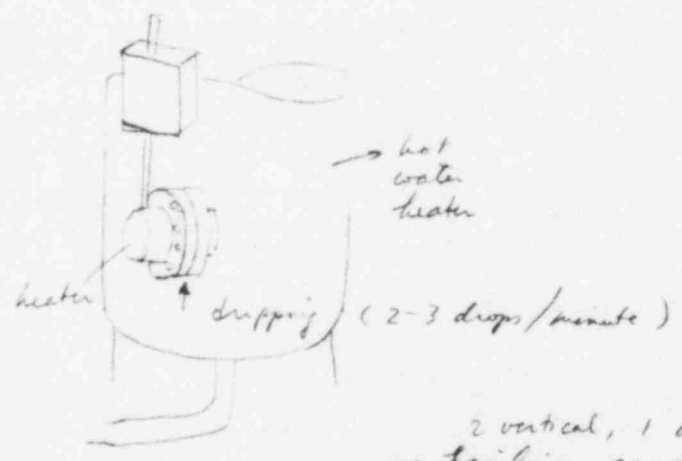
④ Hot water heater pipe flange leaked.

Location: Rad Waste Bldg  
 Elev. 623' <sup>see</sup> attached floor plan

This heater provides clean steam to evaporator, has nothing to do with radiation waste  
 know definitely was there

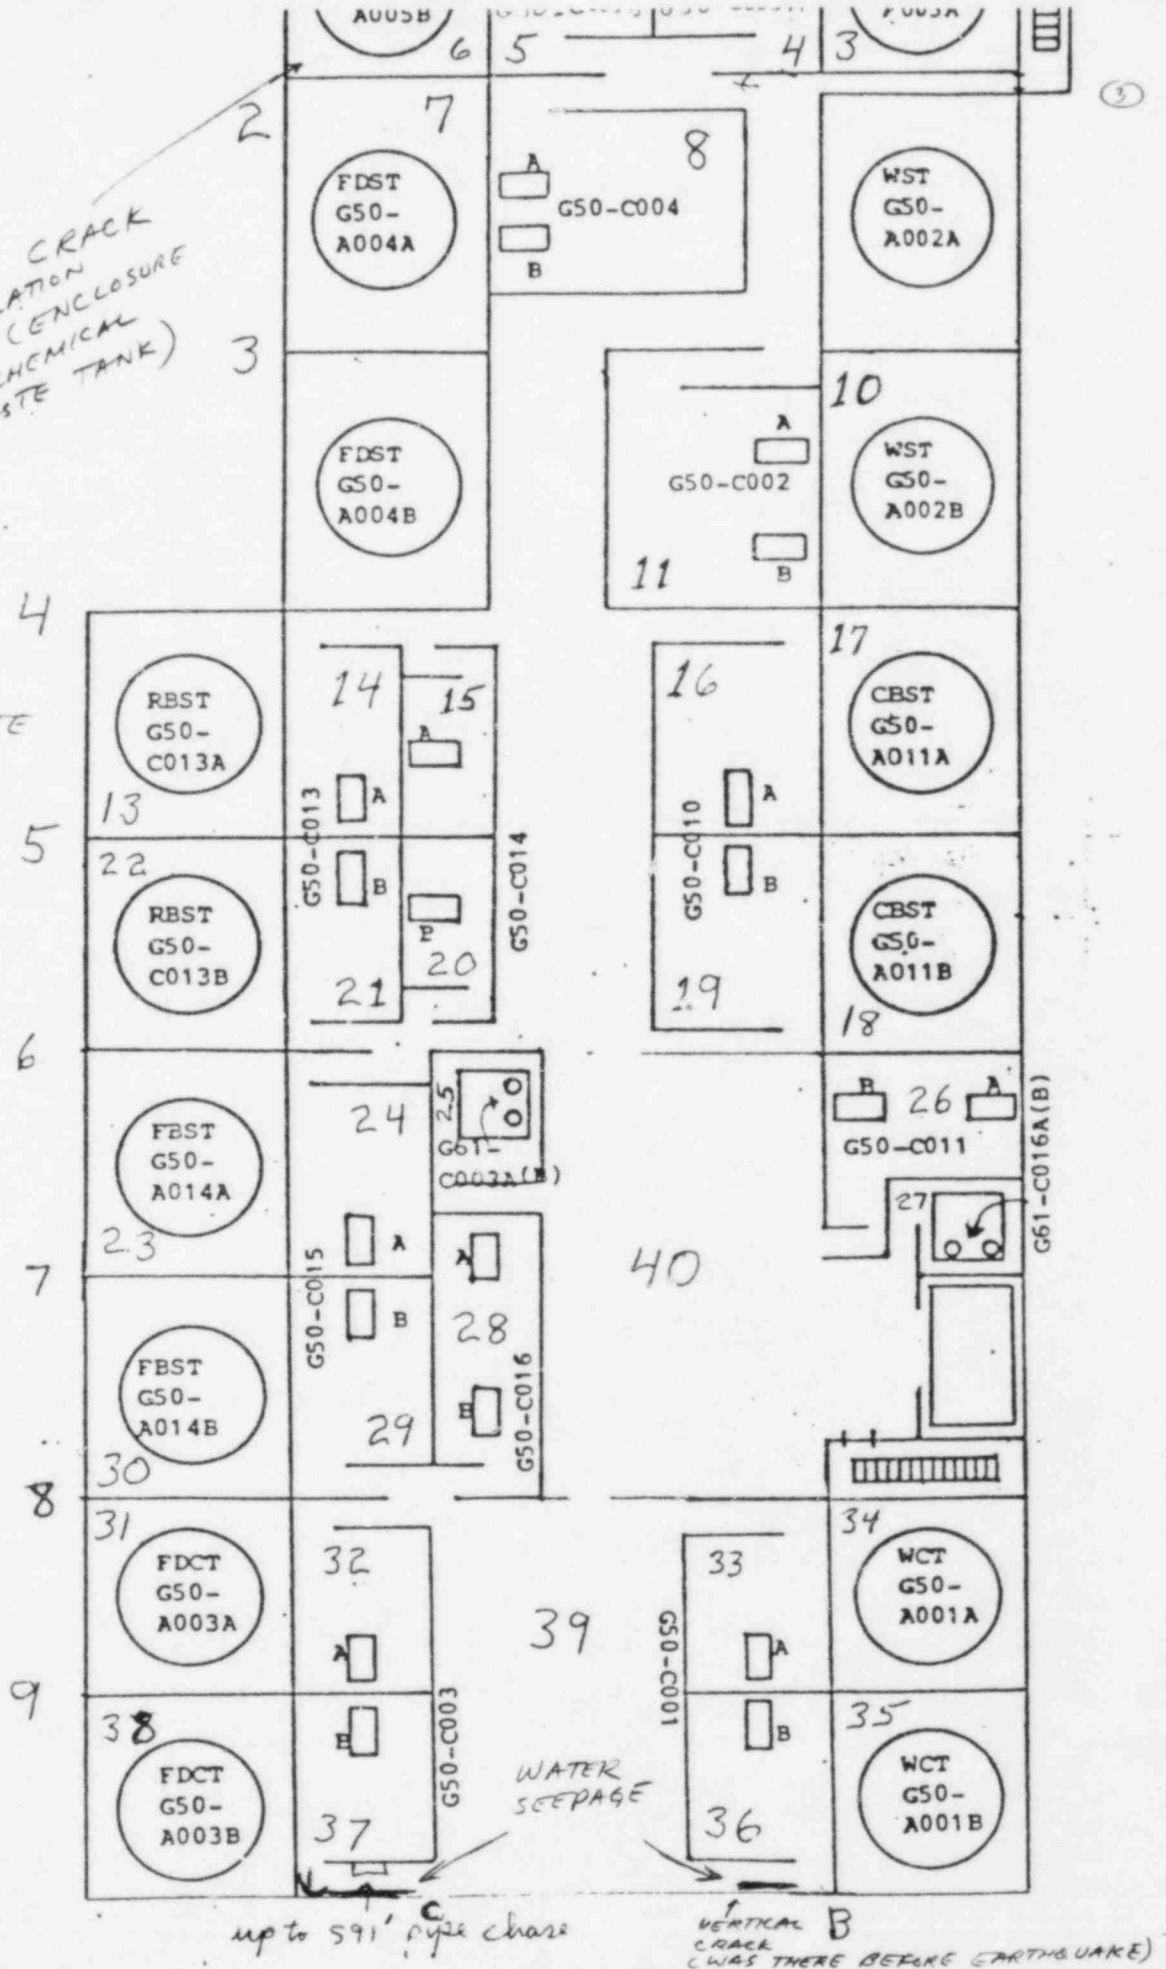
RAD WASTE  
BLDG

- Wall crack for enclosure of chemical waste tank (2' reinforced concrete wall) - <sup>see attached</sup> ~~location~~ <sup>location</sup>
- Wall crack in aux. bldg.
- seepage through Rad Waste room wall. (<sup>from</sup> ~~ground~~ <sup>table</sup> water)

HAIRLINE CRACK  
IN ISOLATION  
WALL (ENCLOSURE  
FOR CHEMICAL  
WASTE TANK)
