LICENSEE EVENT REPORT (LER)

FACILITY NAME (1) Oyster Creek, Unit 1	DOCKET NUMBER (2) 0 5 0 0 0 2 1 9	PAGE (3) 1 OF 0 4
---	--------------------------------------	----------------------

TITLE (4)  
Inadvertent Actuation of "B" Isolation Condenser

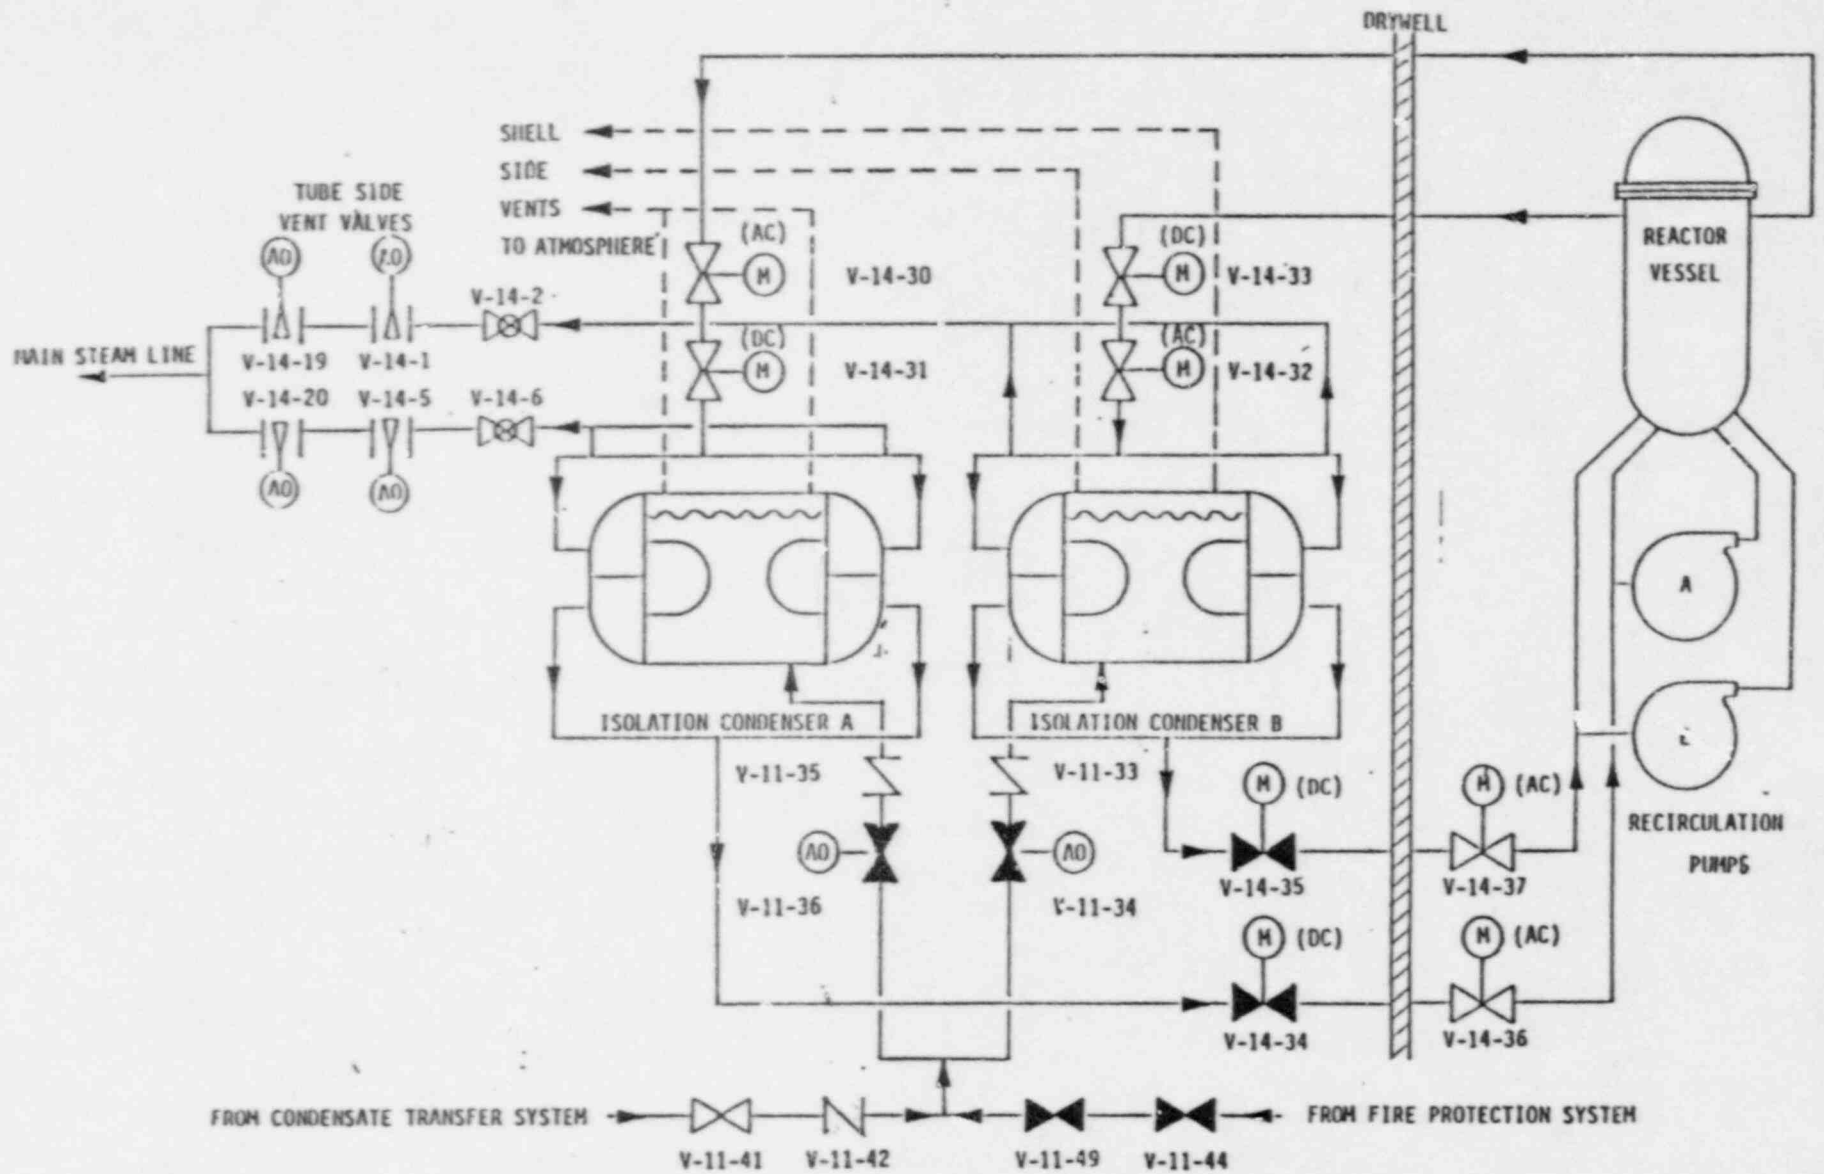
Figure 1: ISOLATION CONDENSER SYSTEM DIAGRAM.

At approximately 1200 hours on August 28, 1988 a valve operability surveillance test, Procedure 609.4.001, was commenced for the "B" Isolation Condenser. The Isolation Condenser had been out of service for repairs to the motor operator on the DC Steam Inlet Valve (V-14-33). See Figure 1 for a sketch of the Isolation Condenser System.

At approximately 1240 hours the procedure had been implemented to a point where both Steam Inlet Valves (V-14-32 and V-14-33) and the DC Condensate Return Valve (V-14-35) were open and the AC Condensate Return Valve (V-14-37) was closed. The next procedure step was to close V-14-35. Instead of closing V-14-35, the Control Room Operator inadvertently placed the control switch for V-14-37 to the "AUTO" position. This position provides a signal to return the valve to its "normal" open position. He immediately realized his error and placed the control switches for both V-14-37 and V-14-35 to "CLOSE". While both valves were closing, a reactor water level increase of approximately one inch was observed. The power level also increased approximately one percent, followed by a decrease of two percent and then a return to normal. Later review of records indicated that a period of seven (7) seconds elapsed between the valve receiving the open signal until it returned to closed. After the Group Shift Supervisor ascertained what had occurred, he attempted to contact the Manager, Plant Operations via pager. The Control Room Operator completed the surveillance procedure and returned the "B" Isolation Condenser to its normal lineup at approximately 1300 hours.

After completion of the surveillance test, the shell side temperature of the "B" Isolation Condenser was observed to be increasing. This indicated leakage past V-14-35. Valve V-14-37 was closed to prevent any additional increase in shell temperature.

Immediate corrective action consisted of closing valves V-14-37 and V-14-35 to secure operation of the system. After it was determined that the plant returned to normal, the surveillance was completed and the "B" Isolation Condenser returned to its normal line-up. The operator was counseled shortly after the event.
