U.S. NUCLEAR REGULATORY COMMISSION  
REGION I

Report No. 50-219/88-24

Facility Name: Oyster Creek Nuclear Generating Station

Areas Inspected: An unannounced inspection of the failure of Main Steam Isolation Valve NS03A Stem. The inspection included a review of the sequence of events, maintenance history, surveillance test history, stem material, industry experience and corrective actions.

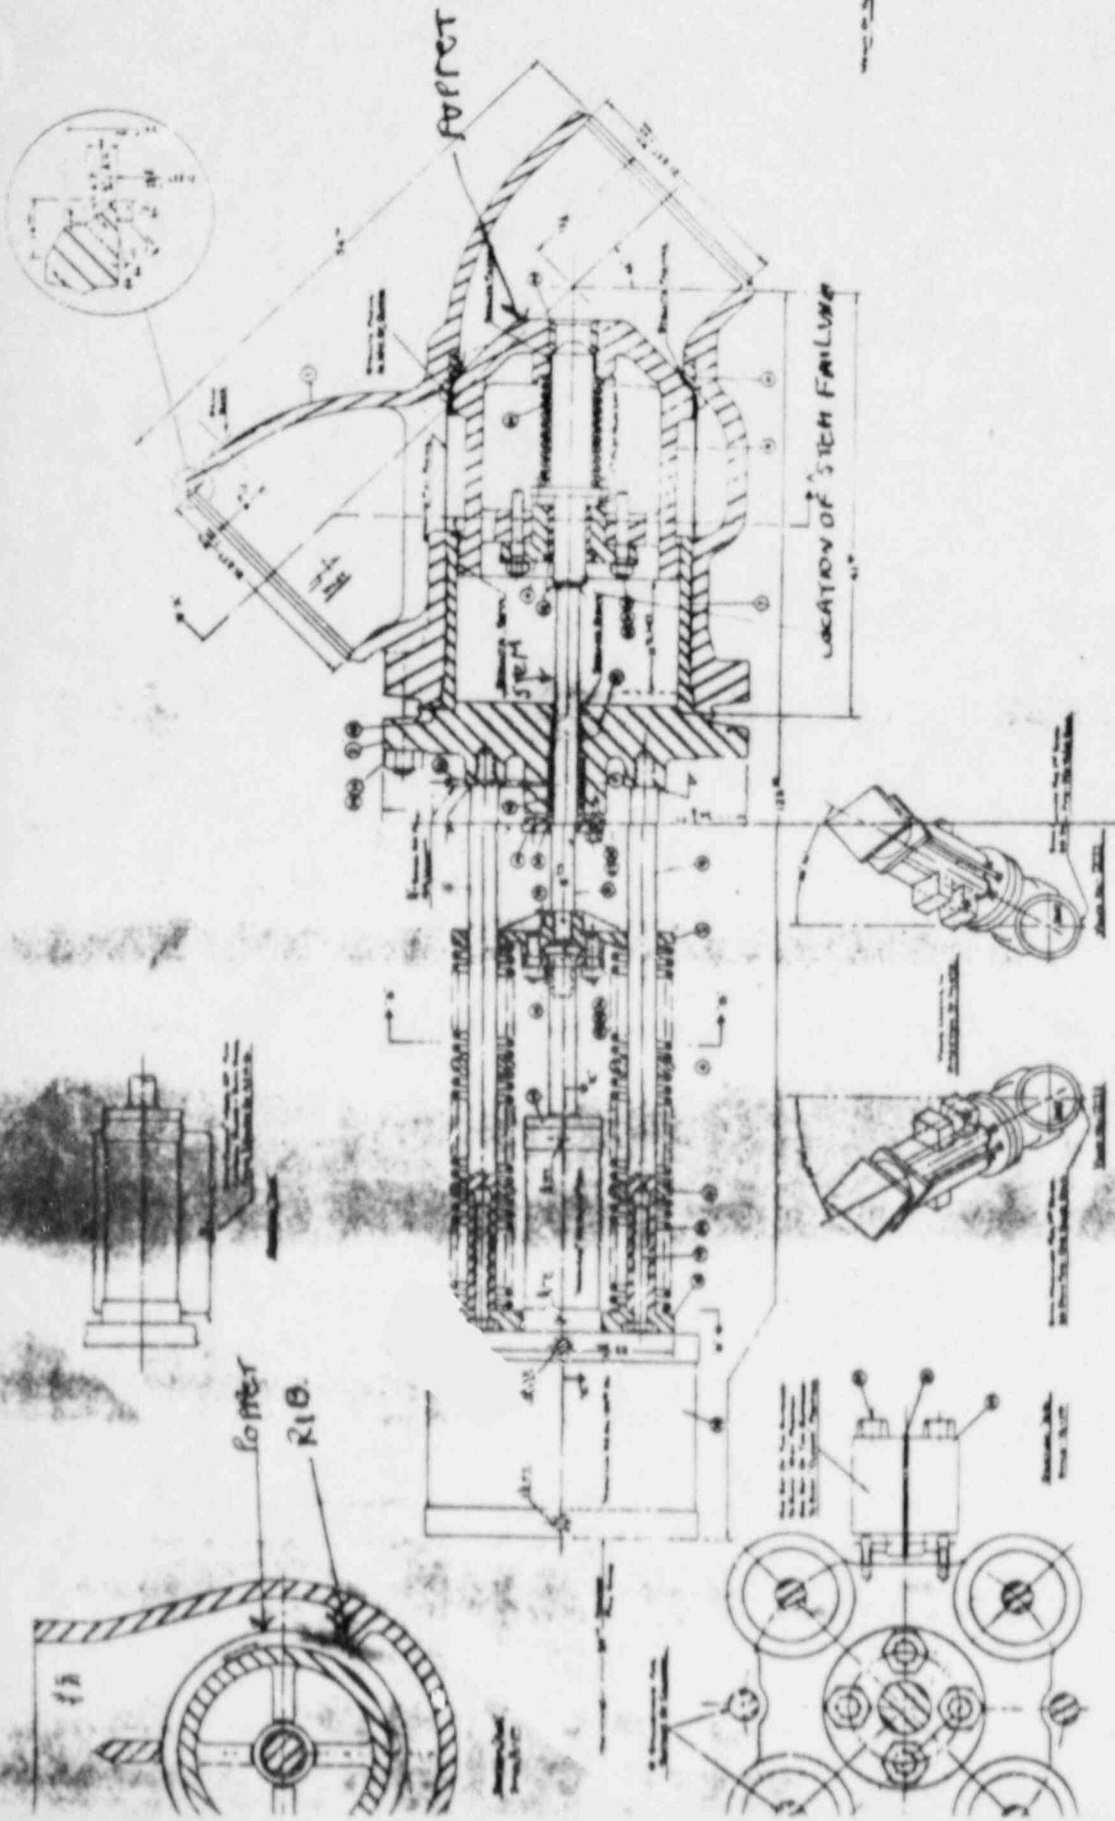
FIGURE 5.4-4A

The Main Steam Isolation Valves, manufactured by Atwood and Morrill Company, are 24-inch angled globe valves having a "Y" pattern body (See Figure 1). The MSIV contains an internal pilot valve. The end of the valve stem seats in the pilot valve seat which is located in the center of the main poppet. The pilot equalizes the pressure across the main poppet prior to lifting the main poppet off its seat. The first one inch of stem travel opens the pilot valve and engages the main poppet. The next 11" of stem travel lifts the main poppet. The full stem travel from full closed to full open is twelve inches.

24" - GLOBE BODY MAIN STEAM ISOLATION VALVE - WITH CYLINDER OPERATOR
