LICENSEE EVENT REPORT (LER)

FACILITY NAME (1) Calvert Cliffs, Unit 1	DOCKET NUMBER (2) 0500003171	PAGE (3) 1 OF 6
---	---------------------------------	--------------------

TITLE (4)
Inadvertent Engineered Safety Features Actuation Due to Modifications Work

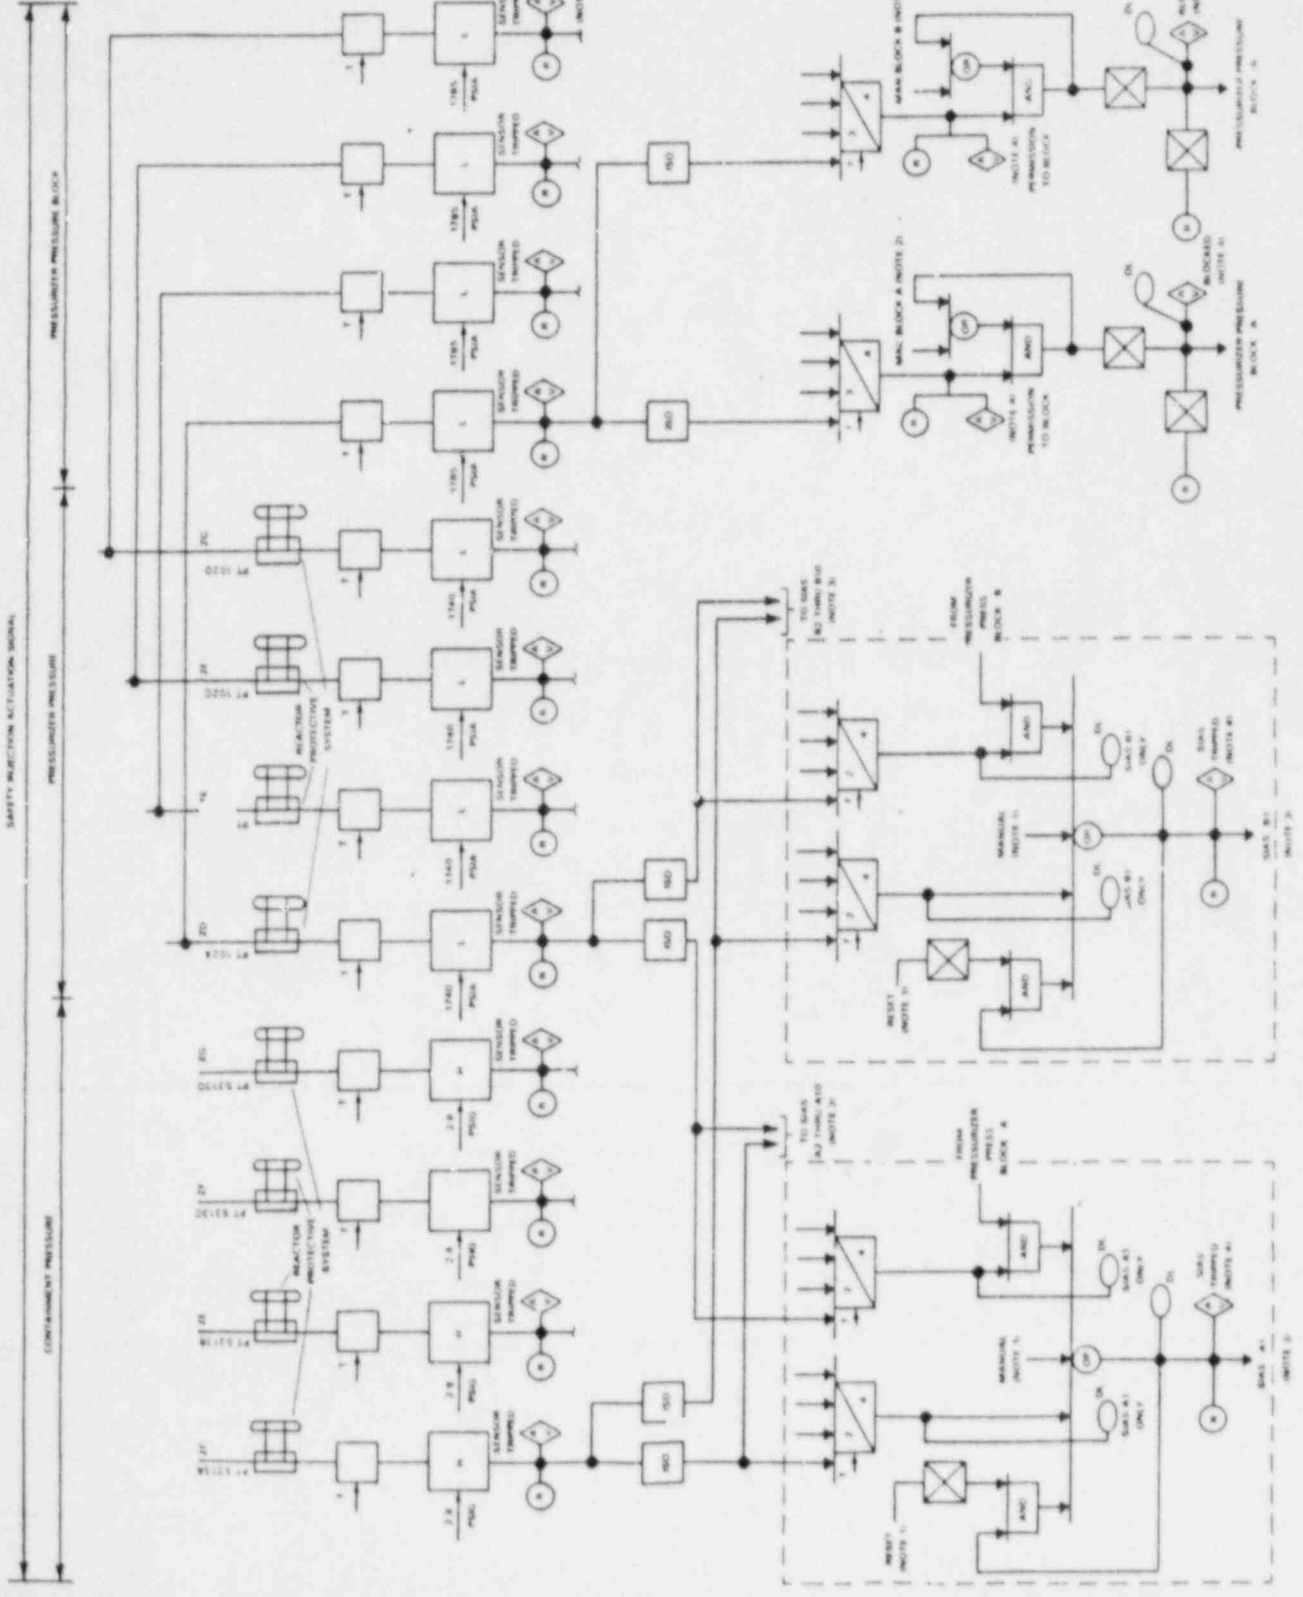
FIGURE 1

- 1A. Sensor Channels (ZD, ZE, ZF and ZG) of the ESFAS system previously had SIAS Pressurizer Pressure blocked due to plant conditions, mode 6 refueling. SIAS block requires 3 out of 4 logic to receive "permission to block" and manual operator action to insert the block (ref. Figure 1).
- 1B. Sensor Channel ZE of the ESFAS was depowered at 1125 to allow the internal modification of the sensor cabinet for the Diverse Scram System (DSS). Prior to this depowering, a full four out of four sensor channel trip condition existed which was due to actual low sensor channel voltage inputs (pressurizer pressure is low in mode 6). The SIAS actuation was blocked in the AL and BL logic cabinets as stated in item 1A above.

Two work crews reterminating the field cables outside containment to the new penetrations were final fitting the cables to the penetrations prior to final termination. These crews were located at the ZF and ZG/C and D ESFAS/RPS channel transmitter output penetrations. Upon the fit up of the cables to the penetrations (with the conductors secured together at the transmitter ends) loop current and voltage input went to maximum (see Figure 2) due to the transmitter loops not being depowered. This condition reset the actuation blocking at ESFAS in AL and BL logic cabinets. (Three out of four logic gives permission to block and two out of four logic resets to clear the block.) (Ref. Figure 1)

With the SIAS actuation now unblocked and the two remaining ESFAS sensor channels, ZD tripped due to actual low signal input and ZE tripped due to the fail safe loss of power design, SIAS initiated in channels AL and BL at 1412.

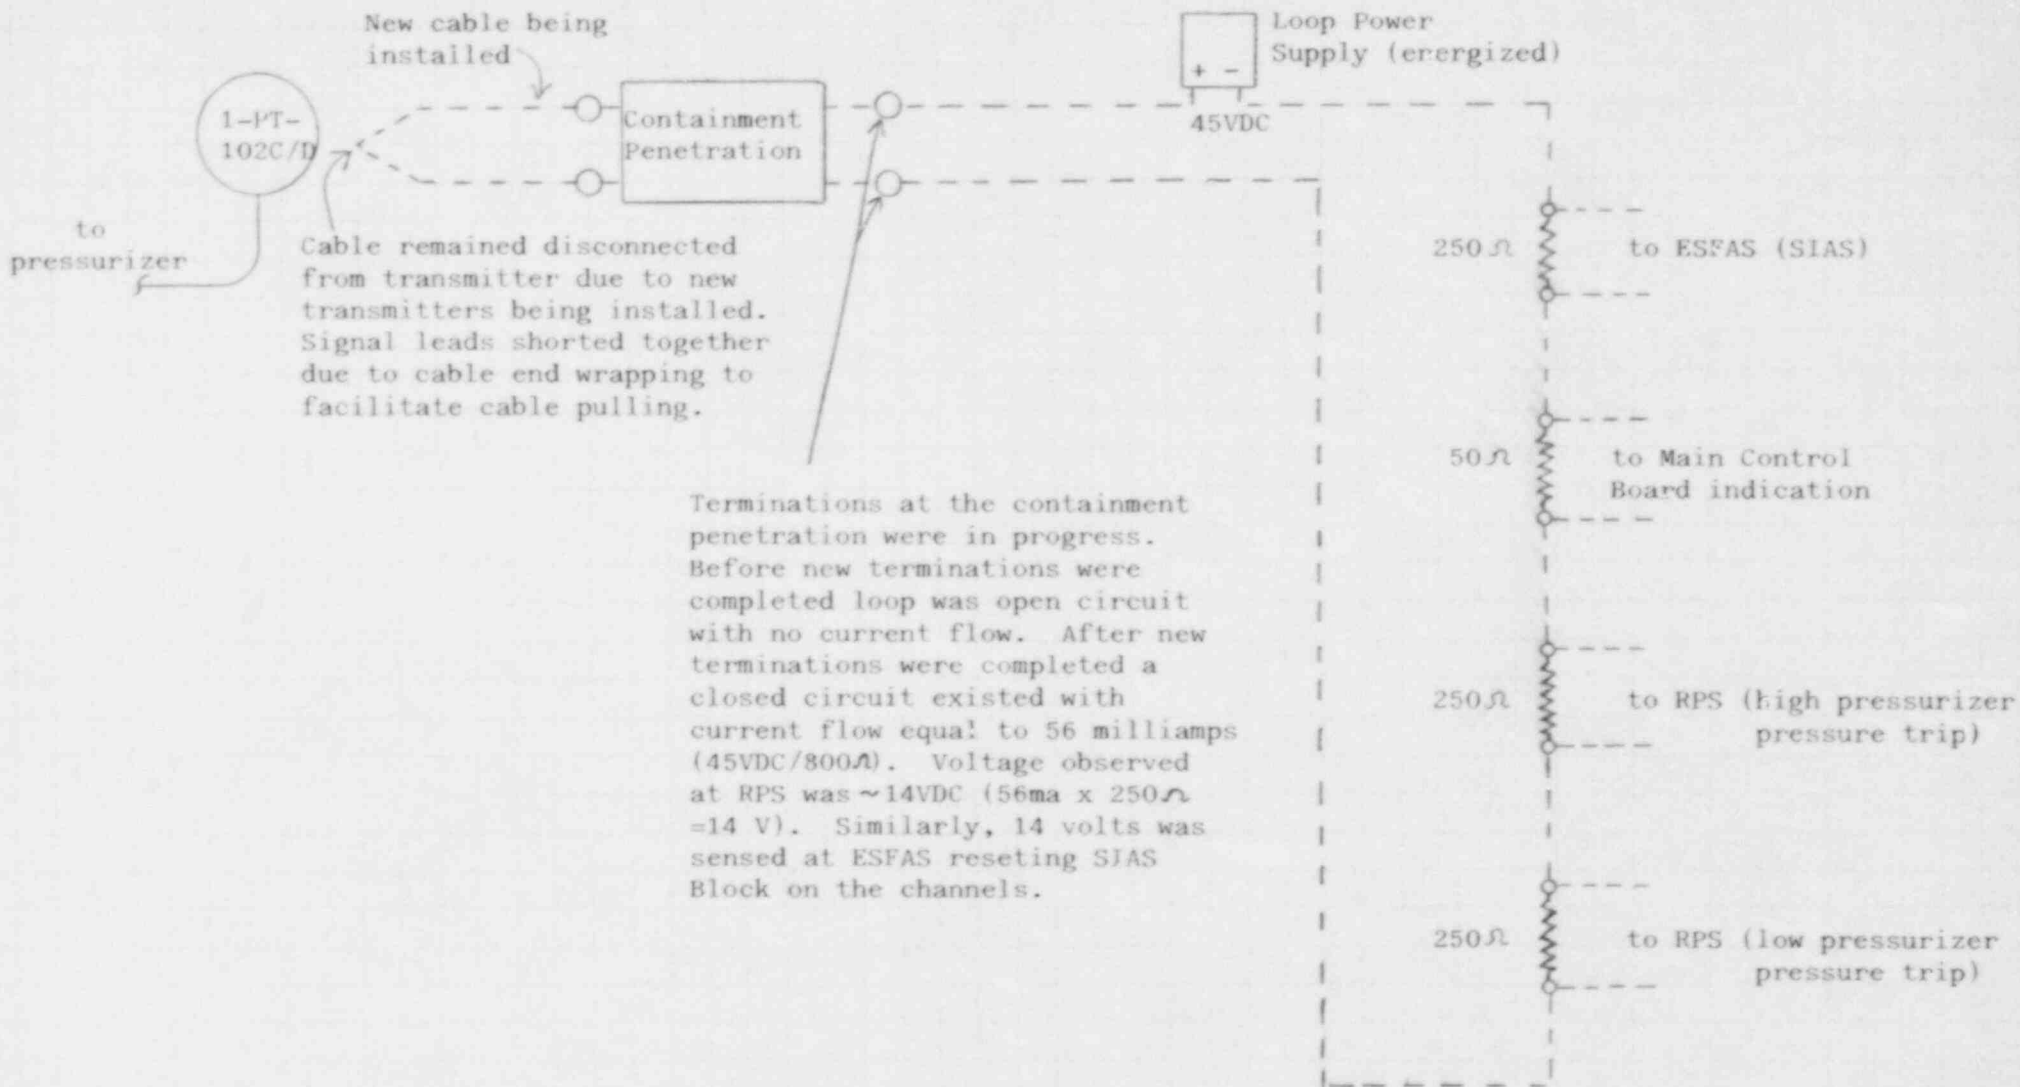
FIGURE 2

2B. Control Room Operators again reset the SIAS initiation from ESFAS and reestablished the SIAS block by dialing down the sensor channel setpoints by 1437. At this time Operators observed that the input voltages to channel C & D of the RPS were close to a 300% full scale value. This was due to the fact that the final termination had been made at the penetration (See Figure 2).

Channel ZF/ZG (C/D) Pressurizer Pressure Instrument Loops

2C. Operations requested all modification work be ceased and the power supply output slide links for the channel C & D or ZF and ZG pressurizer pressure loops located in the Control Room were opened depowering these instrument loops. This returned these loops to the down scale low value normal for the current plant mode.
