UNITED STATES
 NUCLEAR REGULATORY COMMISSION
 REGION II
 101 MARIETTA STREET, N.W.
 ATLANTA, GEORGIA 30323

Report Nos.: 50-424/88-18 and 50-425/88-20

Facility Name: Vogtle 1 and 2

Inspection Conducted: April 18-22, 1988 and May 2-5, 1988

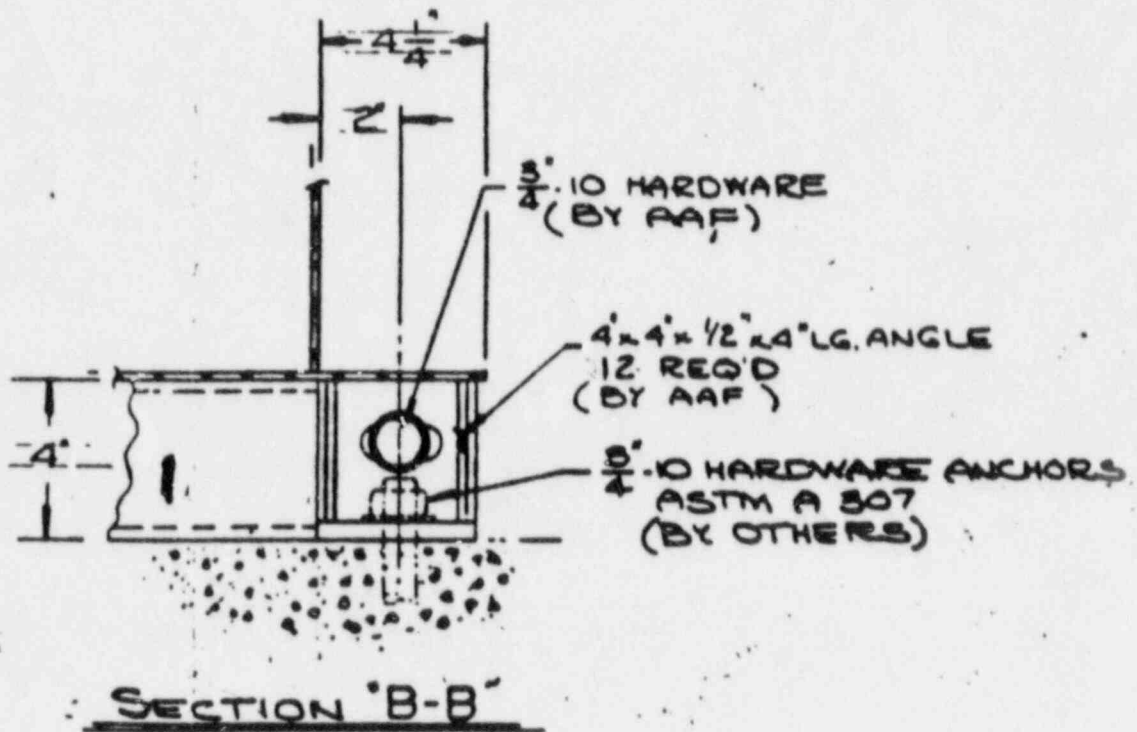
The applicable drawing available to the craftsman who installed the mounting bolts and the QC inspection who accepted the installation of the mounting bolts was 1X4AJ07-273-5 for unit one and 2X4AJ07-325-7 for unit two. Section "B-B" from both drawings (Reproducer as Attachment 1 herein) specifies "3/4-10 hardware provided by AAF." The applicable procedure available to the craftsmen and inspectors for the installation of Type A 307 bolting, P/L-F JP-14.2, "Process Control Program" Exhibit 16 specifies snug tight with the warning "Do Not Over Torque".

1. The bolted contact surfaces were not free of defects (the interfering fillet welds) which prevented solid seating and sound bearing of the component parts.
2. Washers were not installed under the bolt heads over the slotted holes.
3. A 5/8-inch diameter bolt was used when a 3/4-inch diameter bolt was required.

The AAF letter indicates that neither the Unit One or Two air filter housing assemblies were installed in accordance with the FSAR, in that the Unit One assemblies were installed with under-strength bolts that were not pretensioned (torqued) and the Unit Two assemblies were installed with appropriate strength bolts that were not pretensioned (torqued).
