INSPECTION RESULTS OF SONGS - 3 MSIV - 8205

San Onofre Nuclear Generation Station

Southern California Edison

INSPECTION RESULTS OF SONGS-3 MSIV 8205 (Revised)

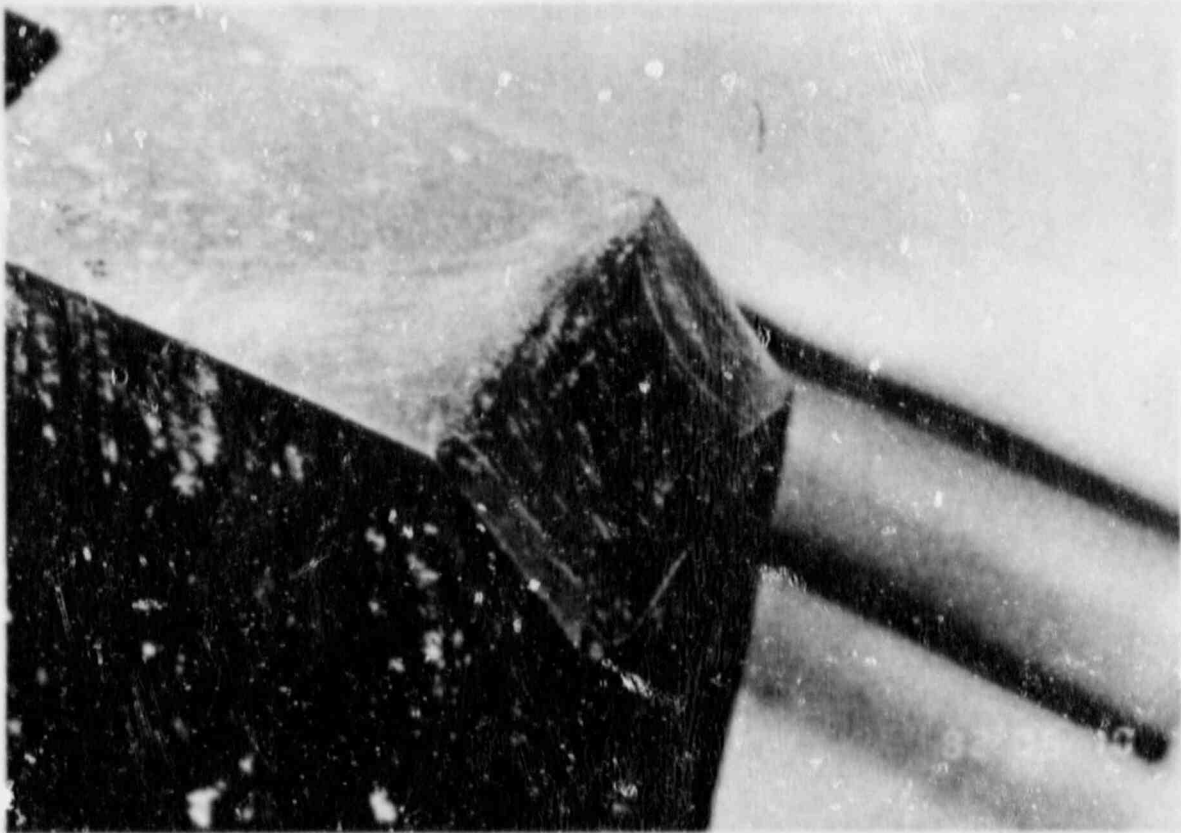
Figure 1

- (1) The two gate guide rails were inspected. The 45° chamfers, where the lev-r-lock arm and the guide rails interact during valve closing, do not show signs of galling. However, wear marks, a result of the lev-r-lock arm/guide rail chamfer contact during the close cycle, are evident. Figures 1 and 2 show close-up views of these chamfers.

A Close-up View of the Chamfer for the North Gate Guide Rail

The galling marks on the lev-r-lock arm shoes and guide rails were removed by grinding. The chamfer angles were decreased slightly by virtue of the grinding operations. The chamfer angles and shoes were polished to a better than 63 RMS surface finish to minimize the coefficient of friction. The decreased angles were identified by the dynamic impact analysis to result in decreased interaction forces between the shoes and guide rail chamfers. The sharp chamfer corners of all four guide rails were rounded off. Removing the chamfer corners will reduce the contact stress concentrations by providing a larger contact area between the shoes and guide rails. The reduced stress between the chamfers and the shoes in

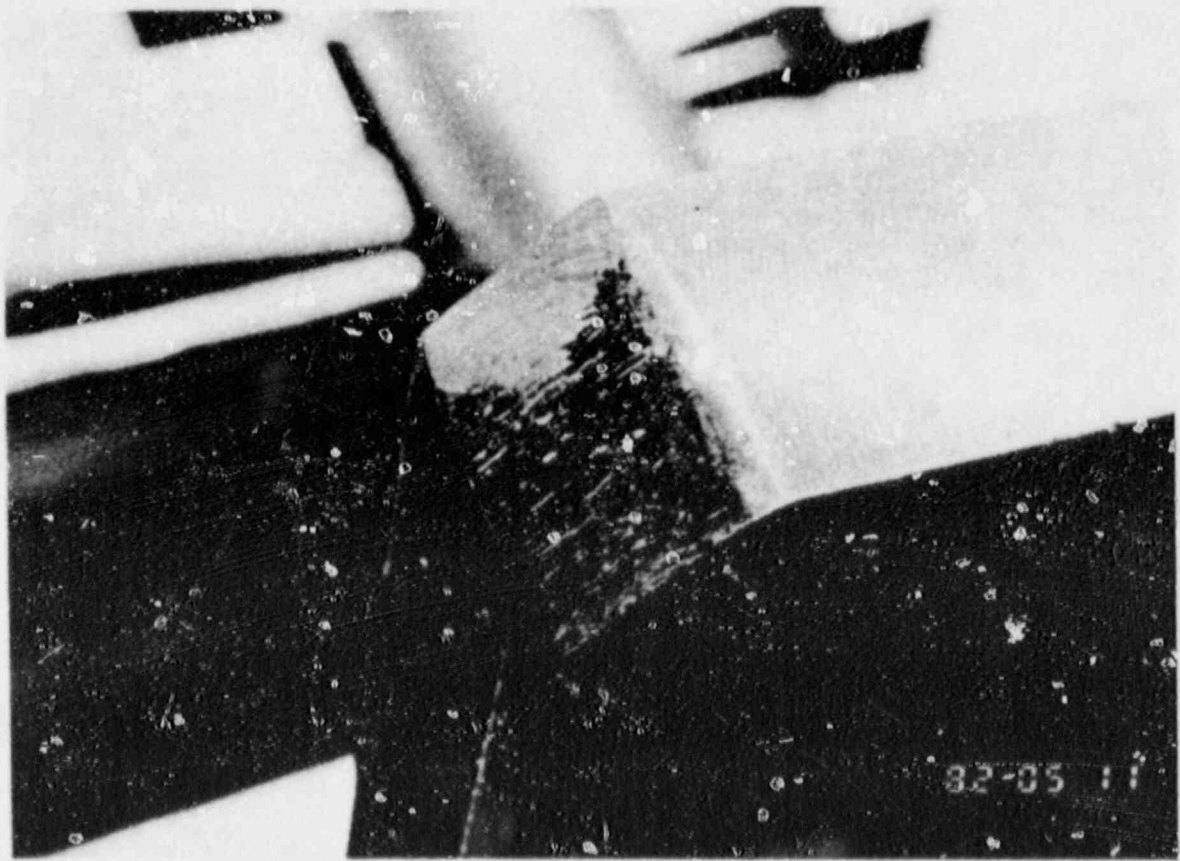
Figure 2

A Close-up View of the Chamfer for the South Gate Guide Rail

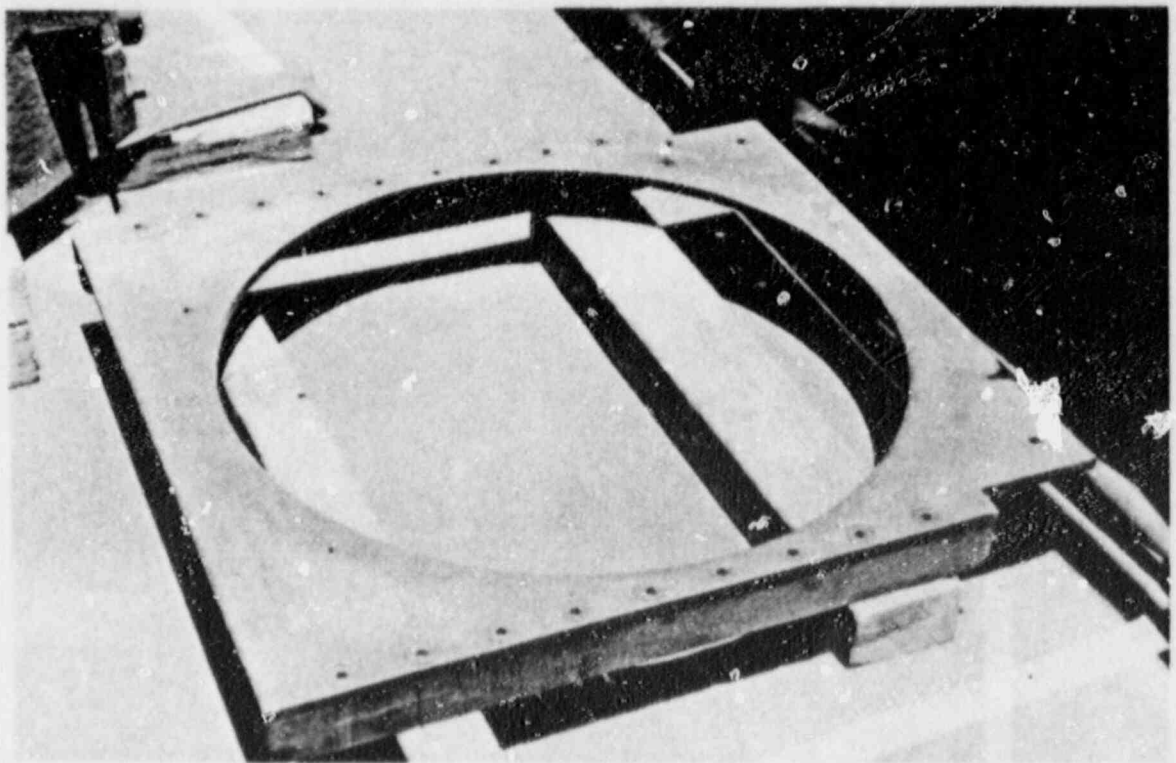
- (2) The 18 capscrews on the two gate guide rails were inspected. All of them appeared to be tight and all of the stakes on the capscrew heads were intact. The guide rails are tightly held against the valve skirt plate. Figures 3 and 4 are close-up views from various angles of the guide rail capscrews.

Figure 3
Various Views of Gate Guide Rails and Valve Skirt

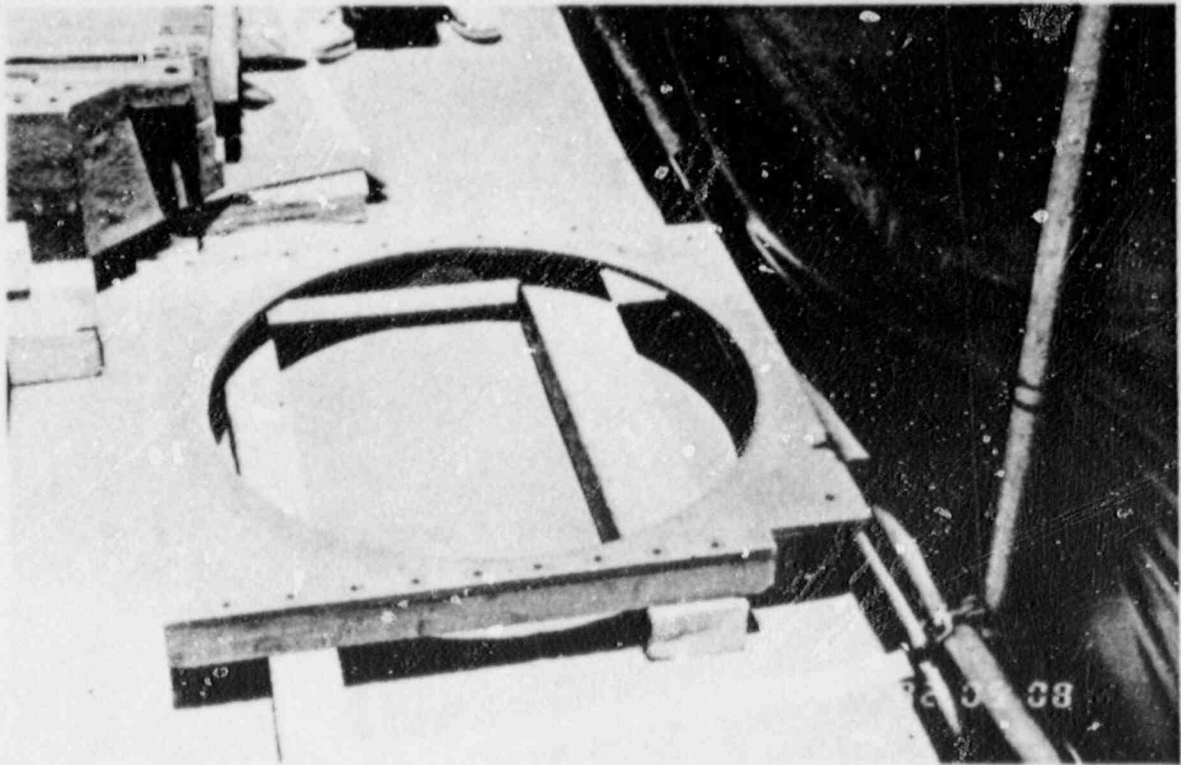
Figure 4

Various Views of Gate Guide Rails and Valve Skirt

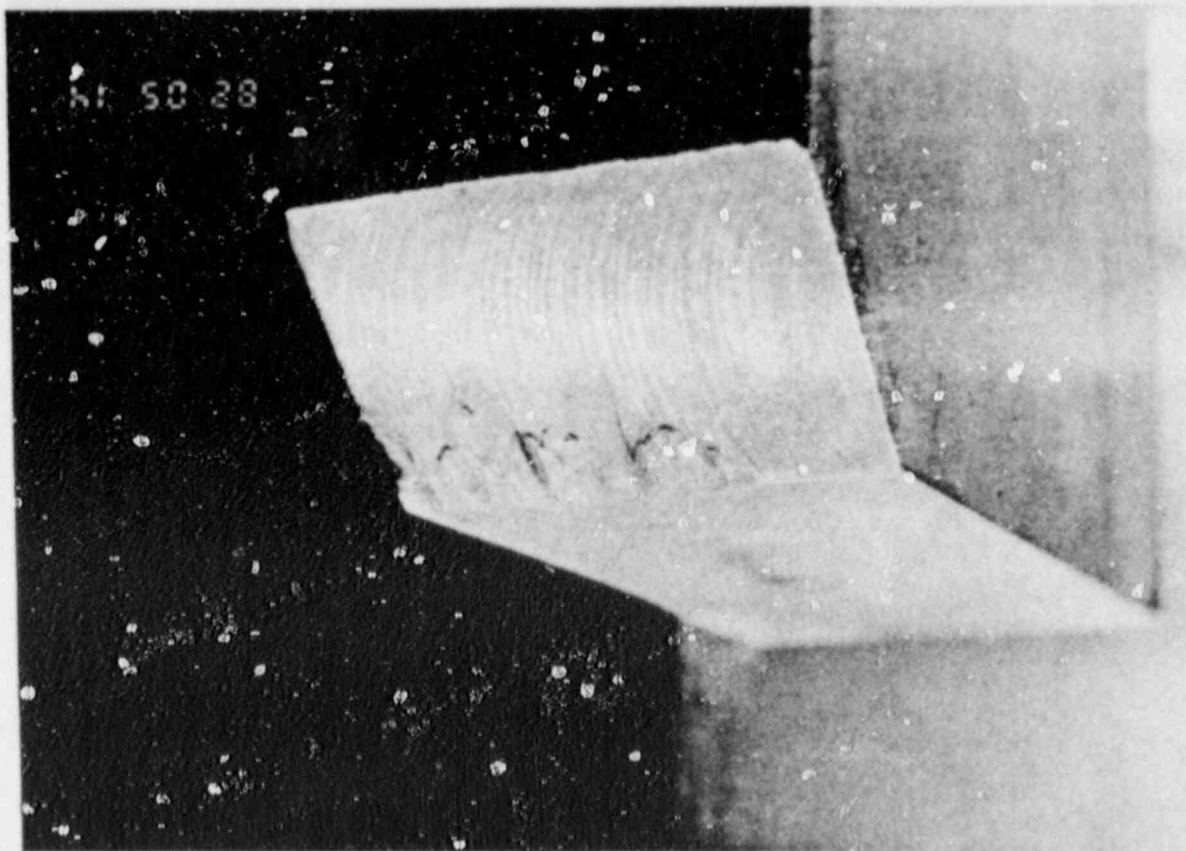
Figure 6

- (3) The two segment guide rails were inspected. The bottom 45° chamfers show signs of galling. The galling occurs on the one chamfer corner which consists of the transition from the bottom end of the rail to the chamfer face. The length of the area which has displaced metal is only approximately 1/4" long. Figures 5 and 6 are close-up views of galling marks for the north and south chamfers.

A Close-up View of the Chamfer for the South Segment Guide Rail

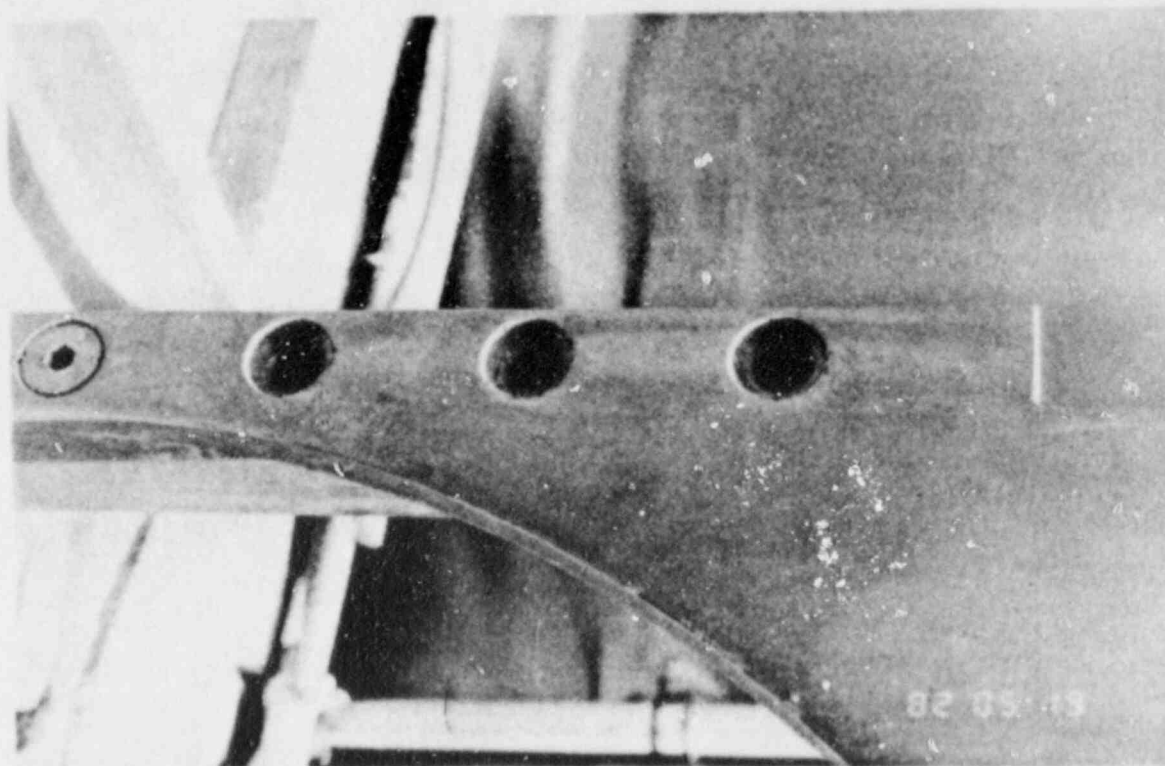
- (4) The capscrews on the opening guide rails were inspected. Three of the 18 capscrews were broken. All the broken capscrews are located at the bottom of the north opening guide rail. There is approximately a 0.050" gap between the north segment guide rail and the skirt plate at the edge of the rail where the three capscrews are missing. Figure 7 shows a close-up view of the empty capscrew holes.

The Location of Three Broken Capscrews

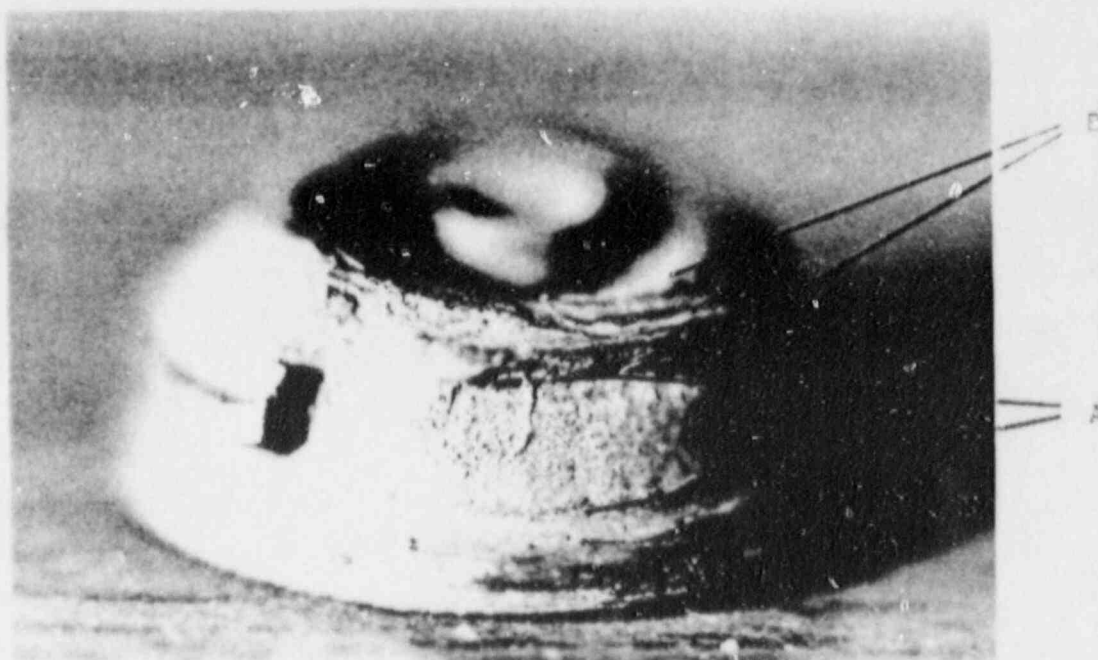
- (8) The fracture faces of the broken capscrews were visually inspected using a 32X light microscope. General deformation around the fracture face is evident for all three broken capscrews, indicating the failure mode is ductile overload.

- (9) The fracture paths of all three broken capscrews are at the bottom of the capscrews hexagonal hole. Figure 8 shows a close-up view of the fracture face. Significant magnetite build-up was found on the fracture faces of all three screws. This indicates that the failure did not recently occur. Figure 9 shows this build-up with a 1400 x magnification.

Fracture Face of the Broken Capscrew Stud

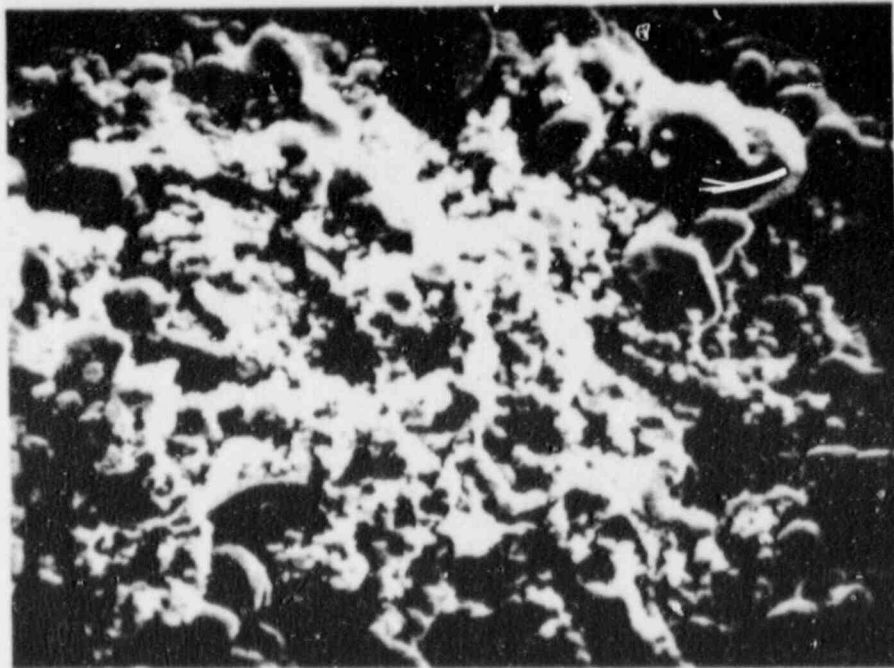
- 6) The fracture faces for all three broken capscrews have significant magnetite build-up, indicating that the fracture did not recently occur.
- 7) The general deformation around the fracture face suggests that the failure mode is ductile overload. However, due to the magnetite build-up on the fracture faces, detailed microscopic examination for dimple marks and fracture face characterization is not possible.

Figure 9
Magnetite Build-up on the Fracture Face (1400 X Magnification)

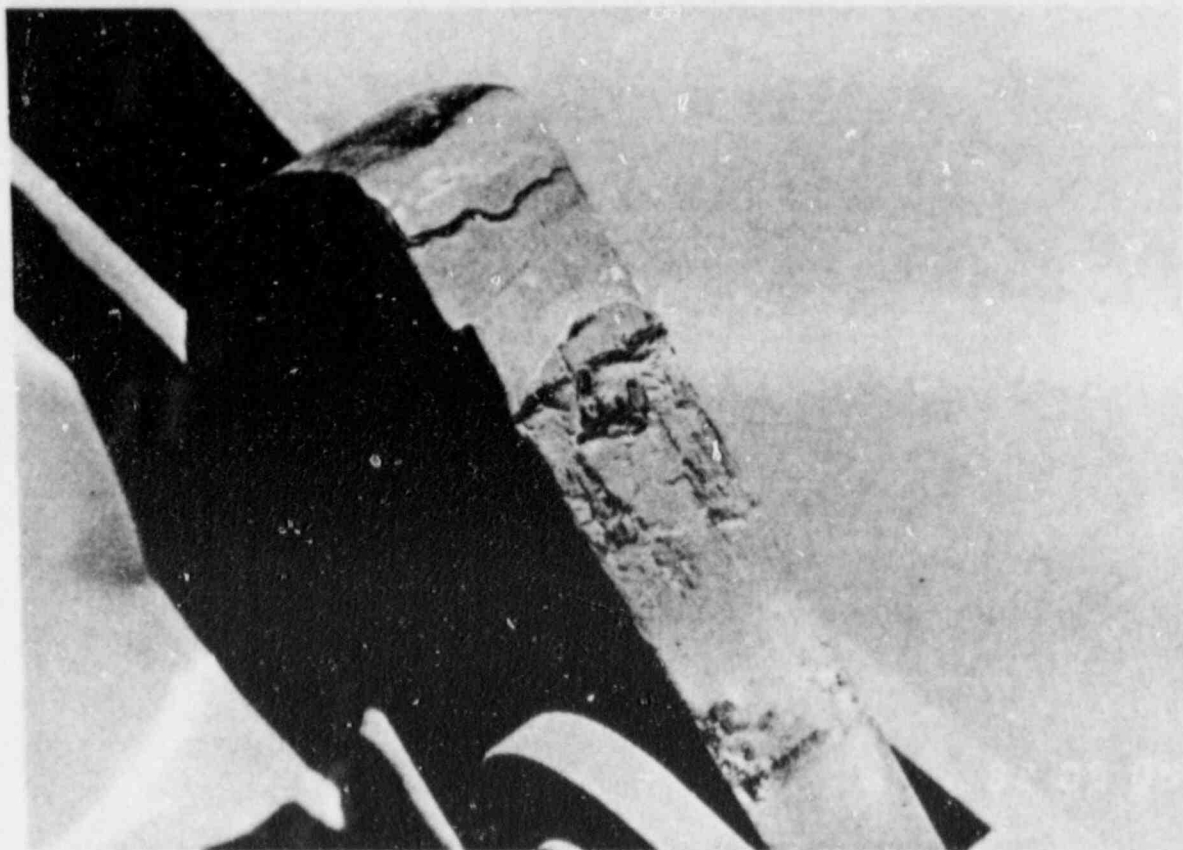
Figure 10

- (12) The shoes of both lev-r-lock arms were examined. Galling marks were found on the tops of both shoes (The shoe tops may contact the segment guide rails during the valve opening cycle). The shoe bottoms were smooth (The shoe bottoms may contact the gate guide rails during the valve closing cycle). Figures 10 and 11 are close-up views of the galling. Figure 12 is a distant view of the galling.

- 3) Based on the failure pattern and the deeper galling mark on the north arm shoe, it seems reasonable to conclude that the preferential loading of the north guide rail is a reasonable explanation for the fact that all three broken capscrews are located on the north guide rail. The preferential loading can be caused either by a shorter lev-r-lock arm or by the out-of-squareness of the guide rail skirt plate installation.

A Close-up View of the Galling Marks on the North Arm Shoe

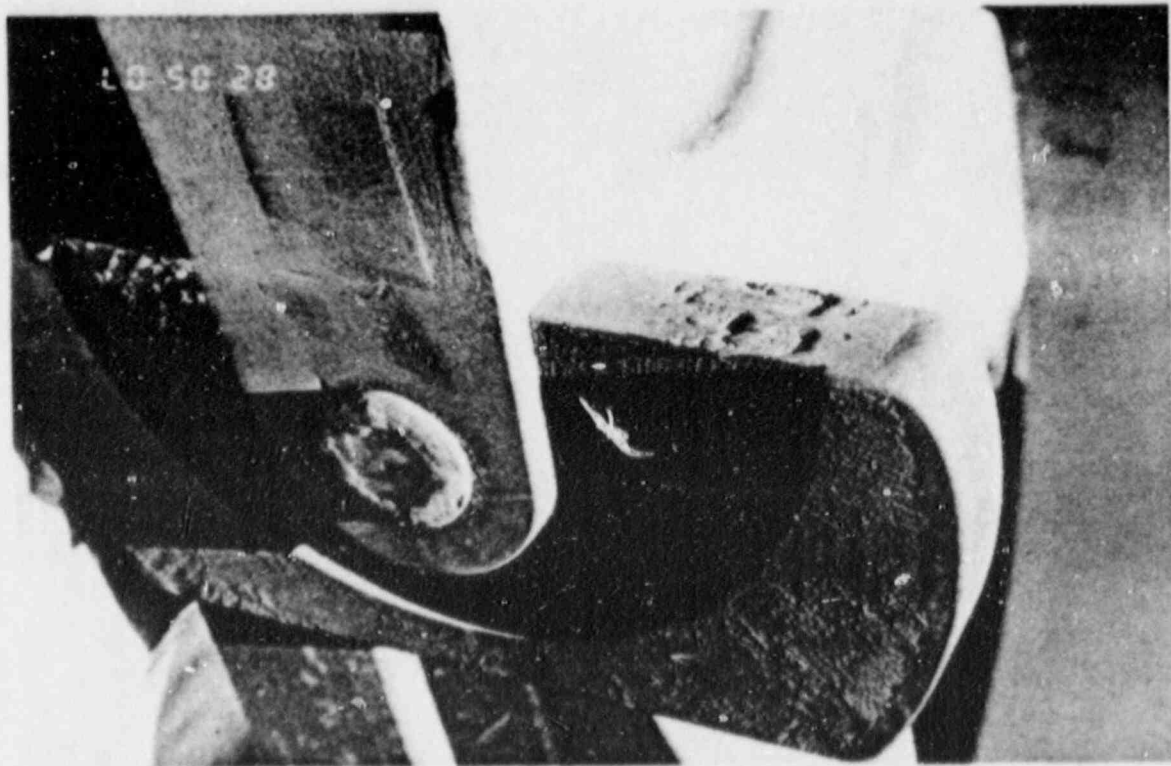
Figure 11

A Close-up View of the Galling Marks on the South Arm Shoe

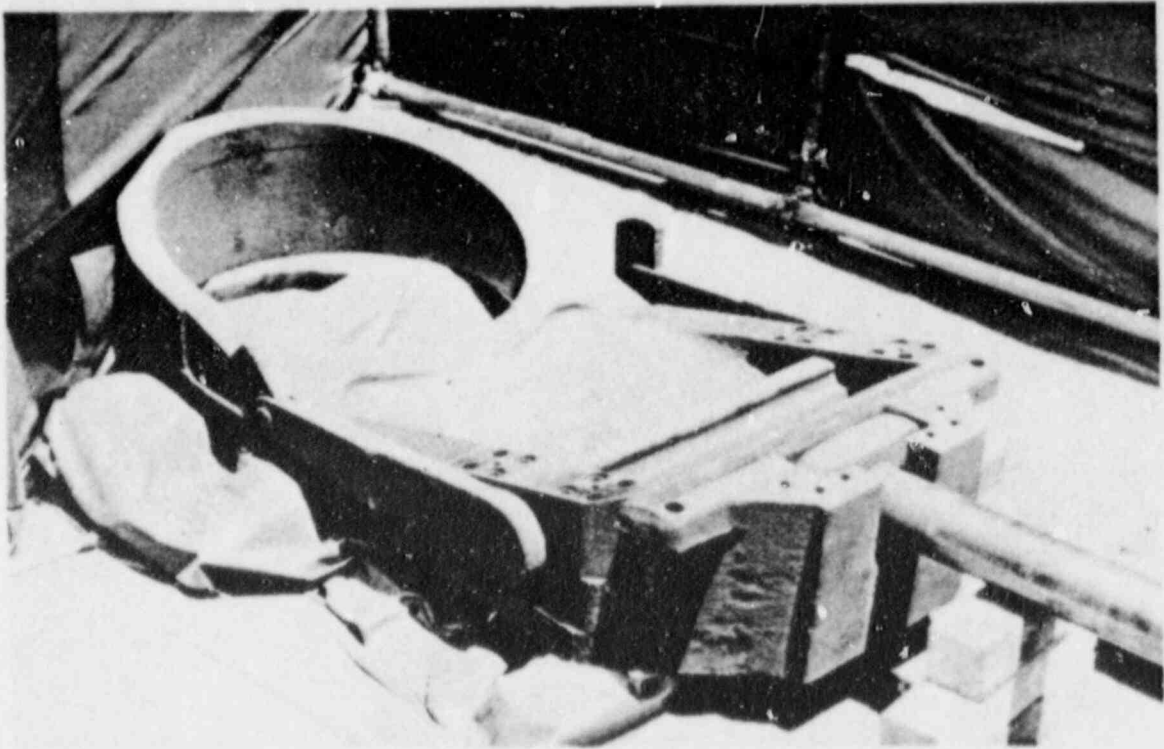
Figure 12

A Distant View of the Galling Marks on the Arm Shoes

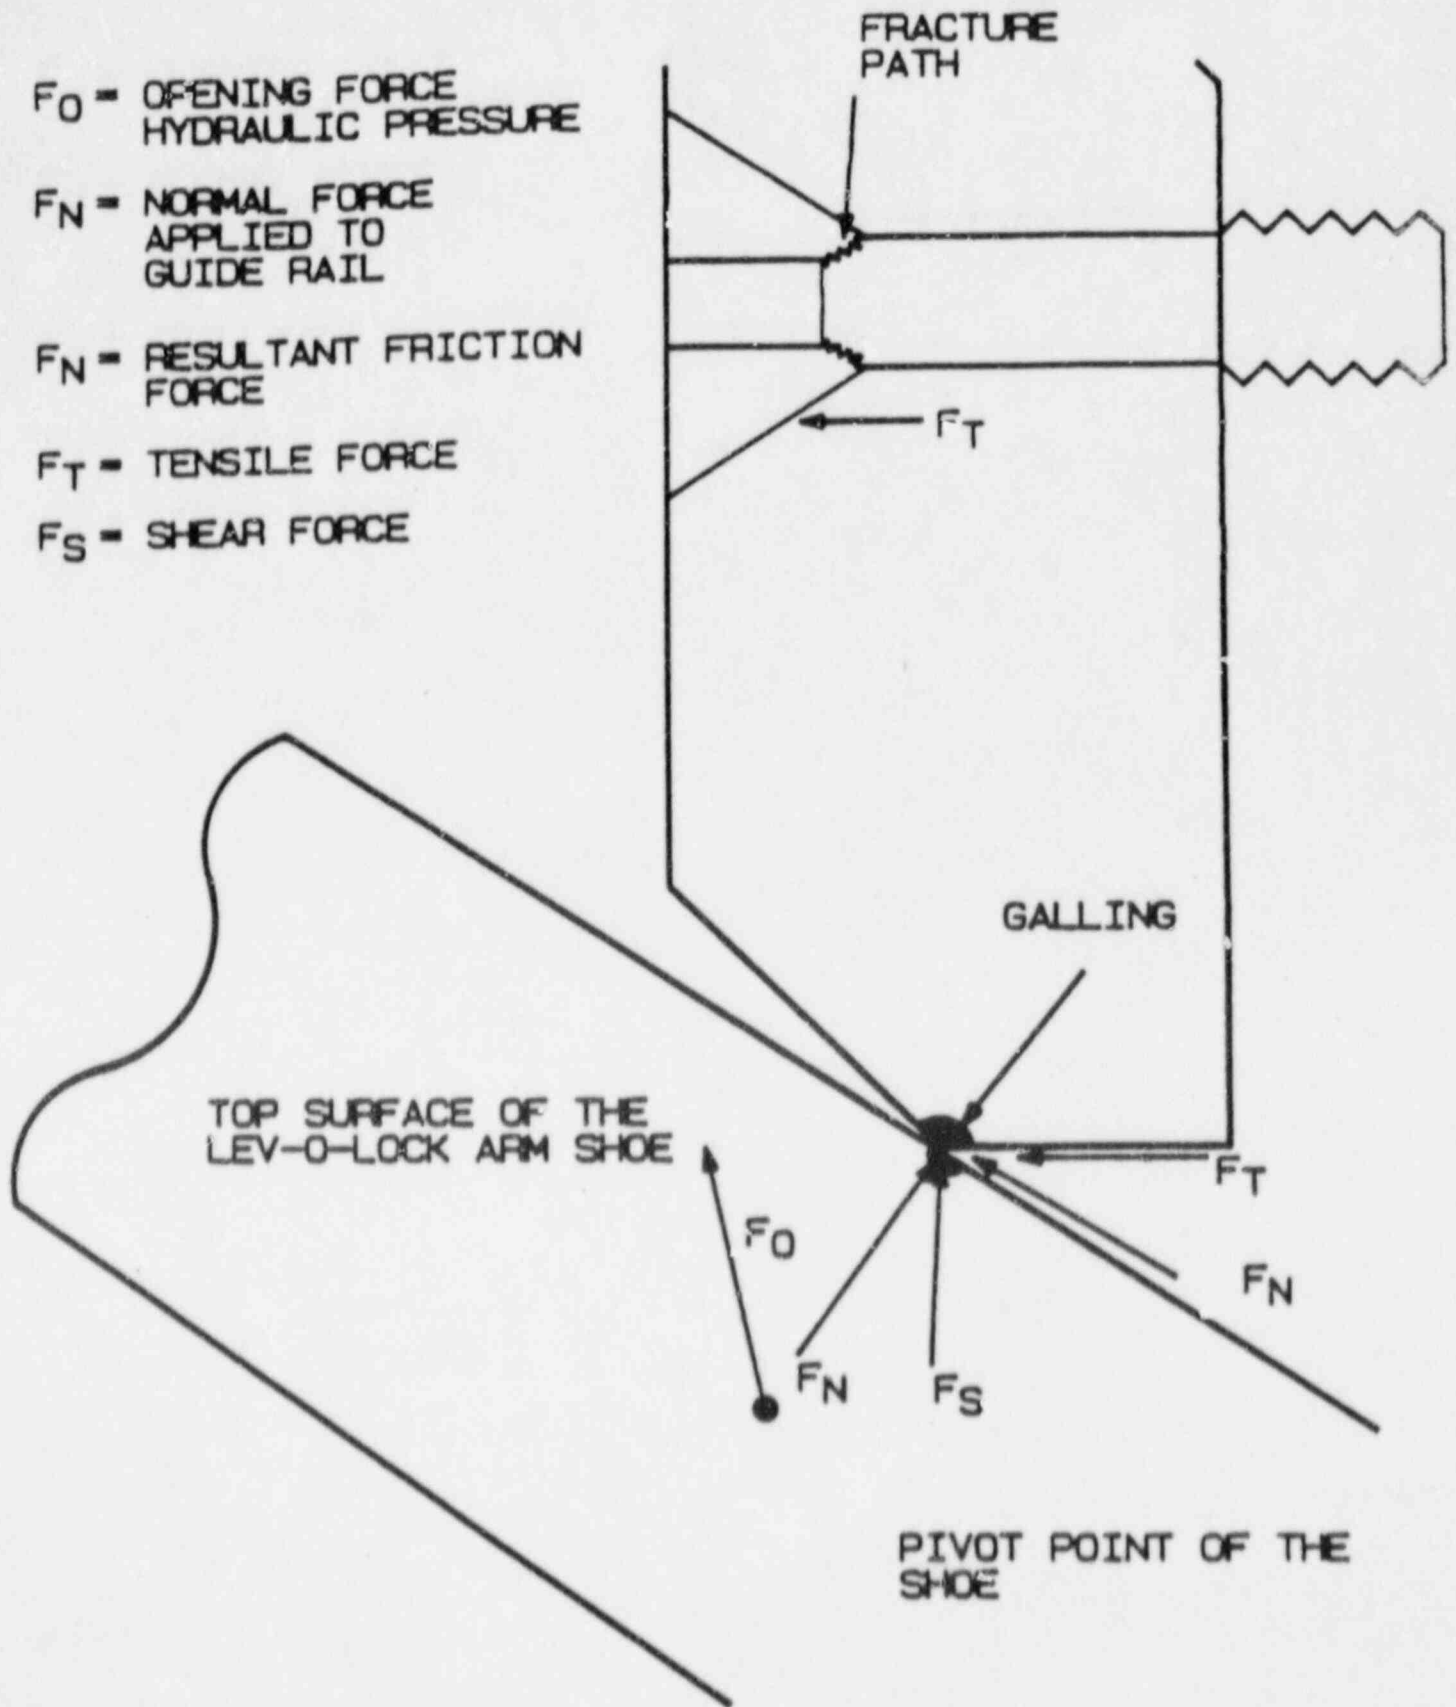
- 1) The fracture of the three broken capscrews seems to be a result of interference with the lower edge of the chamfer and the top of the north arm shoe. Figure A-1 illustrates this interference during valve opening. There are galling marks in the area of interference on both the shoe and the chamfer of the guide rail.
- 2) The galvanic corrosion, if any, is insignificant. This is supported by the absence of any pitting on the broken capscrew threaded areas inspected by fractography.

Based on a stress analysis documented in Appendix A of this report, the maximum tensile force generated by the interaction between the lev-r-lock arm and the guide rail is estimated to be approximately 95,300 lbf. The interaction is assumed to occur with a galling process between two interacting parts. The tensile force needed to fracture a capscrew is estimated to be 32,800 lbf, also considering the co-existence of the shear force. Since 32,800 lbf is less than 95,568 lbf, it is reasonable to conclude that the bottom two to three capscrews of the only interacting guide rail (north guide rail) will fracture.

Forces Resulting from Interference
