UNITED STATES  
**NUCLEAR REGULATORY COMMISSION**  
 REGION II  
 101 MARIETTA ST., N.W.  
 ATLANTA, GEORGIA 30323

Report Nos.: 50-327/88-34 and 50-328/88-34

Facility Name: Sequoyah 1 and 2

Inspection Conducted: June 6 - July 11, 1988

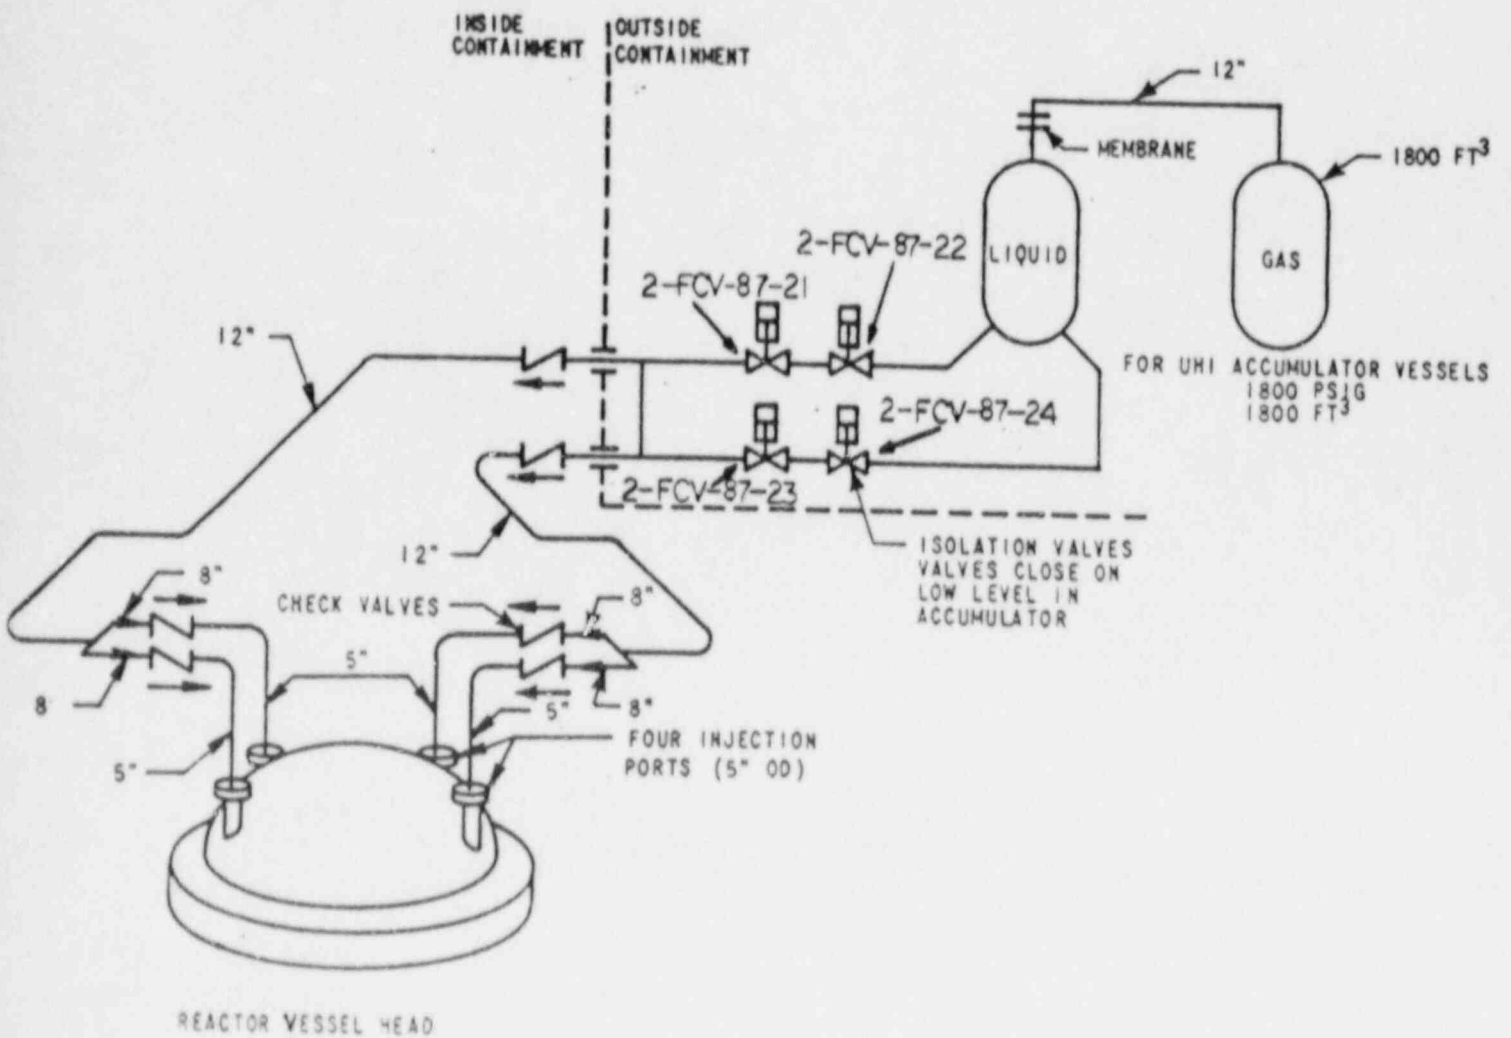
Upper Head Injection System Schematic

On 07/05/88, at 2:30 p.m., Unit 2 operators received indication that the pressure indicator (2-PIS-87-21) for UHI isolation valve 2-87-21 was erratic and indicating high (4000 psig) when all previous readings were steady at approximately 3000 psig. The pressure indicator is the sole method on-line to monitor the condition of the isolation valve's actuator. The actuator is a hydraulic actuator pre-charged with nitrogen to 1400 psig, then hydraulically charged to

pressure was found to be 1165 psig, which is less than the minimum of 1300 psig specified as the lower limit to ensure operability.

The loss of nitrogen was determined to be due to a leaking nitrogen charging valve (Schrader valve). This valve was replaced, the nitrogen side recharged to 1400 psig, and the valve returned to service at 3:55 p.m. on 07/10/88.

1. SI-744 IS BEING REVISED TO PROVIDE ACTIONS TO AID IN THE DETERMINATION OF UHI VALVE OPERABILITY. A RESPONSE TIME TEST WILL BE REQUIRED AFTER A CERTAIN NUMBER OF CHARGES, DEPENDENT UPON THE ORIGINAL NITROGEN PRECHARGE.
2. OPERATIONS PERSONNEL WILL BE TRAINED ON HOW TO INTERPRET THE ACTIONS OF SI-744.
3. AN EVALUATION WILL BE MADE CONCERNING INCREASING THE NITROGEN PRESSURE IN THE ACCUMULATORS SUCH THAT ADDITIONAL CHARGES ARE ALLOWED BEFORE A PRECHARGE CHECK TEST IS REQUIRED.
4. THE NON-TS SIS WILL BE REVIEWED AND REVISED AS APPROPRIATE TO CLARIFY THE ACTIONS WHICH SHOULD BE TAKEN IN THE EVENT THE ACCEPTANCE CRITERIA ARE NOT MET.
5. THE UHI SYSTEM REMOVAL PLAN WILL BE PURSUED. WESTINGHOUSE HAS PERFORMED PRELIMINARY ANALYSIS WHICH INDICATES THE UHI SYSTEM CAN BE REMOVED AT SQN.
