*Oyster Creek Core Spray System
Inspection Program - 17R*

*Topical Report No. TR-119
Project No. 320005*

OYSTER CREEK CORE SPRAY SPARGER SYSTEM
INSPECTION PROGRAM

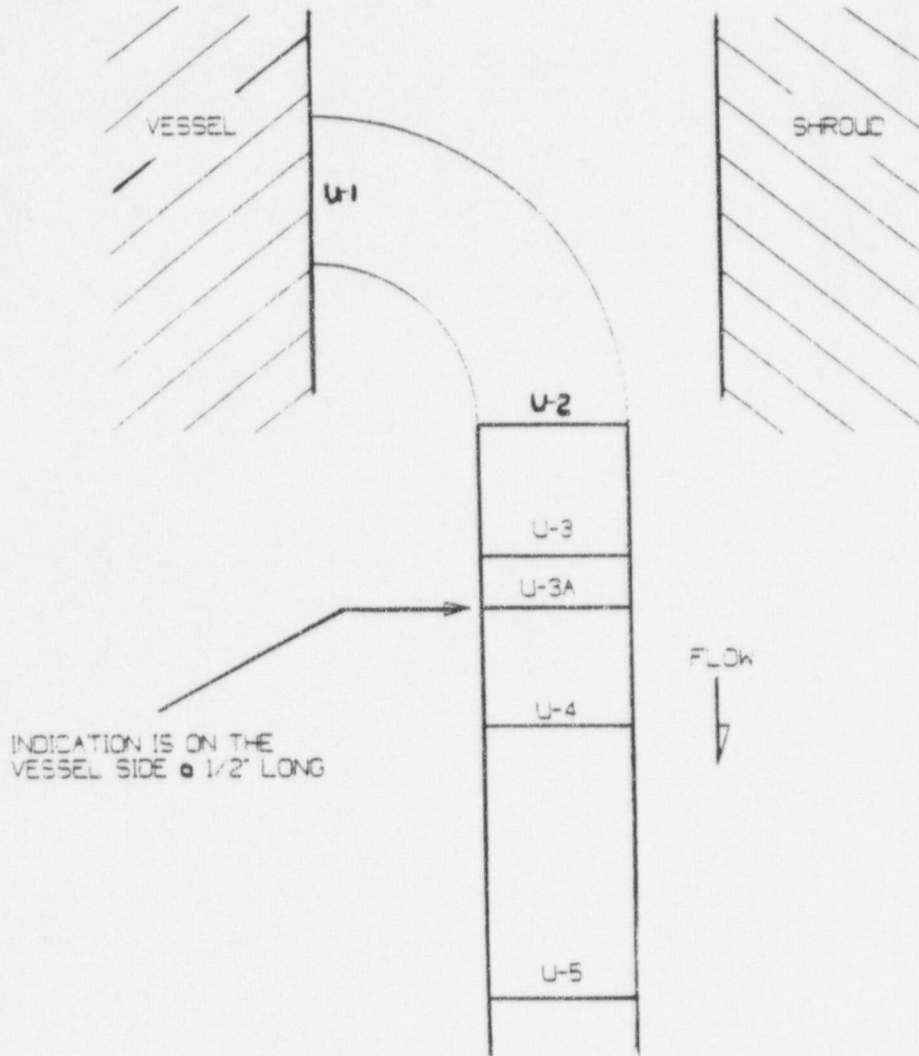
FIGURE 6

- Two linear indications originally observed during outage 14R in the annulus piping in system II, weld U-3A appear to be a weld pass between 2 beads, as determined after cleaning. No changes and no air bubbles were observed emanating from this location during the air test.

CORE SPRAY PIPING WELD ID'S
INDICATION AT WELD U-3A

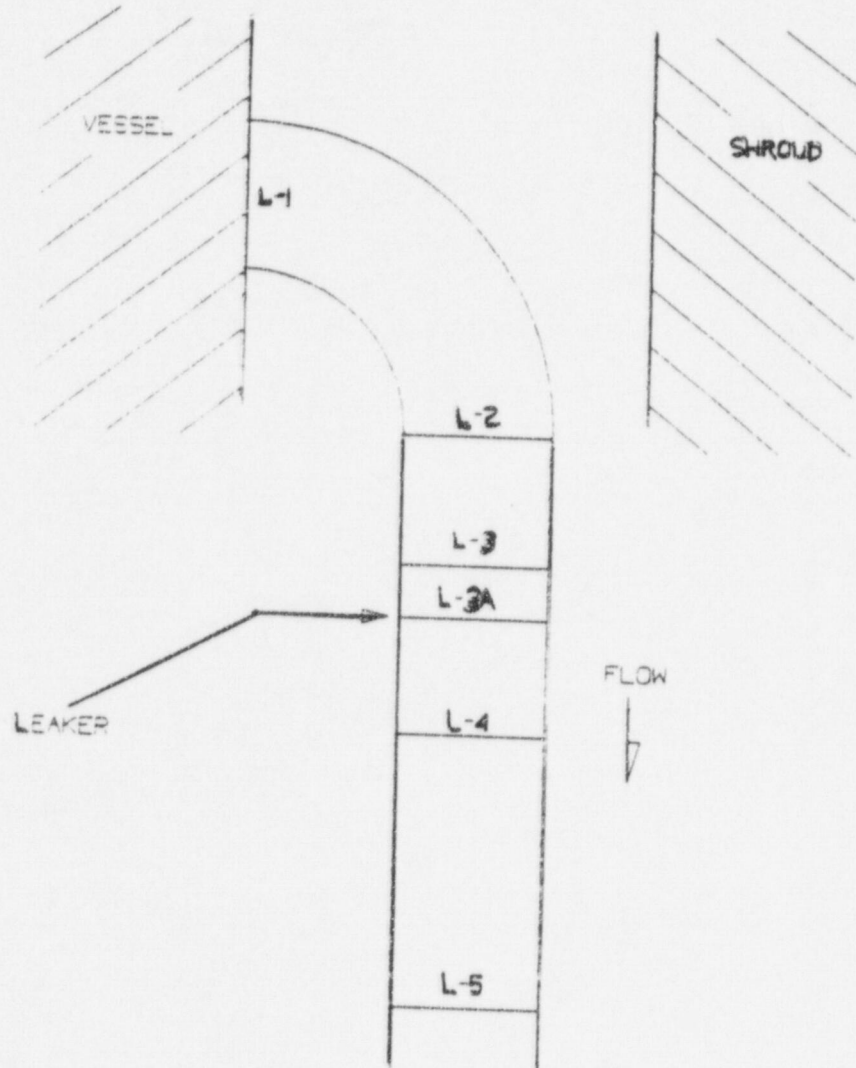
FIGURE 7

Inspection of the sparger during the air test noted air bubbles coming from the nozzles. With no means of isolating the nozzles, air escaping is normal during this examination. Inspection of the balance of the lower spargers on system I revealed no additional air leaks. Air bubbles were observed from the downcomer at 240°, weld L-3A as previously observed.

- One rounded, through wall, indication was observed in the toe of weld designated as L-3A. This weld is in System I of the annulus piping. Visual examination during 17R and previous air test revealed no change in this indication since it was discovered in 14R. This indication was determined to be a fabrication flaw.

CORE SPRAY PIPING WELD IDS
LEAKER AT WELD L-3A
