LICENSEE EVENT REPORT (LER)

FACILITY NAME (1) Palo Verde Unit 2	DOCKET NUMBER (2) 050000529	PAGE (3) 1 OF 03
--	--------------------------------	---------------------

TITLE (4)
MSIS Actuation Due to an Incorrect Amperage Fuse

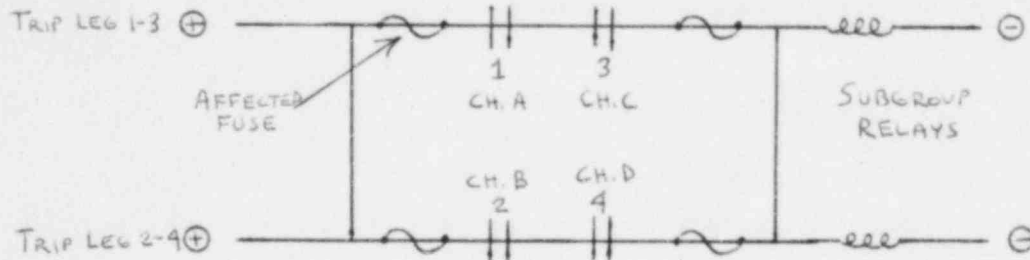
The cause of this event was an undersized fuse (FU) in the 1-3 leg for Train B MSIS circuitry. With the 2-4 leg in test, all circuit current was passing through this fuse, which resulted in exceeding its current rating and causing the fuse to open.

The root cause of the event was an incorrect amperage fuse (vendor: Bussman, Model Number: KLM4), which caused the trip on the MSIS 1-3 leg. The fuse was found to be a 4 amp fuse in a location where the design calls for an 8 amp fuse. An investigation is being conducted into the root cause of how and when the fuse was installed.

As an immediate corrective action, an 8 amp fuse was installed in the affected path. As corrective action, a work order has been developed to verify that the fuses in similar circuits in Unit 1 are appropriately sized. Performance of the work order is scheduled during the March 1986 outage. Work orders have been completed to verify all fuses in similar locations in Unit 2. The surveillance test has been satisfactorily completed in Units 1 and 2.
