LICENSEE EVENT REPORT (LER)

FACILITY NAME (1) **Palo Verde Unit 2** DOCKET NUMBER (2) **050005219** PAGE (3) **1 OF 013**

TITLE (4) **MSIS Actuation Due to an Incorrect Amperage Fuse**

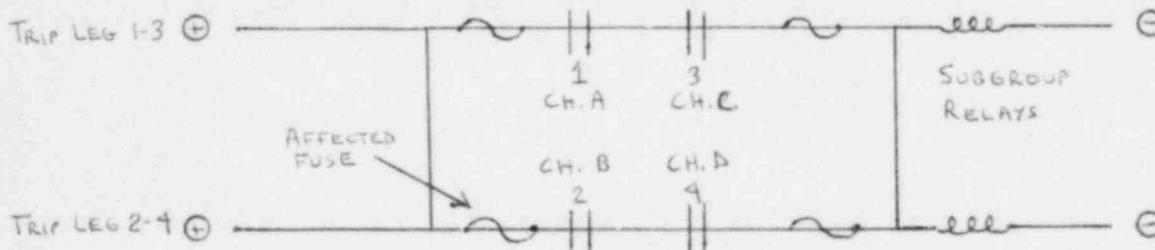
The cause of this event was an undersized fuse (FU) in the 2-4 leg of the Train A MSIS logic trip path. The 2-4 leg fuse was unable to support the current load of both legs, resulting in the actuation of the A Train MSIS devices. An investigation determined that the A Train schematic was not correct. A discrepancy between the PPS initiation panel schematics was discovered in that the indicated fuse ratings were different between the two ESFAS trains for the same ESFAS features.

The root cause of the event was an incorrect amperage fuse (vendor Bussman, Model Number: KLM4), which caused the trip on the MSIS 2-4 leg. The fuse was found to be a 4 amp fuse in a location where the panel calls for an 8 amp fuse. An investigation is being conducted into the root cause of how and when the fuse was installed.

As an immediate corrective action, an 8 amp fuse was installed in the affected path. As corrective action, an engineering evaluation has been submitted to the vendor for his evaluation and corrections of the schematics. A work order has been developed to verify that the fuses in similar circuits in Unit 1 are appropriately sized. Performance of the work order is scheduled during the March 1986 outage. The surveillance test has been satisfactorily completed in Units 1 and 2. Work orders have been completed to verify the fuses in similar locations in Unit 2.
