NUCLEAR REACTOR LABORATORY
AN INTERDEPARTMENTAL CENTER OF
MASSACHUSETTS INSTITUTE OF TECHNOLOGY

Subject: Reportable Occurrence 50-20/1986-1, License R-37
Detection of a Blister on a Fuel Plate

1. Report No: 50-20/1986-1
- 2a. Report Date: 28 February 1986
- 2b. Occurrence Date: 19 February 1986
3. Facility: MIT Nuclear Reactor Laboratory
138 Albany Street
Cambridge, MA 02139
4. Identification of Occurrence:

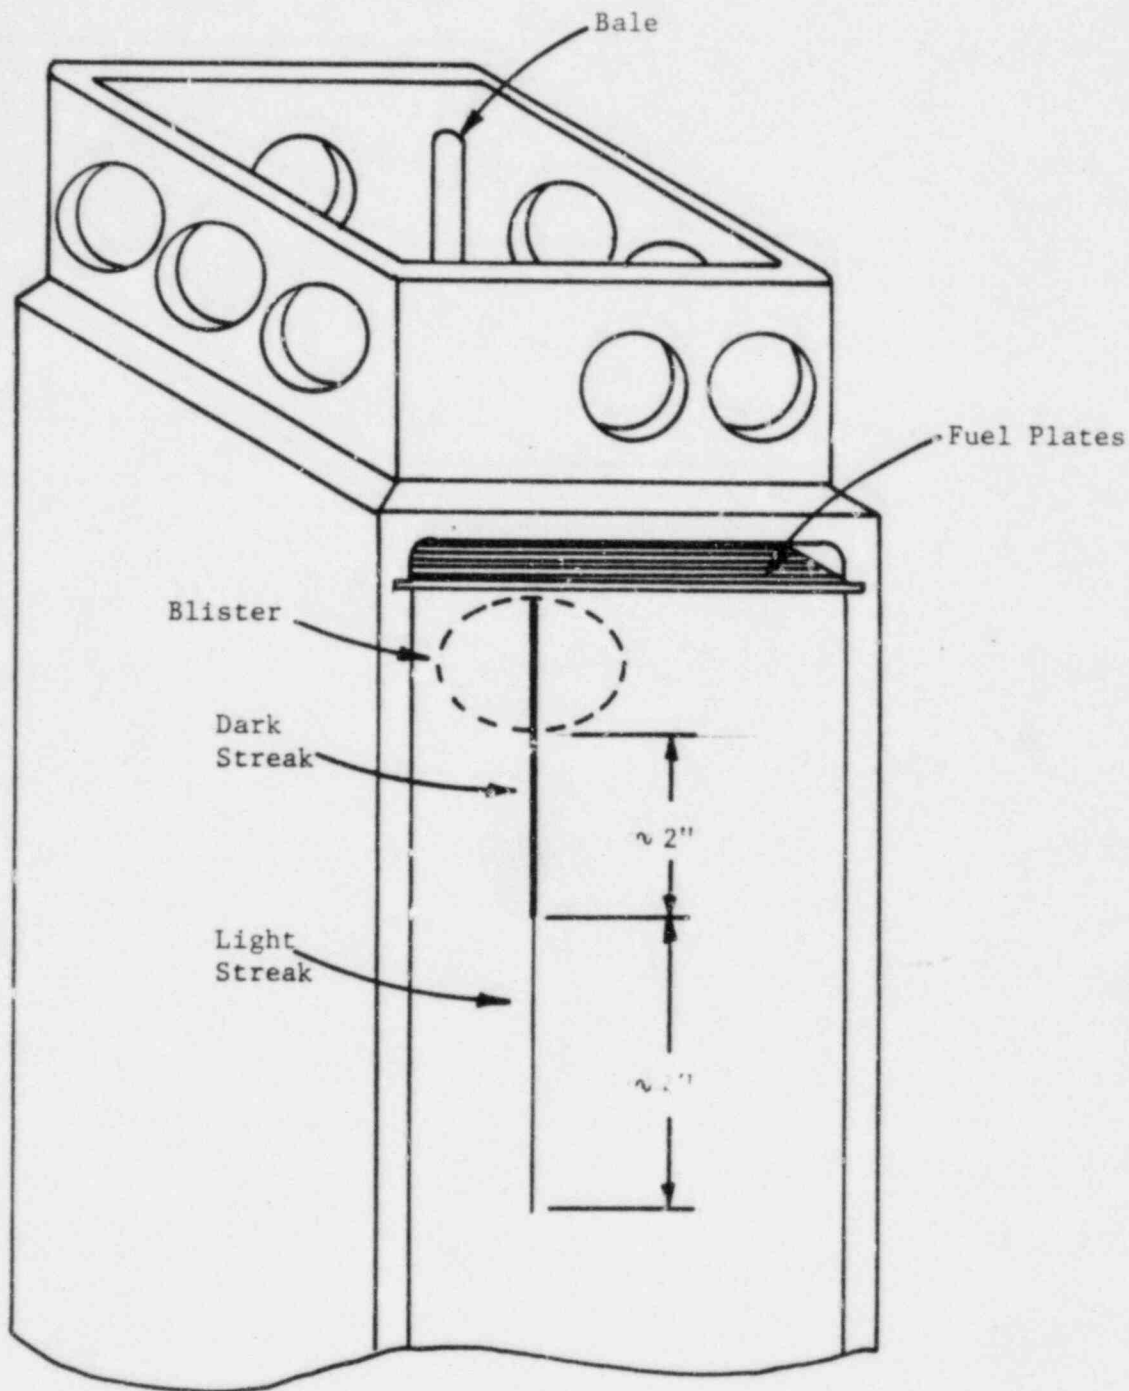
Schematic of Fuel Element MIT-11 Showing Blister

The apparent cause of this occurrence is a blister on the surface of one of the outer fuel plates of element MIT-11. The presence of this blister was detected during a visual examination (under water) of the element once it had been removed from the core. (The blister is not visible with the element in the core.)

The blister is about 3/4 inches in width and 3/8 inches in height. It is at the extreme end of the fuel plate in the "dog-bone" region. The area of the fuel plate that now contains the blister is such that it would have been at the lower end of the fuel element (i.e., high flux region) for all of its time in core until 23 Sept. 1985 when element MIT-11 was inverted. Upon inversion, the area now covered by the blister became the upper end of the element (i.e., low flux region). A streak that runs vertically through the center of the blister is visible. The streak is initially quite dark and then somewhat lighter. The cause of this blister can not be determined without the use of hot cells and other special facilities not available at MIT. However, the existence of the dark streak suggests staining of the fuel plate, possibly as the result of an inclusion of foreign material at the blister site or from fission products leaked from the fuel matrix.

A simplified drawing showing the location of the blister on MIT-11 is attached to this report. One copy of a slide showing the blister has been sent to Region I. This slide was taken during the aforementioned visual inspection. The image was taken through twelve feet of water.

It was not possible to determine if the blister also existed on the inside of the fuel plate in question because the element's end adapter blocks the view. All elements adjacent to MIT-11 were removed from the core and their exterior plates visually examined. No abnormalities were found.

The immediate corrective action consisted of removing element MIT-11 from the core. Fission product gas levels subsequently decreased and are currently what was measured prior to the occurrence. All other in-core elements have been "sipped" and no abnormalities were found.
