LICENSEE EVENT REPORT (LER)

FACILITY NAME (1) **Wolf Creek Generating Station** DOCKET NUMBER (2) **0 5 0 0 0 4 8 2** PAGE (3) **1 OF 0 6**

TITLE (4) **Hydraulic 4-Way Valve Failures on Main Steam Line Isolation Valve Actuators**

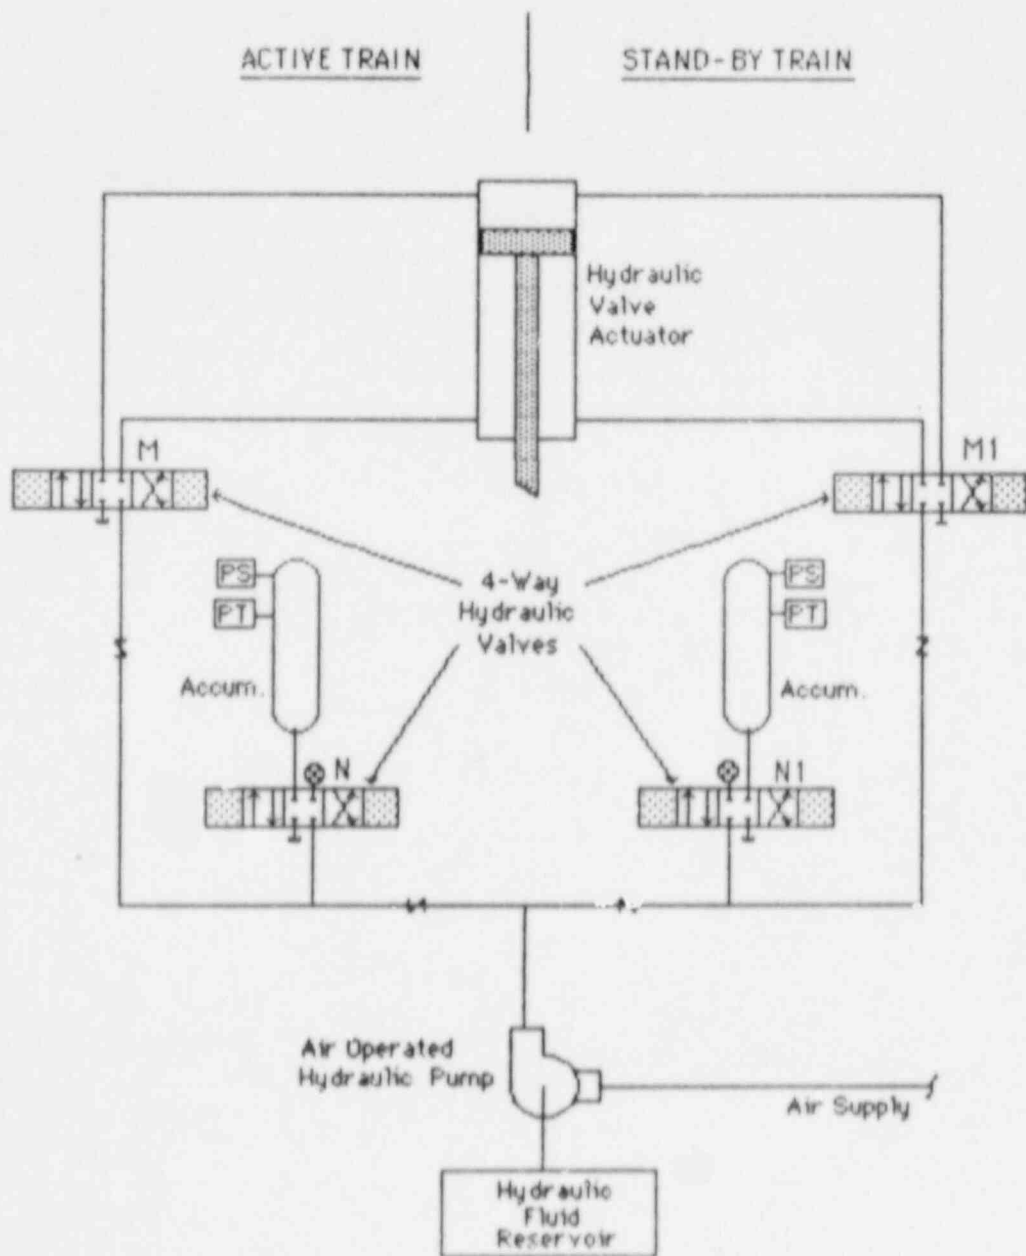
Figure 1

Each MSLIV and MFIV has two redundant hydraulic trains supplying actuation fluid to the valve hydraulic actuator. Each train consists of an accumulator [ACC] charged to 5000 pounds per square inch, gauge (psig), a 4-way valve ("N" position) controlling the accumulator discharge flow and a 4-way valve ("M" position) directing the hydraulic fluid to the appropriate open or close ports on the hydraulic actuator (see figure 1). The accumulators are charged via a common air operated hydraulic pump [P] which takes suction from the hydraulic reservoir [RVR].

For normal valve positioning (slow mode of operation), the output of the hydraulic pump is directed to the valve actuator by the "M" or "M1" 4-way valve. During this mode of operation, the "N" or "N1" 4-way valve is centered, isolating the accumulator from the hydraulic circuit. During an Engineered Safety Features Actuation Signal (ESFAS) (fast closure), the precharged accumulators are discharged through the "N" position 4-way valves and the hydraulic fluid is directed to the valve actuator by the "M" position 4-way valves. The 4-way valves installed in the "N" positions are continually subjected to accumulator pressure of 5000 psig. Any leakage of hydraulic fluid from these valves is detectable as decreasing accumulator pressure which is displayed and alarmed in the Control Room.

MAIN STEAM LINE and MAIN FEEDWATER ISOLATION VALVES
