LICENSEE EVENT REPORT (LER)

FACILITY NAME (1) Peach Bottom Atomic Power Station - Unit 3 DOCKET NUMBER (2) 050000278.1 OF 015 PAGE (3)

TITLE (4) PCIS Group II Reactor Water Cleanup System Isolation Signal as a Result of a Loss-of-Power Caused by a Tie Breaker Malfunction

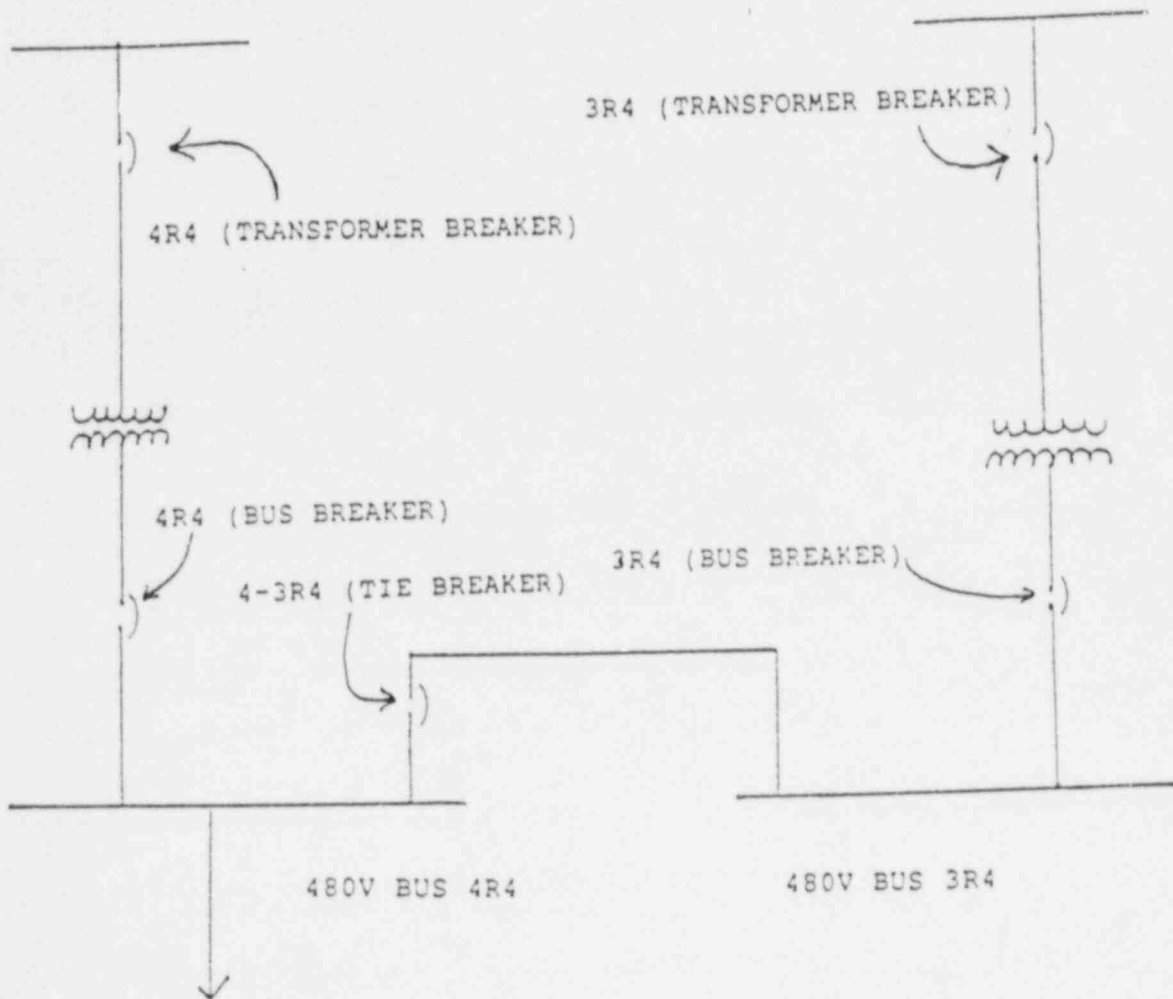
FIGURE 1

At the time of the event, the nonsafety-related 4R4 Bus was temporarily providing power to the safety-related E334-R-B Motor Control Center. The normal source (the E33 bus) was out-of-service for maintenance. The E334-R-B Motor Control Center provides power to the 30C62 RWCU instrument panel which contains the power source for temperature switch TS-3-12-99. The loss-of-power to temperature switch TS-3-12-99 completed the necessary PCIS logic to cause a PCIS Group II RWCU isolation signal. No valve movement occurred as a result of the isolation signal since the RWCU System was out-of-service. The following alarms were received in the Control Room:

At the time of the event, the nonsafety-related 4R4 Bus was providing power to safety related instrumentation which included temperature switch TS-3-12-99. This was being done because the normal power source (the E33 bus) was removed from service for maintenance. This temporary power source was permissible by Special Procedure 1109, "Deenergization of 4KV Bus E33". During normal operation, the nonsafety-related power supply would not be allowed to feed safety-related instrumentation, therefore, this event would not have occurred during normal plant operation.

REACTOR AREA LOAD CENTER 30B04

TEMP. POWER FEED TO E334-R-B  
MCC AND TIS 3-12-99
