Subject: Main Steam Nozzle Weld Indication Relief Request
Cooper Nuclear Station, NRC Docket 50-298, DPR-46

INSERVICE INSPECTION RELIEF REQUESTS
RELIEF REQUEST NUMBER: RI-27, REVISION 0

Code Class: 1
References: IWB-2430(a), ASME XI, 1989 Edition
Examination Category: B-D
Item Numbers: B3.10
Description: Additional Examinations
Component Numbers: Main Steam Nozzle to Vessel Weld NVE-BD-N3A

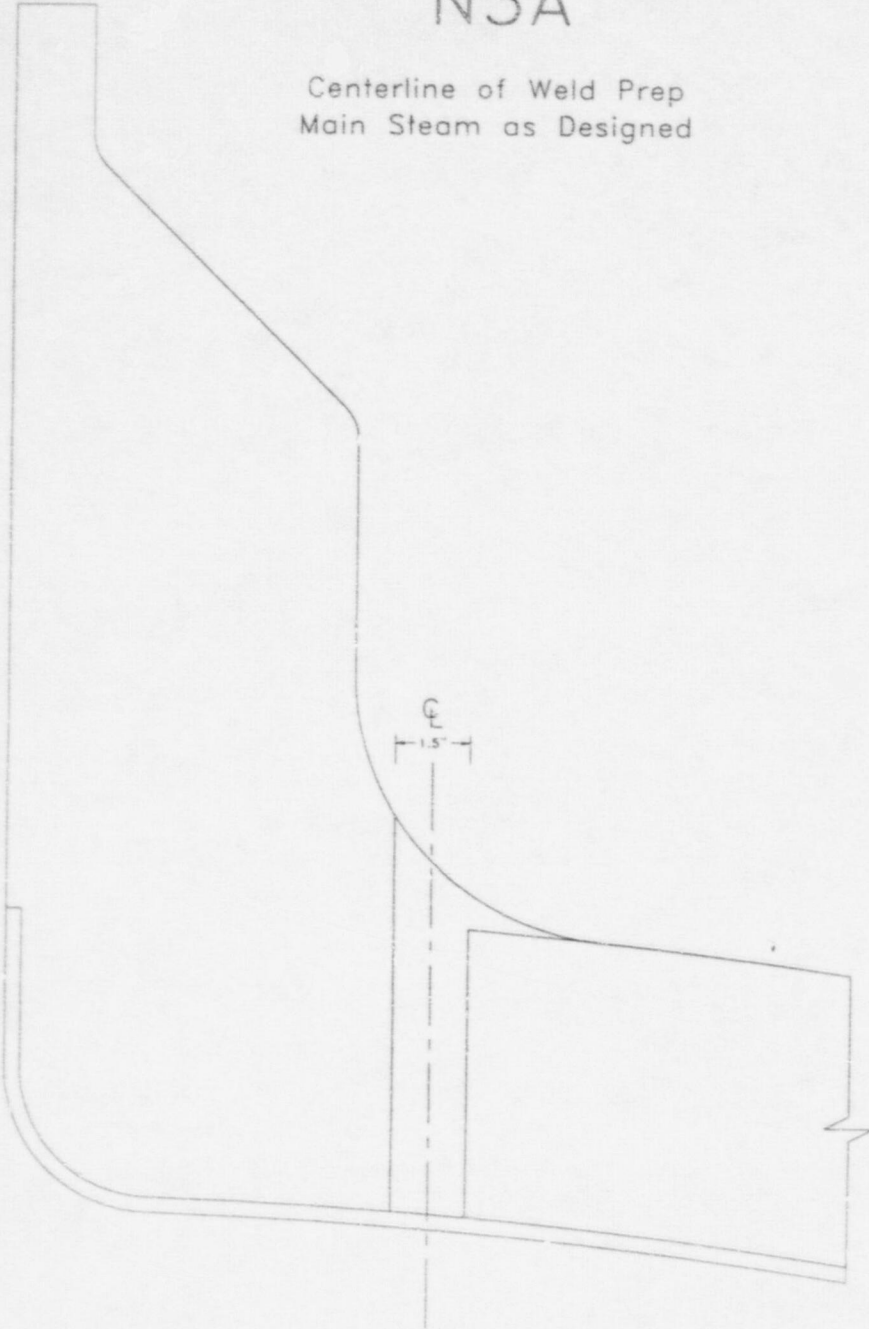
N3A

Centerline of Weld Prep
Main Steam as Designed

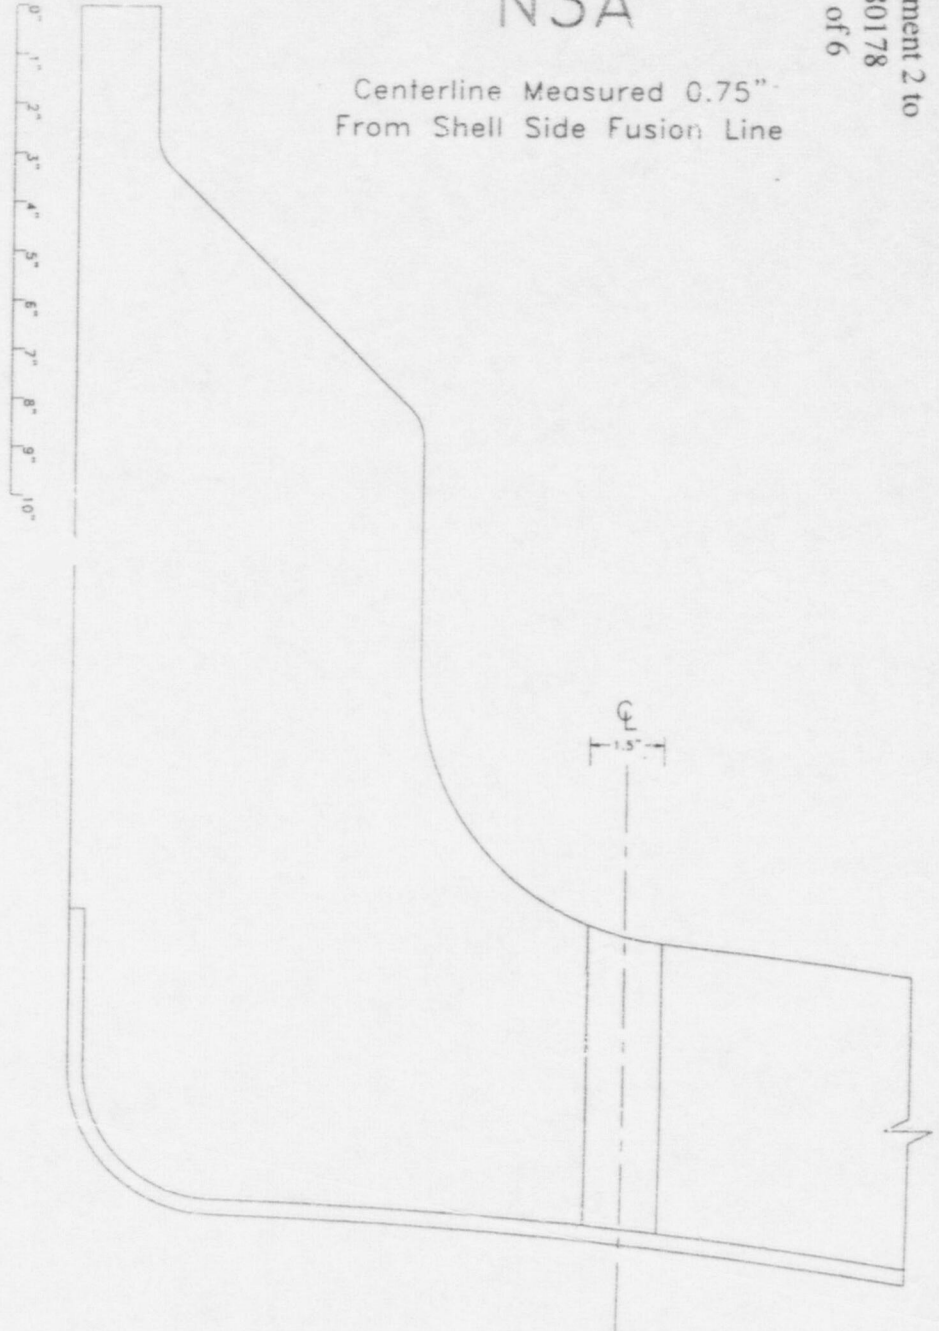
N3A

Centerline Measured 0.75"
From Shell Side Fusion Line

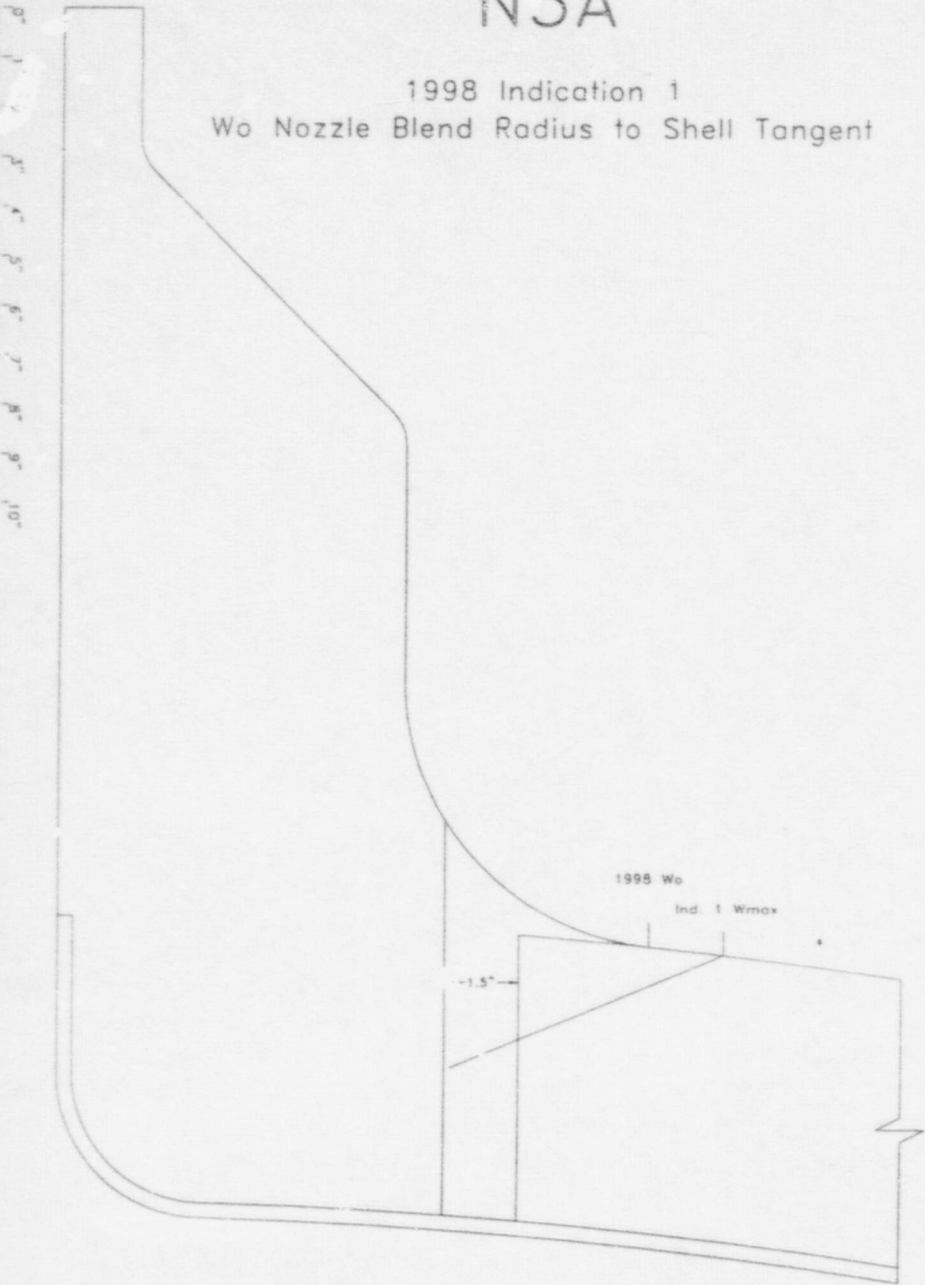
N3A

In 1998 (RFO-18) the examination with the 60° shear wave transducer identified one (1) recordable indication with the following parameters: "W" distance = 1.20"; Metal path to reflector = 5.5"; Length to maximum amplitude = 13"; and Maximum amplitude = 80% DAC. This indication is located at mid-wall along the nozzle side fusion line between 10.5" and 22.75" (see attached sketch). No flaw indication could be found in the nozzle forging as was found in 1976 and 1986. The 1976 and 1986 indication mislocation were entered into the District's corrective action program. The following comparisons clarifies the size and locational differences.

1998 Indication 1
Wo Nozzle Blend Radius to Shell Tangent

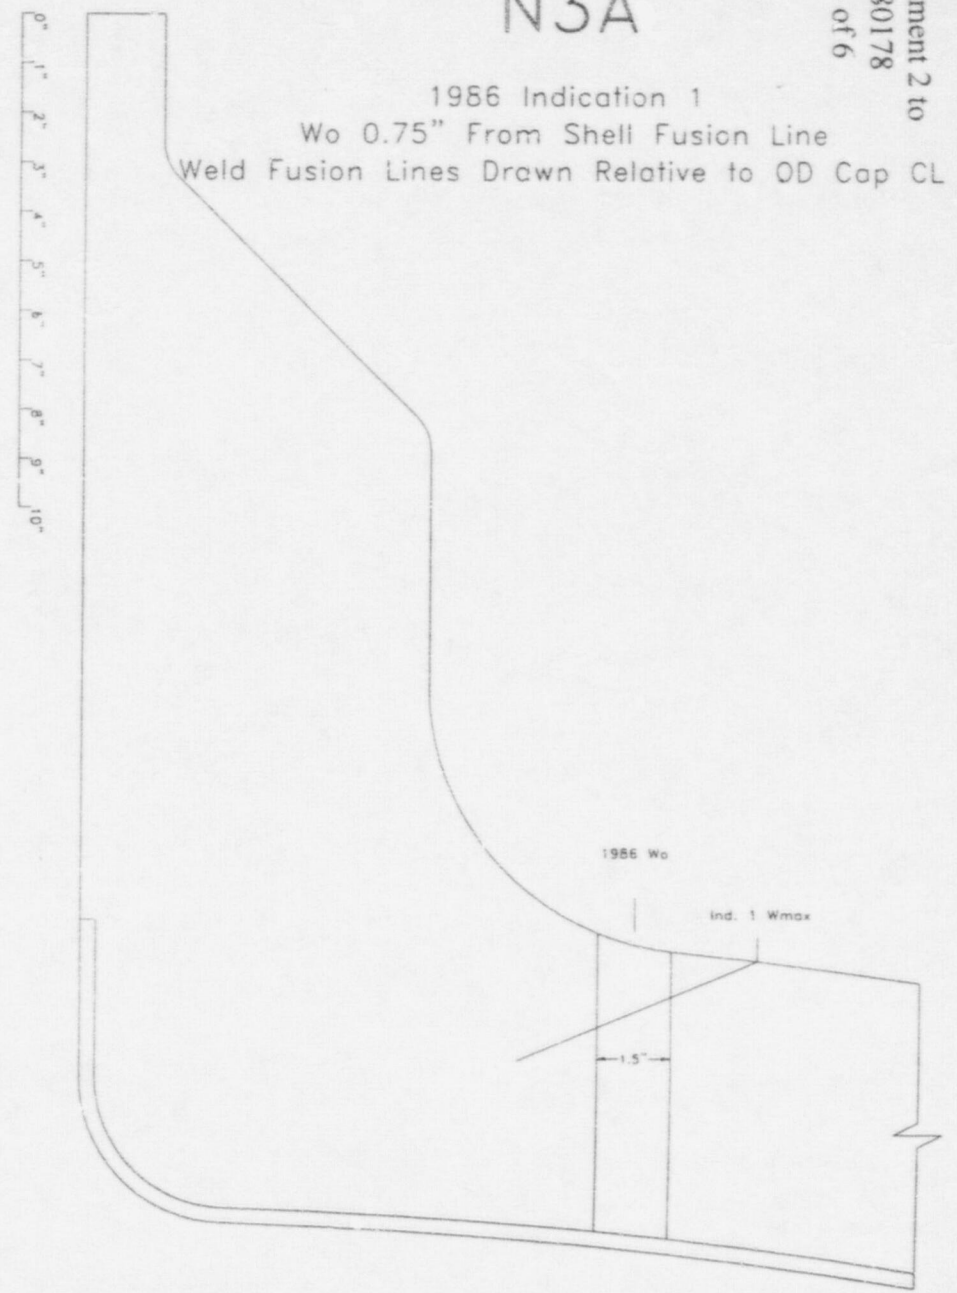
N3A

Main Steam nozzle (N3A) was examined again in 1986 with similar results. During the examination with the 60° shear wave transducer one (1) indication with the following parameters was recorded: "W" distance = 1.75"; Metal path to reflector = 5.3"; and Maximum amplitude = 90% DAC. The evaluation of this indication determined that it was located in the nozzle forging and not in the weld.

1986 Indication 1
Wo 0.75" From Shell Fusion Line
Weld Fusion Lines Drawn Relative to OD Cap CL

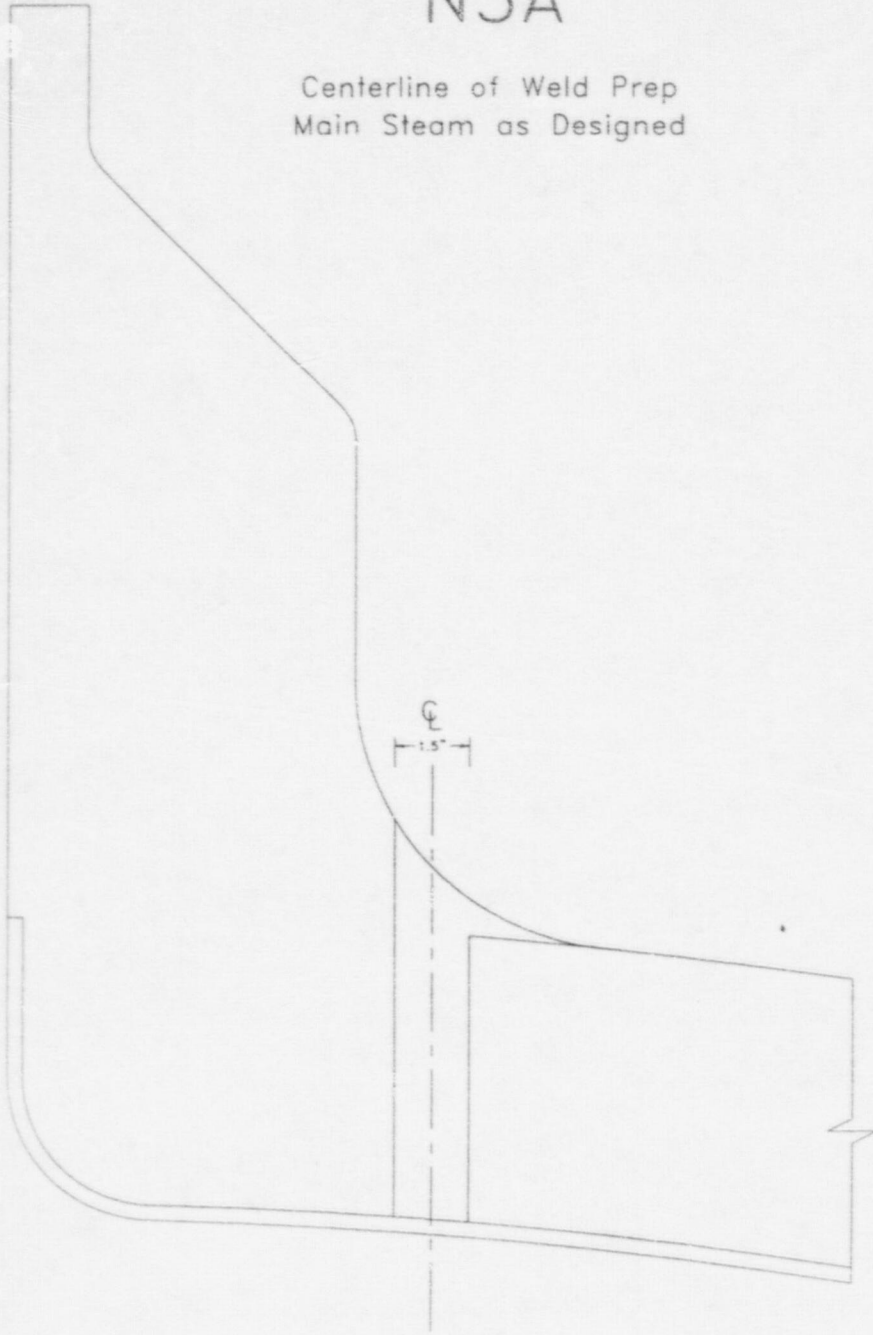
N3A

Centerline of Weld Prep
Main Steam as Designed

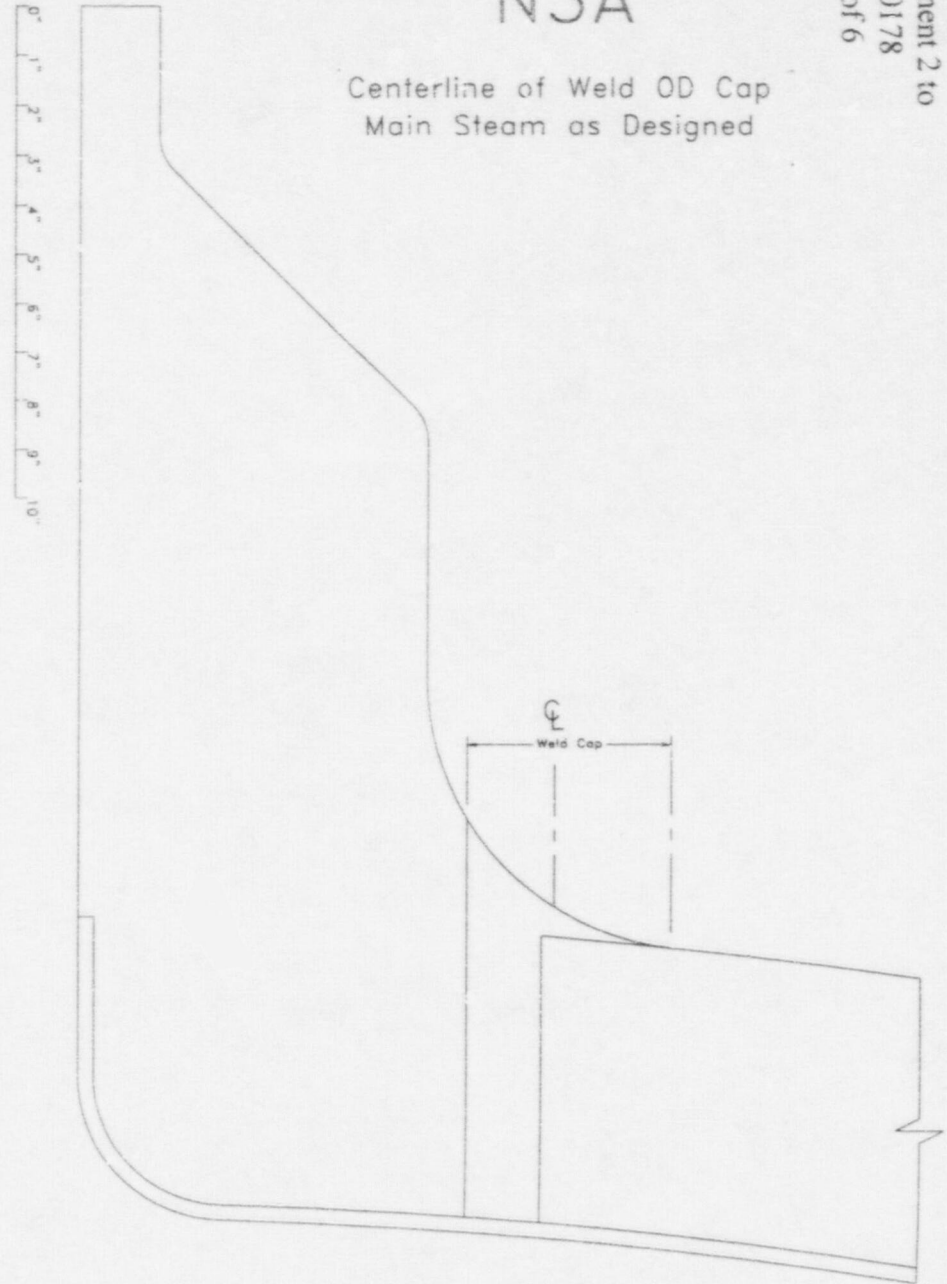
N3A

Centerline of Weld OD Cap
Main Steam as Designed

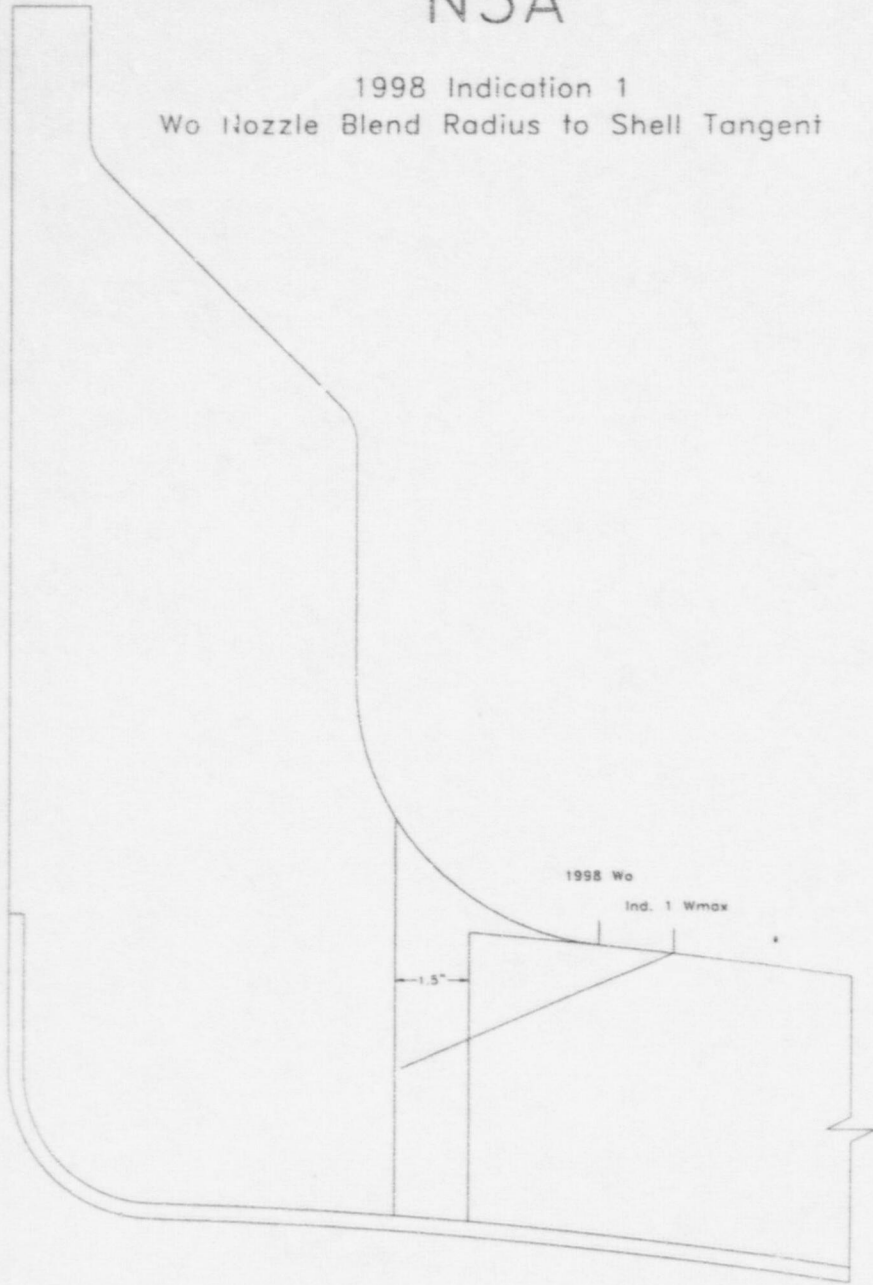
N3A

1998 Indication 1
Wo Nozzle Blend Radius to Shell Tangent

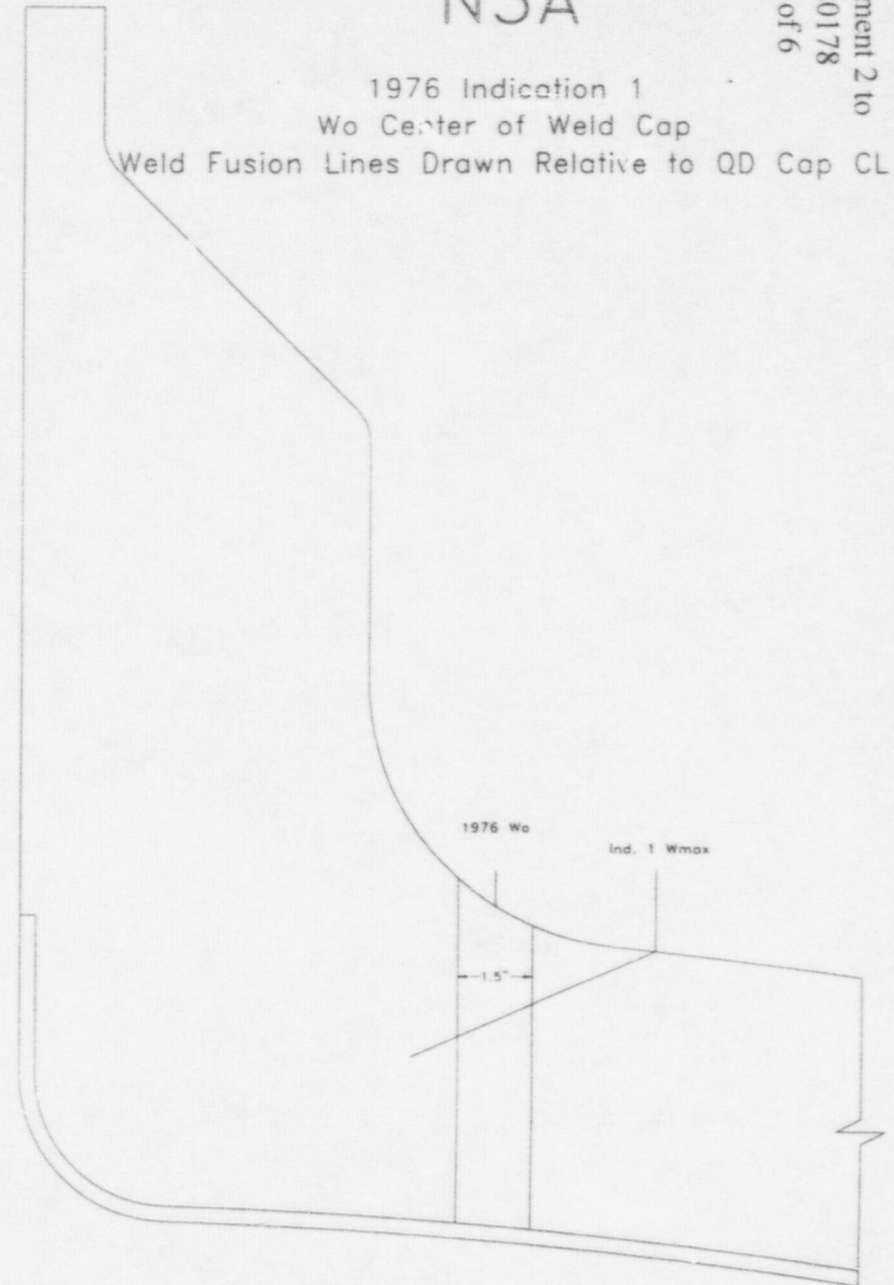
During the first refueling outage in 1976, manual ultrasonic examinations were performed on nozzle N3A in accordance with the 1974 Edition of ASME Section XI. During the examination with the 60° shear wave transducer one (1) indication with the following parameters was recorded: Distance to weld centerline = 3.25"; Metal path to reflector = 5.4"; Length to maximum amplitude = 14.5"; and Maximum amplitude = 100% distance amplitude correction (DAC). The evaluation of this indication determined that it was located in the nozzle forging and not in the weld. See attached sketch.

1976 Indication 1
Wo Center of Weld Cap
Weld Fusion Lines Drawn Relative to QD Cap CL
