LICENSEE EVENT REPORT (LER)

TITLE (4) Leakage of Aluminum-Bronze Essential Cooling Water System

South Texas Project Electric Generating Station
Units 1 & 2
Docket Nos. STN 50-498 and STN 50-499
Leakage of Aluminum-Bronze Essential Cooling Water System

BECHTEL REPORT
ON
FAILURE ANALYSIS AND STRUCTURAL
INTEGRITY EVALUATION OF LEAKING
ALUMINUM - BRONZE CAST VALVE BODIES
AND FITTINGS IN THE ECW SYSTEM

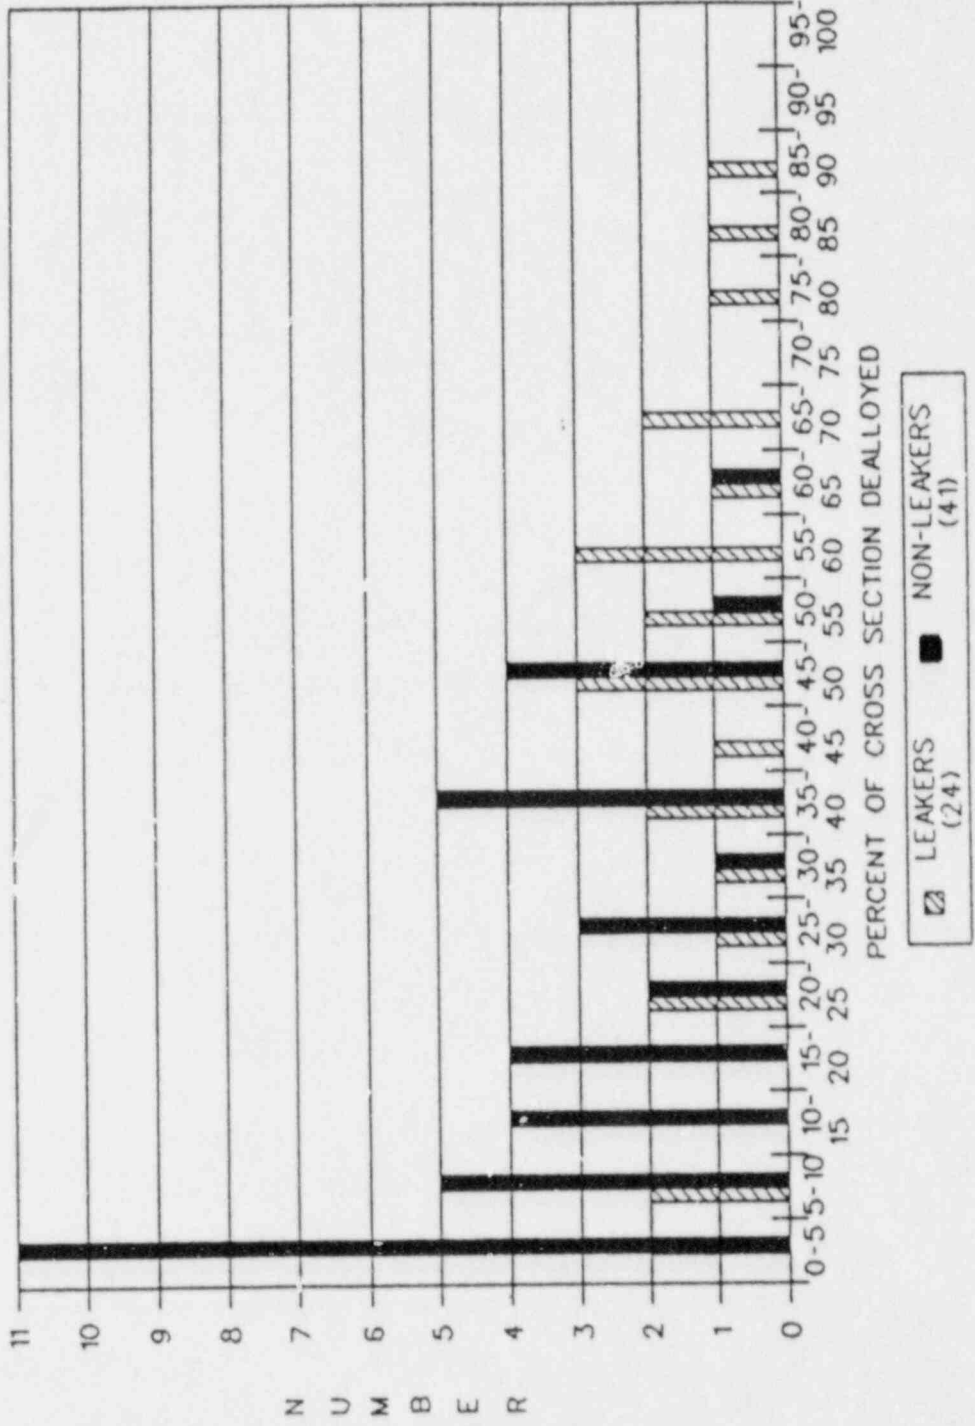
FIGURE 1

A program of walkdowns was immediately instituted, which resulted in the detection of more indications of seepage. The seepages in many cases are difficult to identify because of the extremely low seepage rates. As a result it took several cycles of inspection to identify all leaking components. The baseline has now been established and the rate of occurrence of new leaks is low (See Figure 1). The maximum leak rate was estimated to be 10 ml/day.

STP UNIT 1 ALUMINUM/BRONZE ECWS
DISTRIBUTION OF SAMPLED FITTINGS

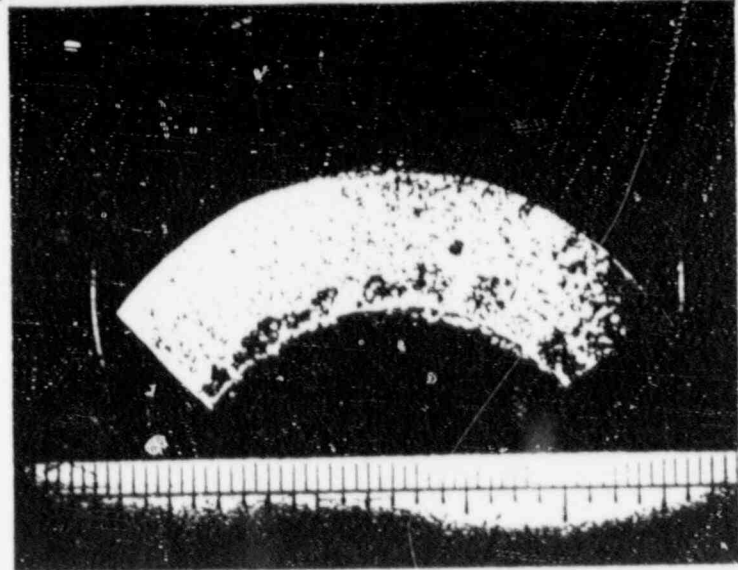
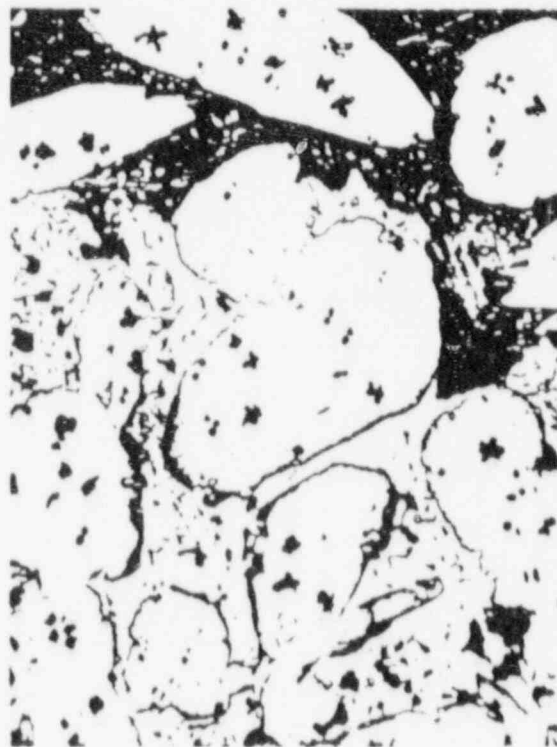
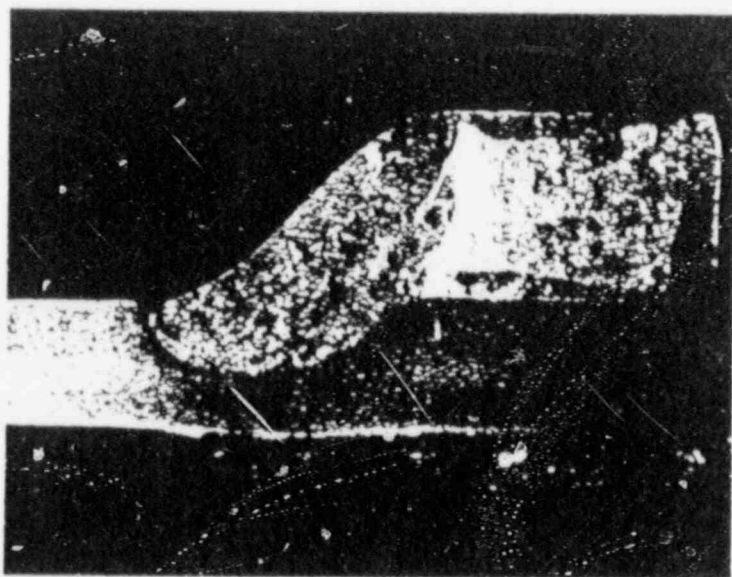
FIGURE 1.3 Valve EW 269

- C. Cross sections were taken through the valve that leaked, the fitting (elbow) that leaked and the valve that did not leak. Table 1.1 compiles all the information obtained from this work and references the applicable figures that show the microstructures and macrostructures.

Mount 7040
2X
NH₄OH - H₂O₂ etch

Mount 7040
480X
NH₄OH - H₂O₂

Mount 7041
5X
NH₄OH - H₂O₂

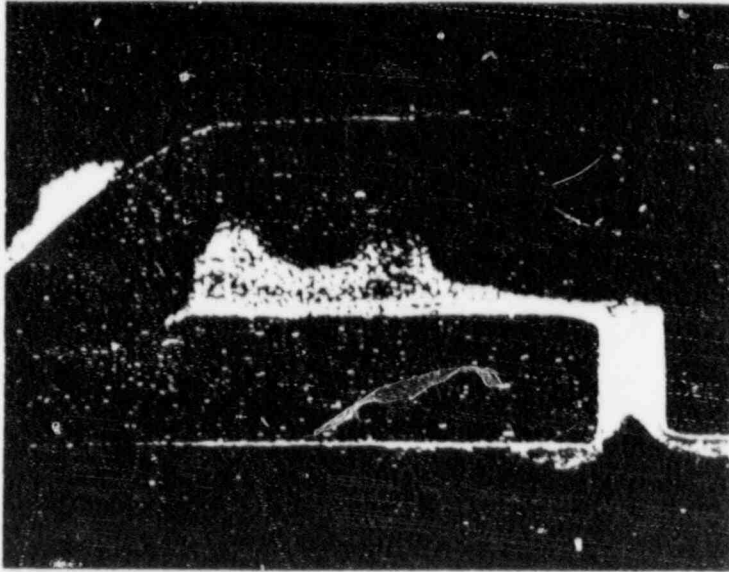
FIGURE 1.4 Valve EW 315

Mount 7043
5X
NH₄OH - H₂O₂

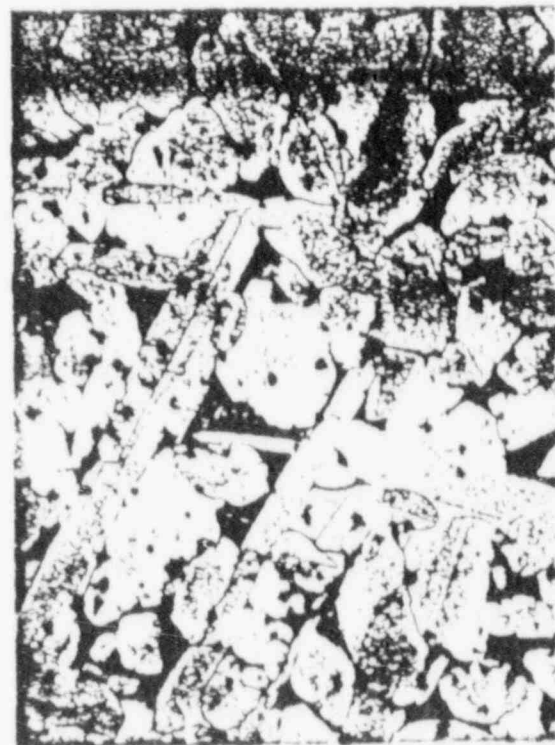
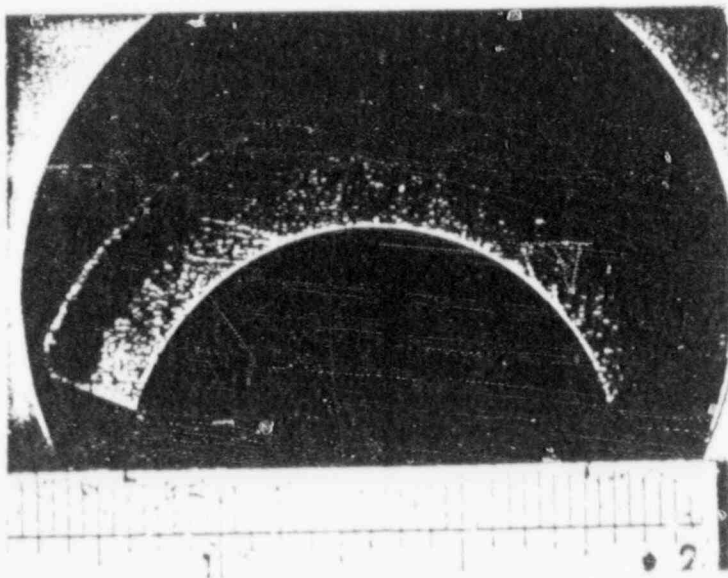
FIGURE 1.5 - Elbow Heat No. H9528-36

Mount No. 7044
2X
NH₄OH - H₂O₂

Mount 7047
500X
NH₄OH - H₂O₂

Mount No. 7045
2X
NH₄OH - H₂O₂

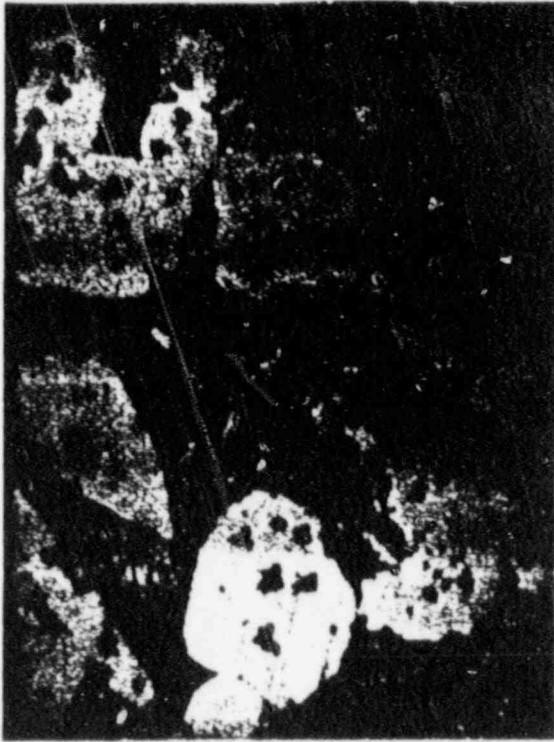
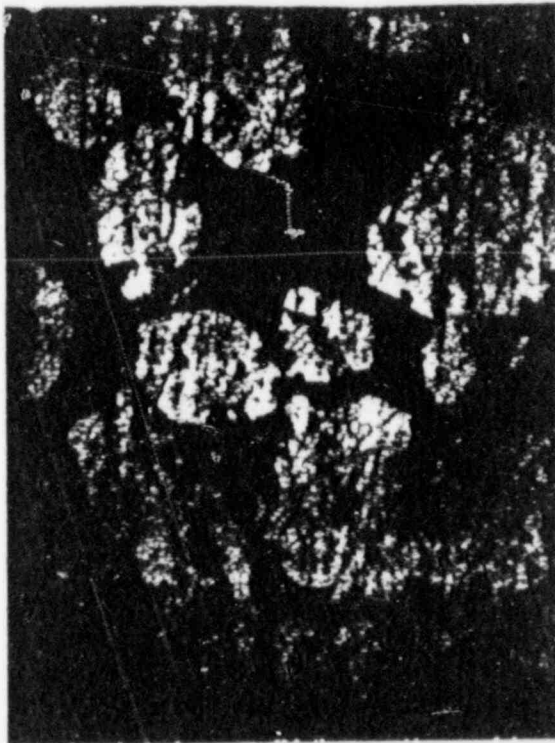
FIGURE 1.6 Comparison of replica micrograph with laboratory micrographs, Valve EW 269

- G. It is common practice to use a technique called replication at a field location, when a metallurgist wants to know the microstructure of a piece of equipment but can't cut out a sample of material. This method is well understood for carbon and stainless steels. In case it was needed in the field, a test was made to be sure that the techniques also work for Al-bronze. The standard field replication techniques for grinding, polishing and etching work quite well. Replicas were taken from a laboratory specimen and from an elbow polished and etched as if it was being done in the field. The photomicrographs of the two replicas and of the actual piece of material are almost identical (see Figure 1.6).

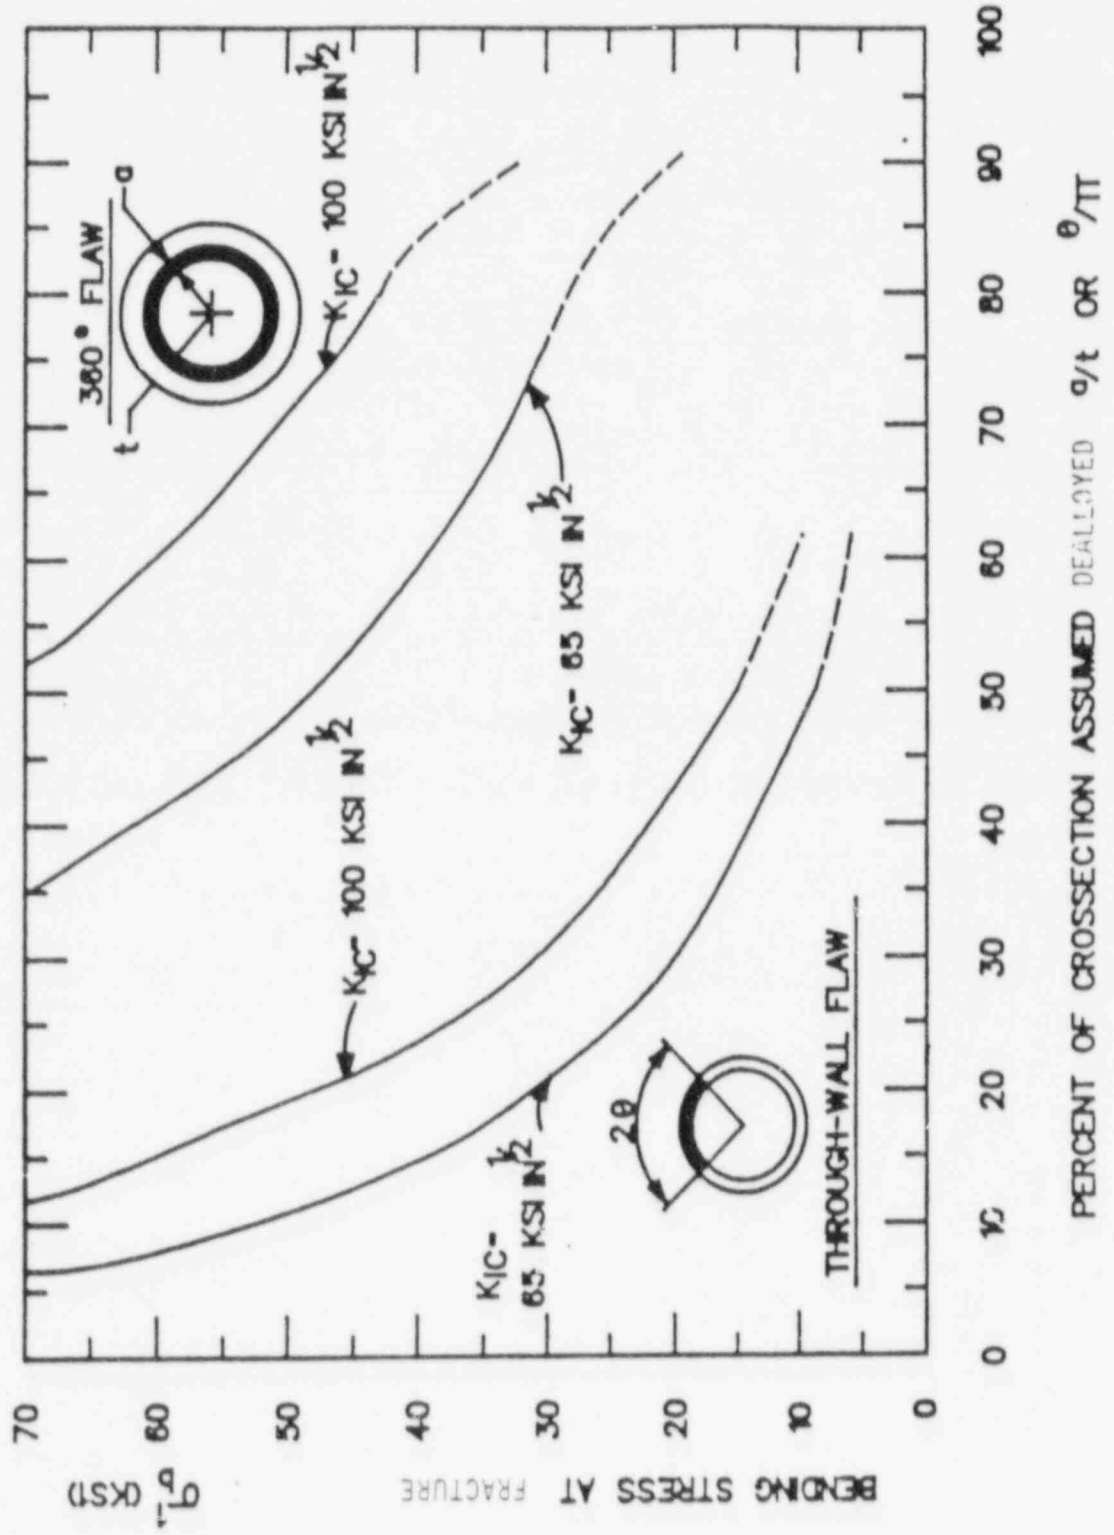
Figure 2.1 Bending Stress Capacity for Dealloyed 2 - inch Fittings Based on LEFM

Additionally, a linear elastic fracture mechanics screening analysis was performed. The fracture analysis treated the dealloying as a planar flaw which is highly conservative since there is actually no discontinuity. Brittle fracture was demonstrated not to be the controlling mechanism.

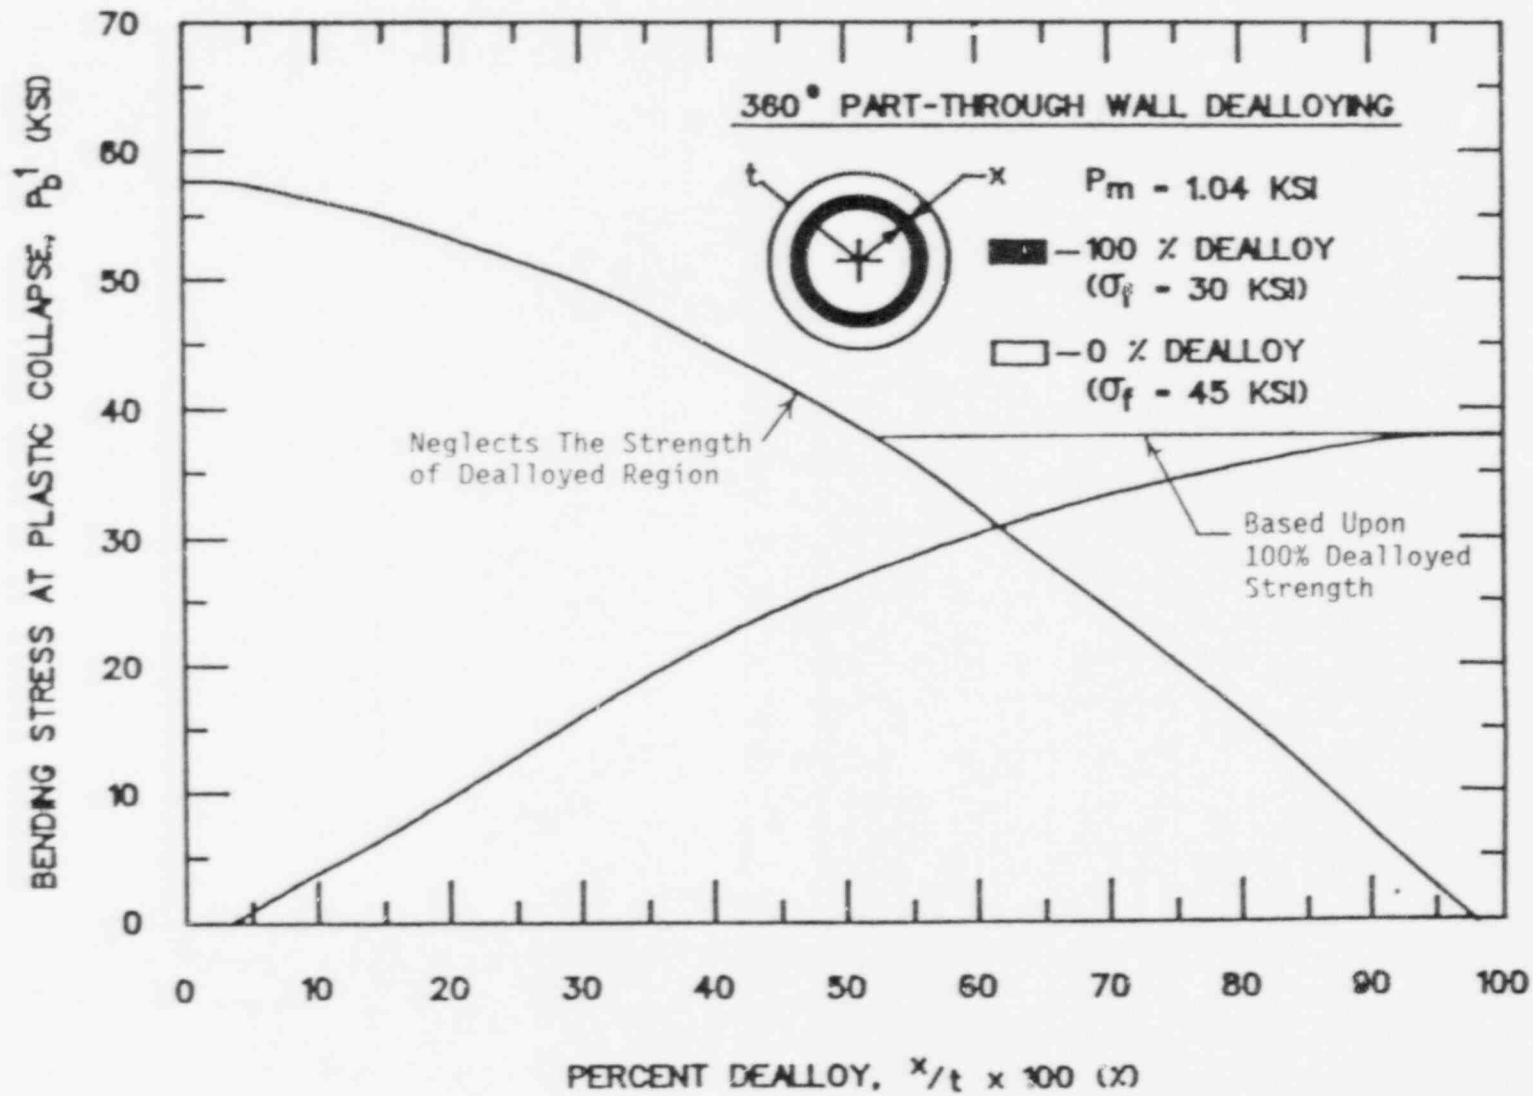
Figure 2.2 Conditions for Net-Section Plastic Collapse for 360 Degree Part-Through Dealloying

A limit load analysis for plastic collapse was then performed using two bounding cases: dealloying uniformly distributed in a circumferential plane, and dealloying concentrated in a worst case bending plane. In addition, the increase in the extent of dealloying three years into the future was also evaluated. The composite sections, allowing for the specification properties for aluminum bronze and 30 ksi for the dealloyed section, showed good margins to failure.

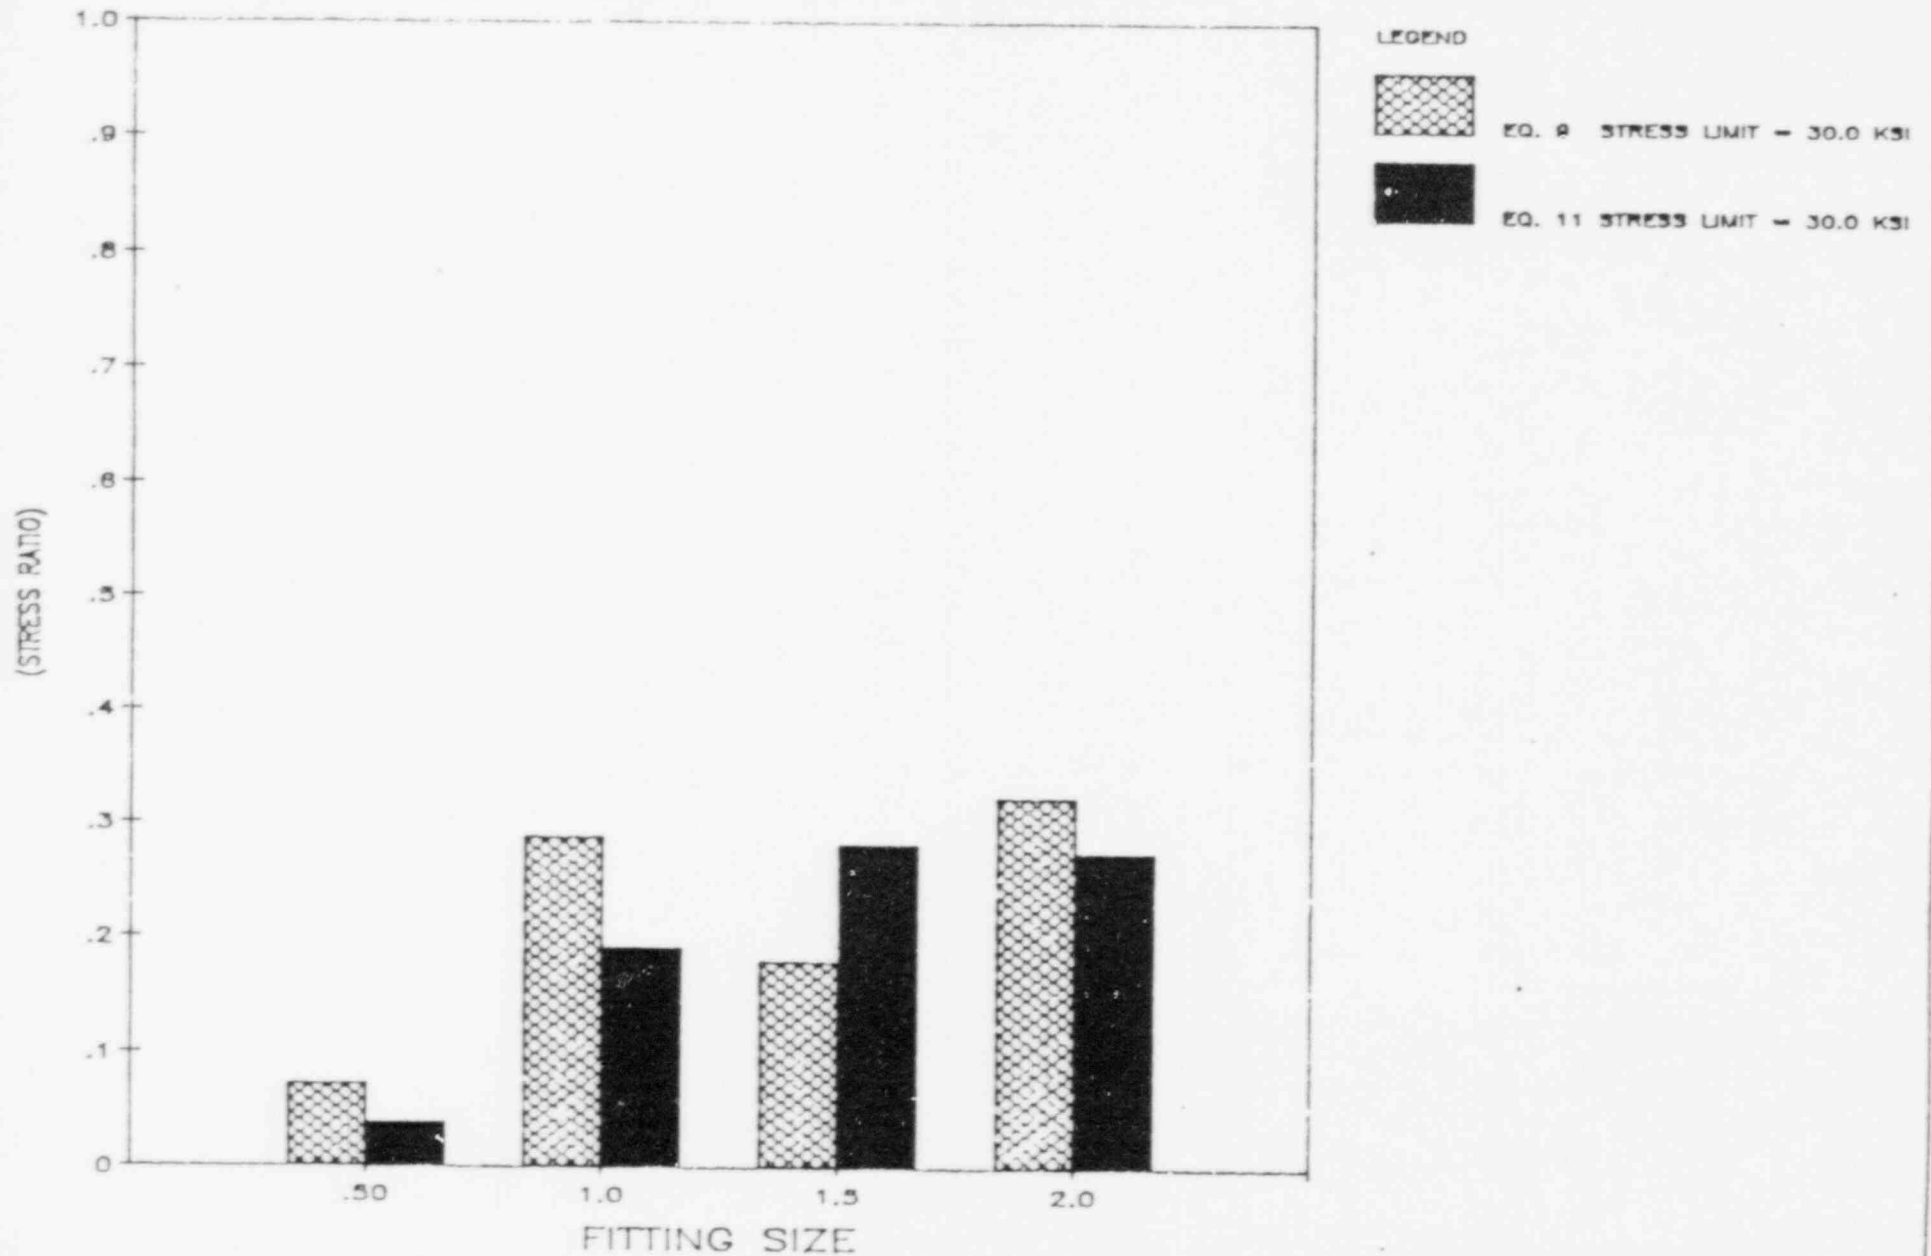
FIGURE 2.4

SOUTH TEXAS PROJECT - UNIT 1 ALUMINUM BRONZE FITTING STRESS RATIO TO ALLOWABLE

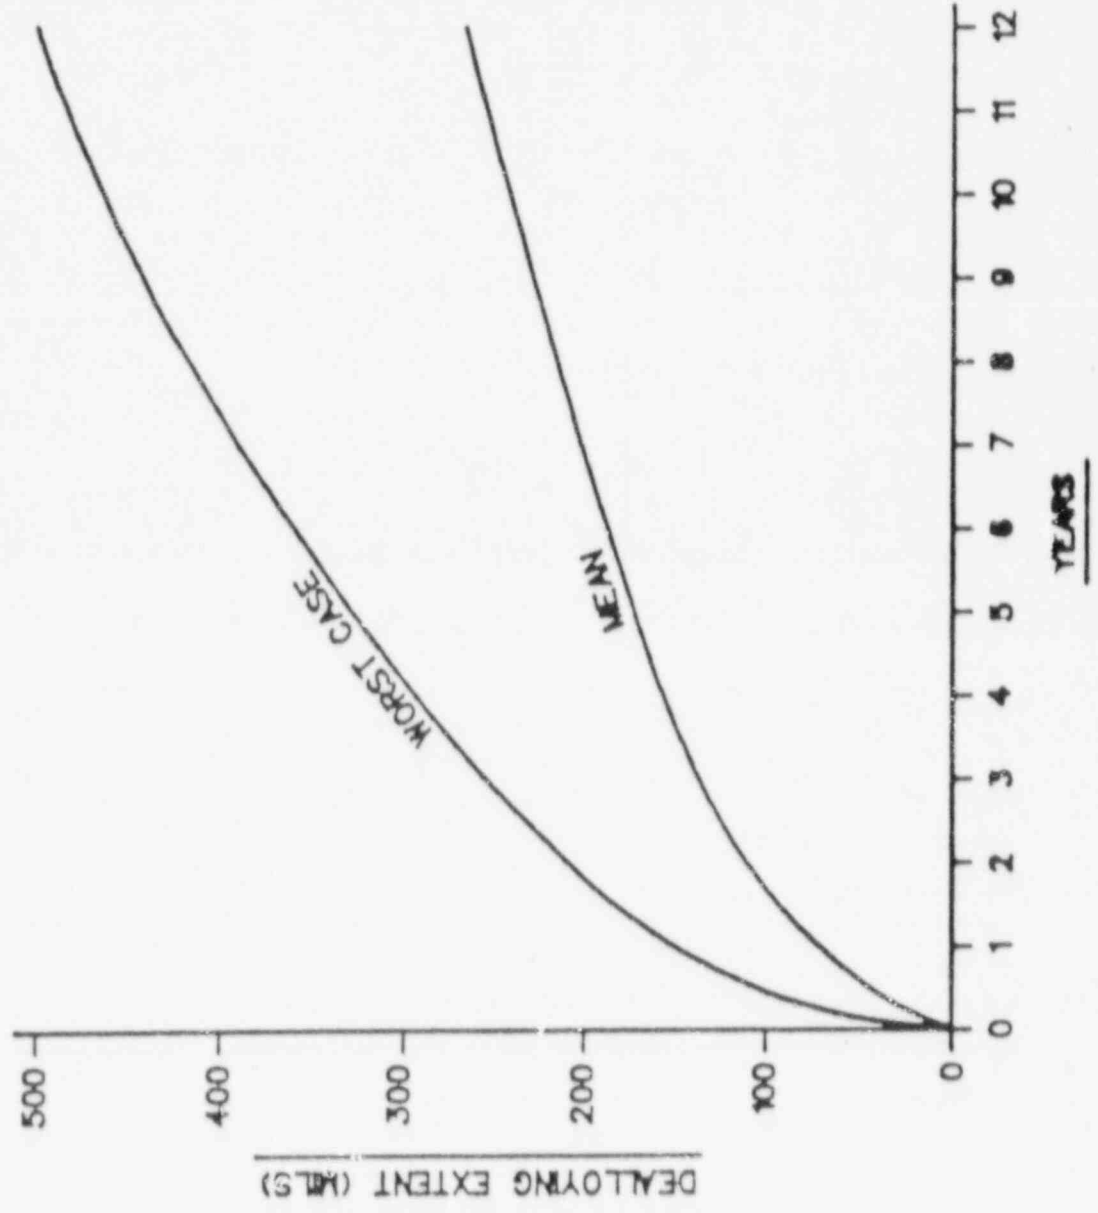
Figure 2.6

DEALLOYING OF LEAKING
ALUMINUM BRONZE SOCKETS
