U. S. NUCLEAR REGULATORY COMMISSION
REGION I

Report Nos. 50-277/278/88-29

Facility Name: Peach Bottom 2 & 3

Inspection Summary: Inspection on August 5, 1988, August 8-12, 1988
(Report No. 50-277/278/88-29)

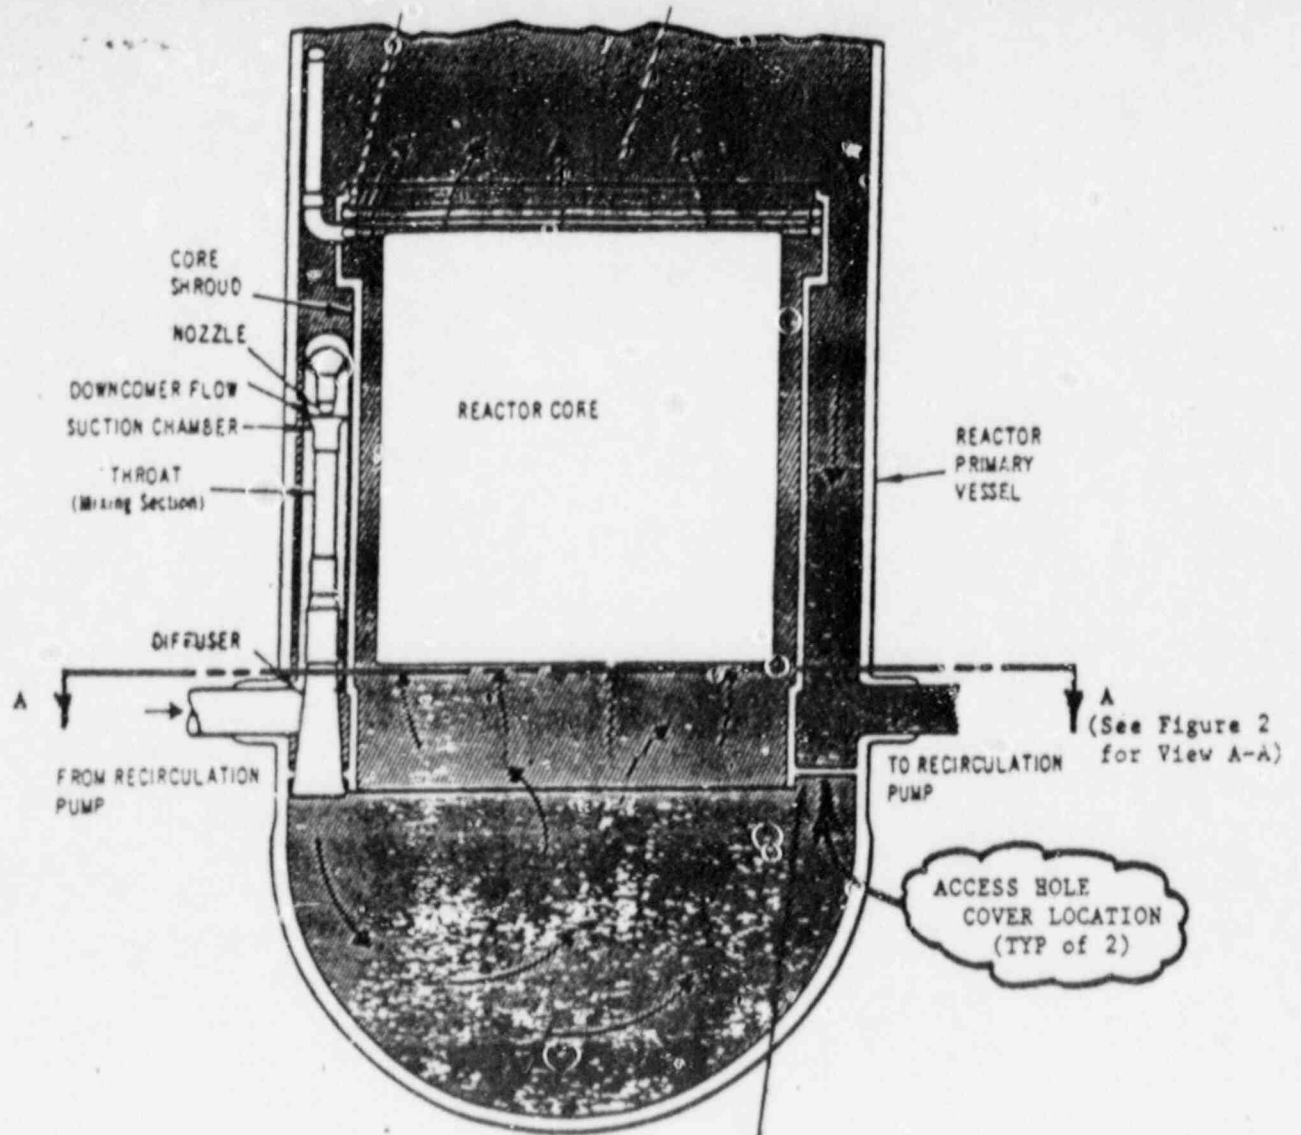
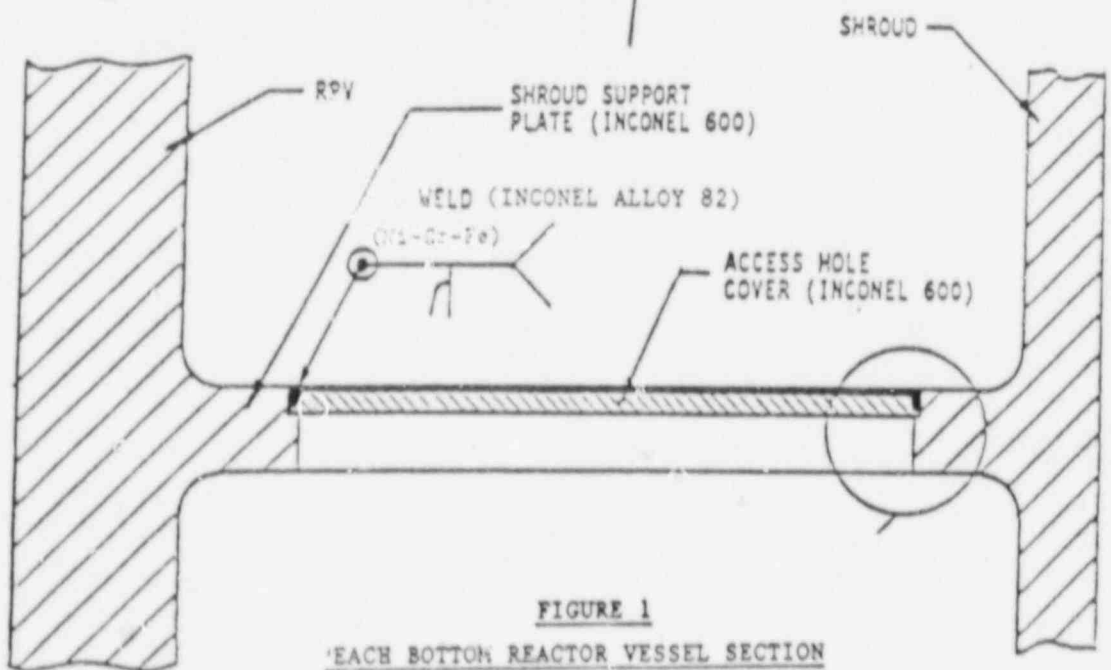
FIGURE 1
 EACH BOTTOM REACTOR VESSEL SECTION

As reported in IR-88-08, January 1988, GE performed a remote, ultrasonic examination of two Inconel 600 shroud access hole cover plate welds (see figure 1) in the Unit 3 reactor vessel which were suspected of having intergranular stress corrosion cracking. The 21" diameter cover plates were welded to the shroud support plates with a "J" groove configuration (see figure 1) that resulted in a crevice in the weld joint. The UT examination which employed the GE Ultra Imager III instrument for data acquisition disclosed significant indications which GE interpreted to be due to intergranular stress corrosion cracks. The licensee questioned the validity of the test and requested that GE repeat the examination.

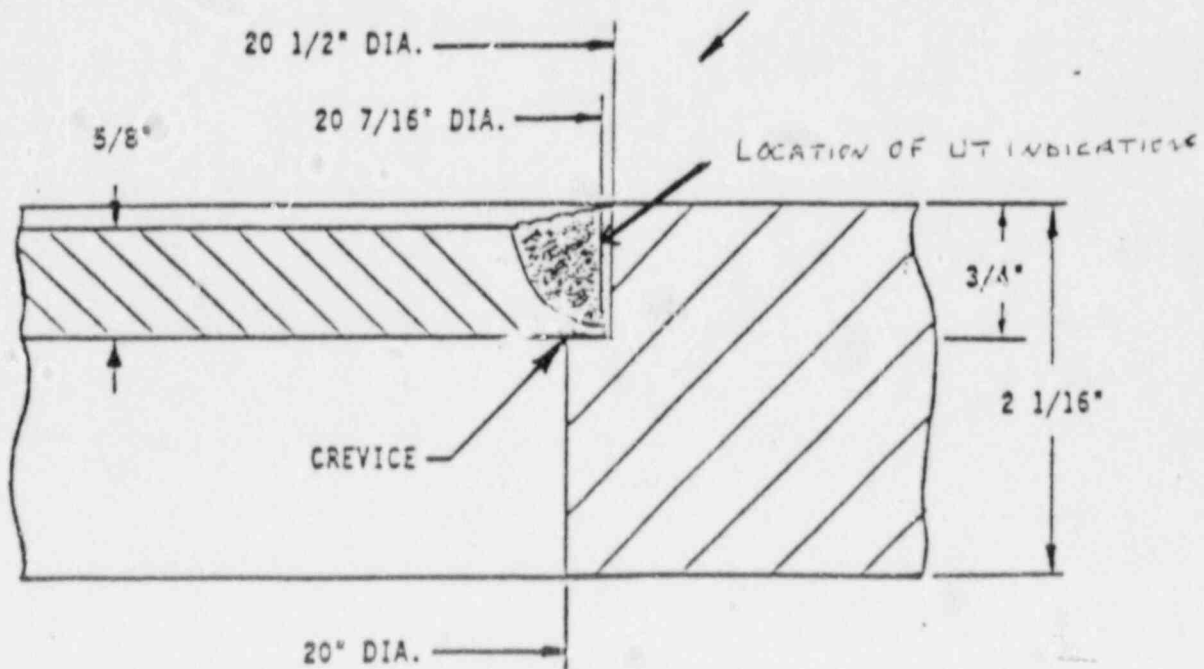
FIGURE 2

On August 6, 7 and 10, 1988, GE reexamined the 0° and 180° cover plate welds in Unit 3 using the same procedure and personnel employed in the examination of Unit 2. The inspector witnessed the calibration phase of the examination and found it to be in agreement with Procedure UT-57. The examination revealed significant indications located on the vertical fusion line along the shroud support side of the weld (see figure 2). The 0° cover plate weld indications were present 360° intermittently with an

average of 40% thru wall depth and with some areas showing 80% thru wall. The 180 cover plate weld showed indications intermittently 25% around the cover with an average of 20% thru wall depth and with areas showing up to 40% thru wall. The indications were confirmed by GE using a focused 65 refracted longitudinal search unit from the shroud side of the weld whereas the initial examination was performed from the access cover side.

The inspector and two regional inspectors reviewed the video tapes of the data and concurred with GE's findings with regard to the presence and location of the indications. Although GE stated that these indications are typical of intergranular stress corrosion cracks, the inspector and PE were of the opinion that the indications may also be related to other conditions such as cracking originating from root defects or lack of fusion along the side wall. The welds were reportedly made by the manual Tungsten Inert Gas process using Inconel 82 (ER NiCr-3) filler wire.

The licensee expressed the opinion that the Unit 2 and Unit 3 conditions with regard to the presence of defects in the latter, but not the former is due to differences in water chemistry and, as suggested above, welding conditions. Unit 2 is reported to have had better oxygen control than Unit 3. Differences in welding may be related to fit up or welding technique. Welding conditions could have played a large role in the formation of the defects.

PEACH BOTTOM RPV ACCESS HOLE COVER DETAILS
 (Showing location of Unit 3 cracking)

In anticipation of repairing the defective cover plate welds in Unit 3, the inspector reviewed a proposed GE repair procedure consisting of cutting out the existing cover plates and replacing them with new cover plates using a bolted connection. Other repair procedures are being considered by PE such as welding a strong back over the existing cover plates.
