LICENSEE EVENT REPORT (LER)

FACILITY NAME (1) **THREE MILE ISLAND, UNIT 1** DOCKET NUMBER (2) **0500002891** OF **05**

TITLE (4) **FAILURE OF CRD BREAKER UNDERVOLTAGE DEVICE DURING SURVEILLANCE TESTING**

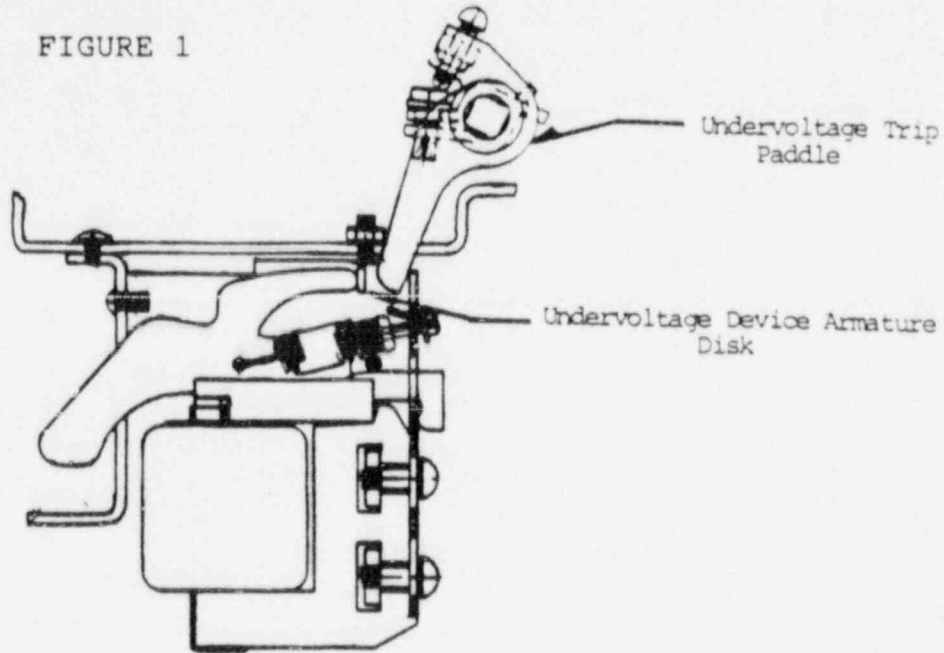
FIGURE 1

The UV device was tested several times to establish the failure mechanism. Prior to replacing CB-4, the failure was identified as the UV trip paddle lodging itself over the UV armature disk. This failure mode prevented the UV device (when de-energized) from moving upward and striking the UV trip paddle to trip the breaker (See Figure 1).

G.E. Undervoltage Device  
Energized Position

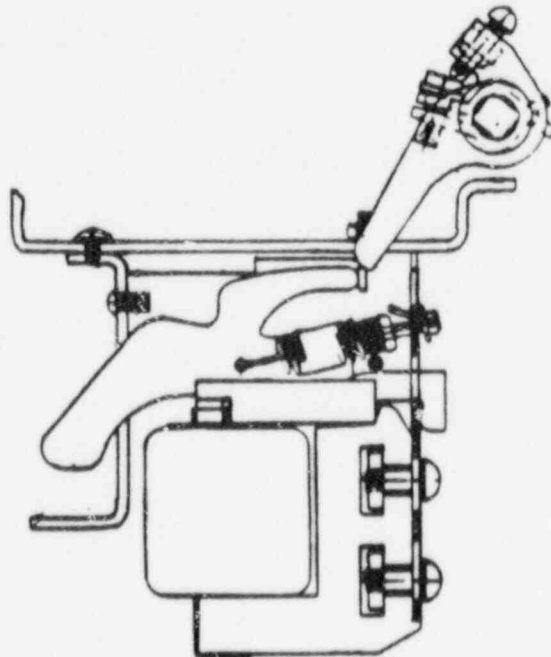
Subsequent investigation of the defective breaker CB-4 revealed two (2) parts that had dimensional or manufacturing defects (the undervoltage device armature disk and the undervoltage trip paddle). These dimensional tolerances caused the mating surface area between the UV trip paddle and armature disk to be reduced. Both parts were replaced and the breaker was successfully tested in accordance with Preventive Maintenance Procedure E-36.

G.E. Undervoltage Device  
Simulated Failure Position on CRD Bkr. CB-4

Defective Breaker CB-4 was replaced with a spare breaker. The replacement breaker was then tested to verify proper operation of the UV and shunt trip devices. The replacement breaker tested satisfactorily. Breaker CB-4 was moved to the Electrical Maintenance Shop for further

A procedure has been prepared to check the remaining in-service and spare CRD breakers and the spare undervoltage devices. These checks will include verifying the:

1. Interface between the undervoltage device armature disk and the undervoltage trip paddle.
2. Length of the trip paddle.
3. Distance between the disk and the armature.

Preventive Maintenance Procedure E-36 will be changed to provide additional direction to verify the proper location of the undervoltage trip paddle and the undervoltage device armature disk. Receipt inspection for replacement parts will be required if the vendor cannot provide dimensional certification.
