FACILITY NAME (1) San Onofre Nuclear Generating Station (SONGS) Unit 2	Docket Number (2) 05000-361	Page (3) 1 of 7
--	---------------------------------------	---------------------------

TITLE (4): Emergency Chilled Water Inoperable Due To Faulty Temperature Control Unit

EVENT DATE			LER NUMBER (6)			REPORT DATE			OTHER FACILITIES INVOLVED (8)	
MONTH	DAY	YEAR	YEAR	SEQUENTIAL NUMBER	REVISION NUMBER	MONTH	DAY	YEAR	FACILITY NAME	DOCKET NUMBER
08	06	1998	1998	-- 020	-- 00	10	26	1998	SONGS Unit 3	50-362
									FACILITY NAME	DOCKET NUMBER

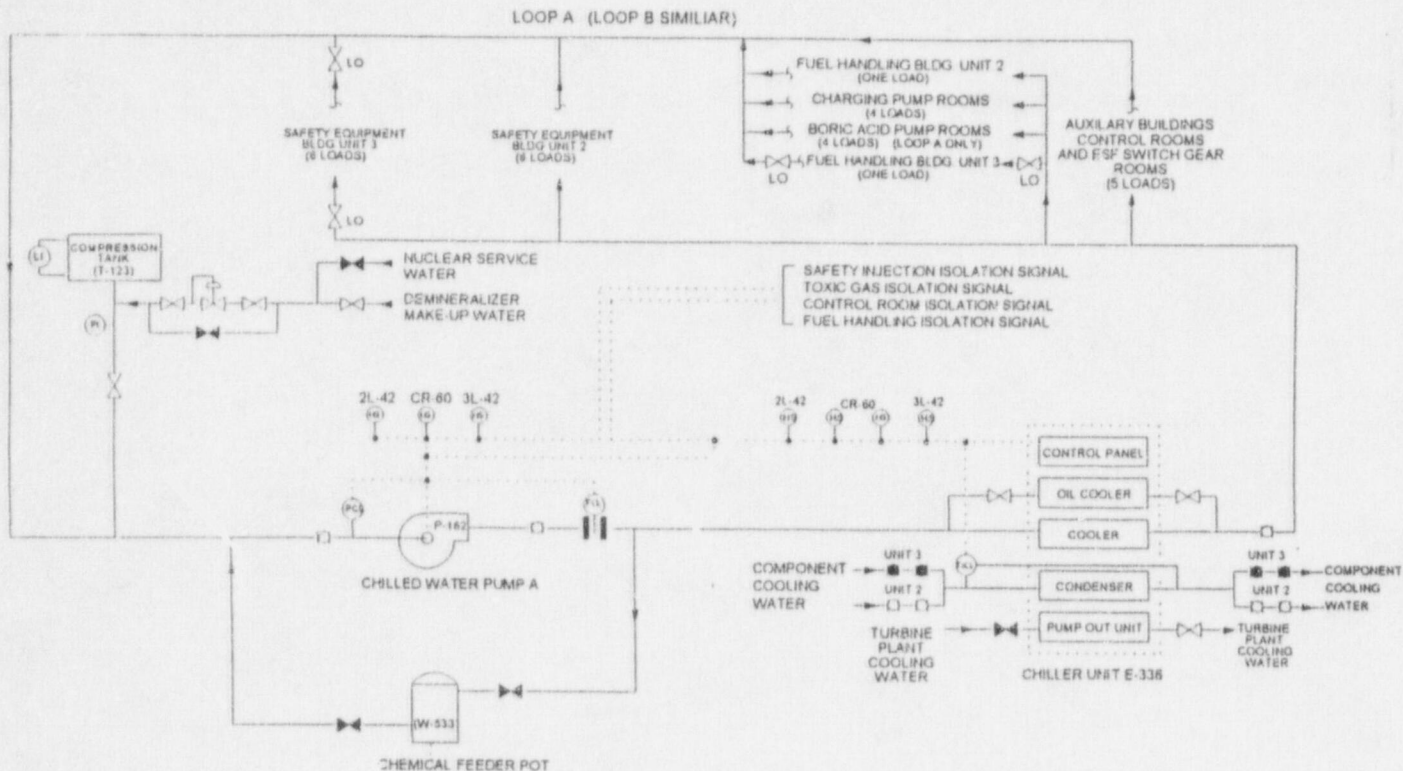
Figure 1 - Emergency Chilled Water System

Chilled water (KM) for the HVAC systems of the support buildings is divided into two systems: Normal Chilled Water System and Emergency Chilled Water System (ECW). ECW is composed of two 100% capacity loops or trains (each loop shared by Units 2 and 3). The purpose of the ECW system is to remove heat from emergency equipment rooms via room cooling coils that are in service when the normal cooling system is not available. For each train, chilled water is pumped by the chilled water pump(s) through a freon cycle chiller unit to its chilled water loop(s) which contain various cooling loads. Chilled water from the loads in each of two loops returns to the suction of the chilled water pump(s). The emergency chiller units remove heat from chilled water and transfers the heat to the component cooling water system. See Figure 1.
