FACILITY NAME (1) San Onofre Nuclear Generating Station (SONGS) Unit 2 Docket Number (2) 05000-361 Page (3) 1 of 7

TITLE (4): Emergency Chilled Water Chiller Inoperable Due Incorrectly Wired Switch

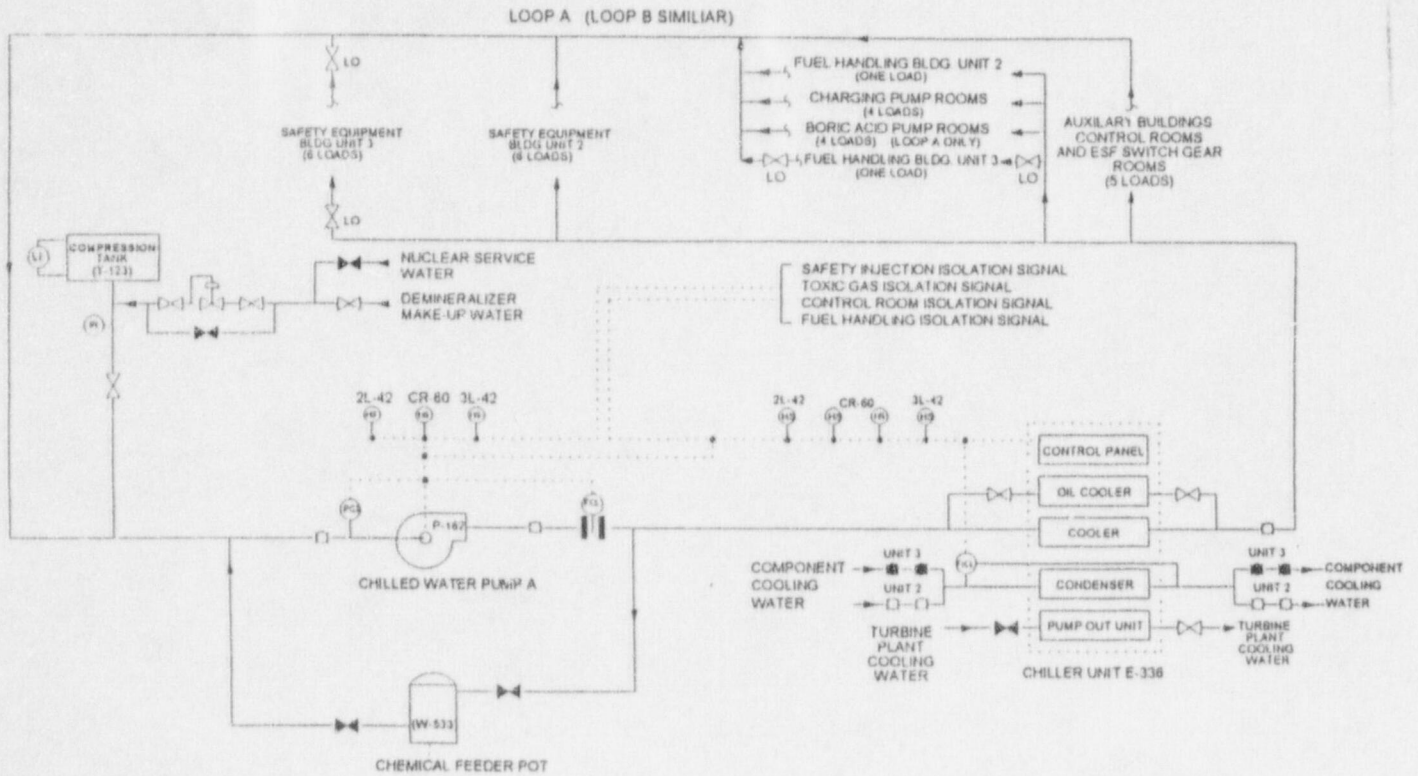
Figure 1 - Emergency Chilled Water System

Chilled water for the HVAC systems of the support buildings is divided into two systems: Normal Chilled Water System and Emergency Chilled Water System (ECW). ECW is composed of two 100% capacity loops or trains (each loop shared by Units 2 and 3). The purpose of the ECW system is to remove heat from emergency equipment rooms via room cooling coils that are in service when the normal cooling system is not available. For each train, chilled water is pumped by the chilled water pump(s) through a freon cycle chiller unit to its chilled water loop(s) which contain various cooling loads. Chilled water from the loads in each of two loops returns to the suction of the chilled water pump(s). The emergency chiller units remove heat from chilled water and transfers the heat to the component cooling water system. See Figure 1.
