LICENSEE EVENT REPORT (LER)

Facility Name (1) LaSalle County Station Unit 2 Docket Number (2) 015000374 Page (3) 1 of 10

Title (4) Reactor Core Isolation Cooling Steam Line Differential Pressure

High Division II Isolation Due to Procedural Inadequacy

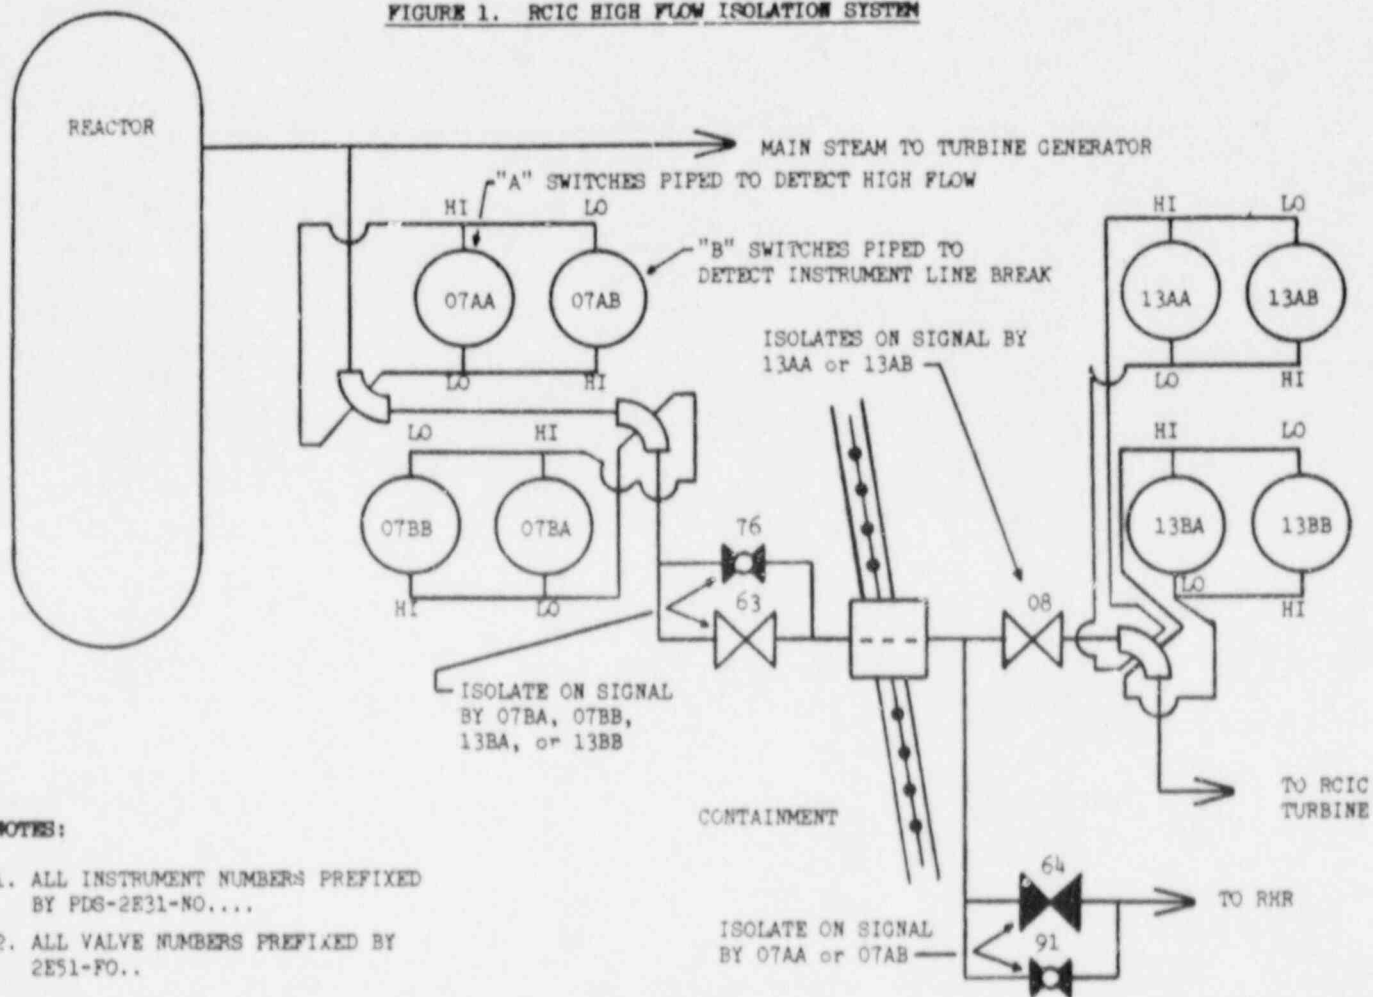
FIGURE 1. RCIC HIGH FLOW ISOLATION SYSTEM

An actuation of PDS-2E31-N007BA, PDS-2E31-N007BB, PDS-2E31-N0138A, or PDS-2E31-N0138B will provide the identical isolations and alarms, a determination had to first be made as to which switch or switches was actuating. The 2E31-N0138A and 138B switches are located on flow elbows downstream of the RCIC steam line outboard isolation valve, 2E31-F008. (See Figure 1.)

The switches are connected to instrument lines attached to flow elbows upstream of the RCIC steam line inboard isolation valve, 2E51-F063, and its parallel warmup line isolation valve, 2E51-F076. (See attached Figure 1.)

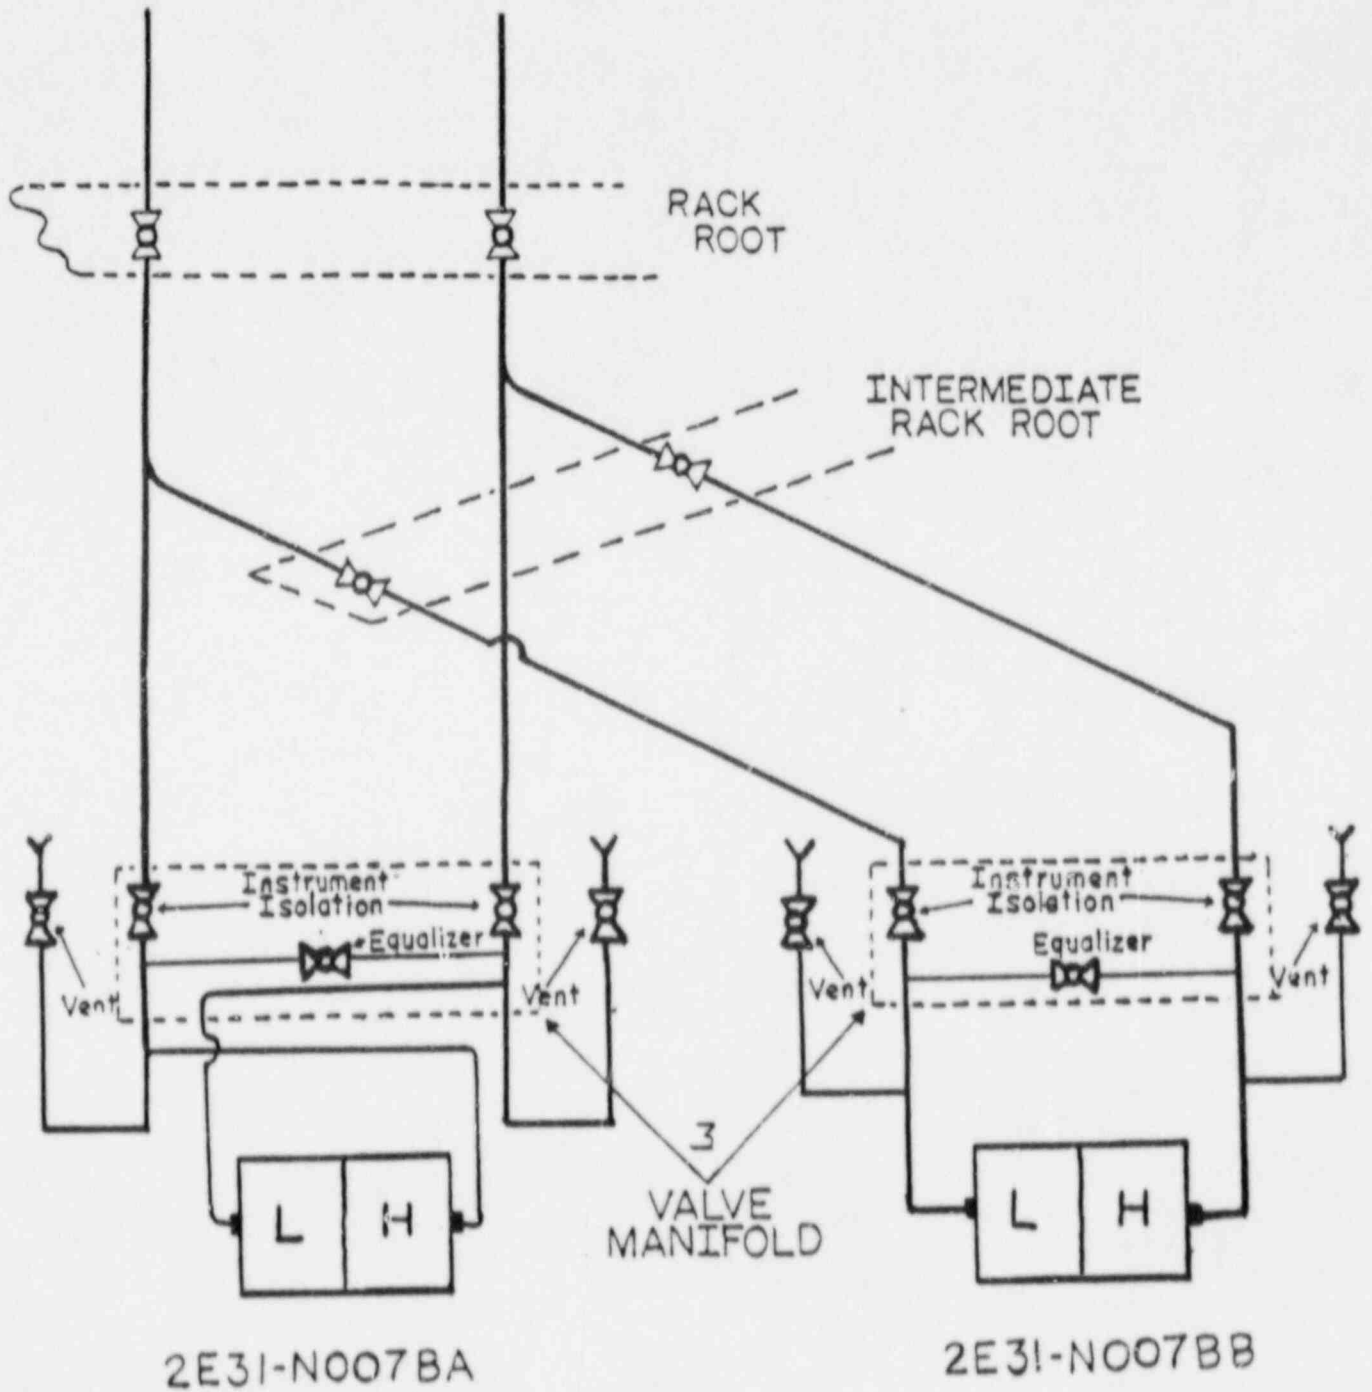
FIGURE 2.

After the 2E31-N007AA, AB and BA switches were satisfactorily tested and returned to service, the 2E31-N007BB switch high instrument isolation valve was closed, the equalizing valve was opened, the low instrument isolation valve closed and then the equalizing valve was reclosed. (See attached Figure 2 of the 2E31-N007BA and 7BB instrument configuration.)

Next, an attempt was planned to determine if the actual switch diaphragm was ruptured or if the 3 valve manifold equalizing valve was leaking. As a Work Request was outstanding indicating that a valve or valves on the manifold was leaking, the Instrument Mechanic proceeded to isolate the 3 valve manifold. In order to accomplish complete isolation of the N007BB switch (and its 3 valve manifold) without affecting the N007BA switch, the Instrument Mechanic closed the Intermediate Rack Root Valves. (See attached Figure 2.)

However, after completing the calibration procedure on the 2E31-N007BB switch the Instrument Mechanics performing the surveillance discovered that the two Intermediate Rack Root Valves were in the fully closed position, isolating PDS-2E31-N007BB.

Because of the fact that the 2E31-N007BB switch actuated, even though it was isolated, it is postulated that one or both of the Intermediate Rack Root Valves were leaking. Even a very small leak would allow one side to depressurize faster than the other.

1. Walkdown all Unit 2 Safety Related instrument racks which have Intermediate Rack Root Valves and verify the valves are open. This was completed prior to Unit 2 Startup. The Instrument Maintenance Department has lockwired these valves in the open position.
